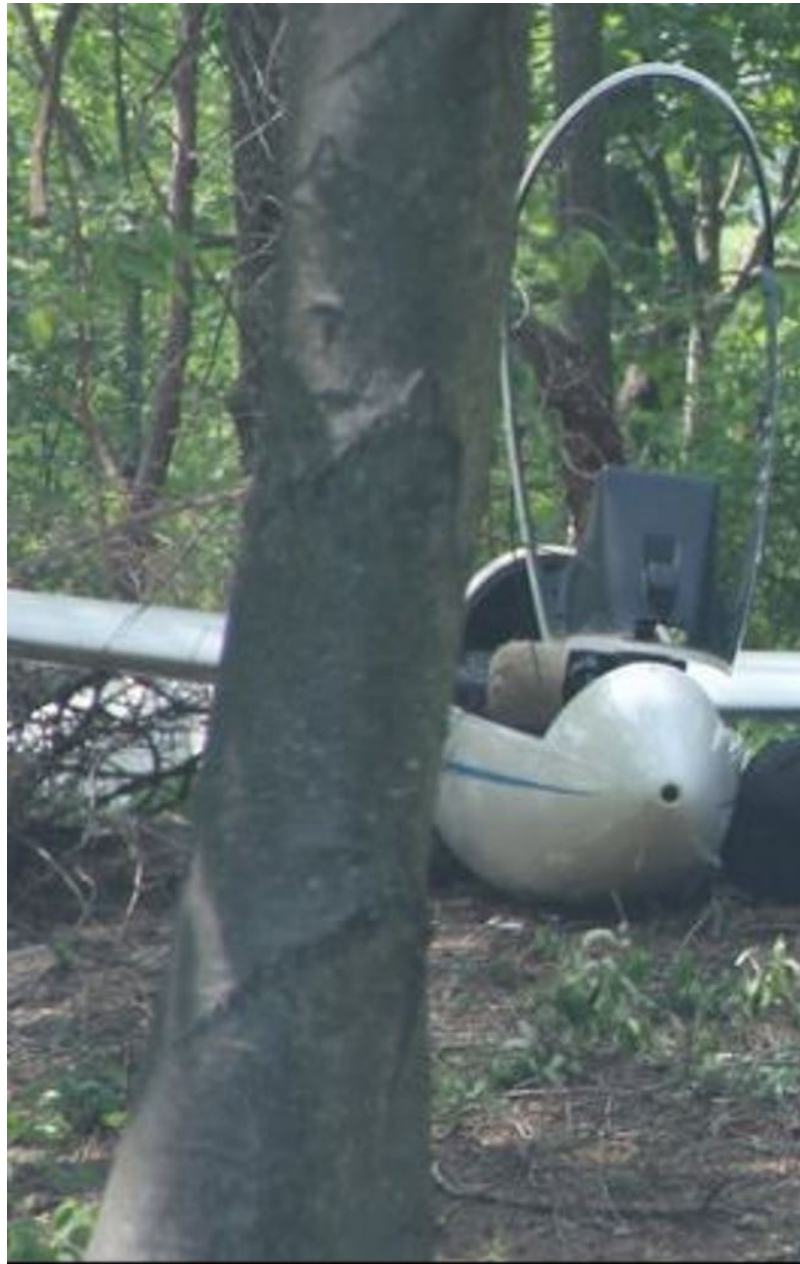
**Photo 1 – View of damage to the canopy and right side of empennage (Courtesy of Kathryn's Report)**
