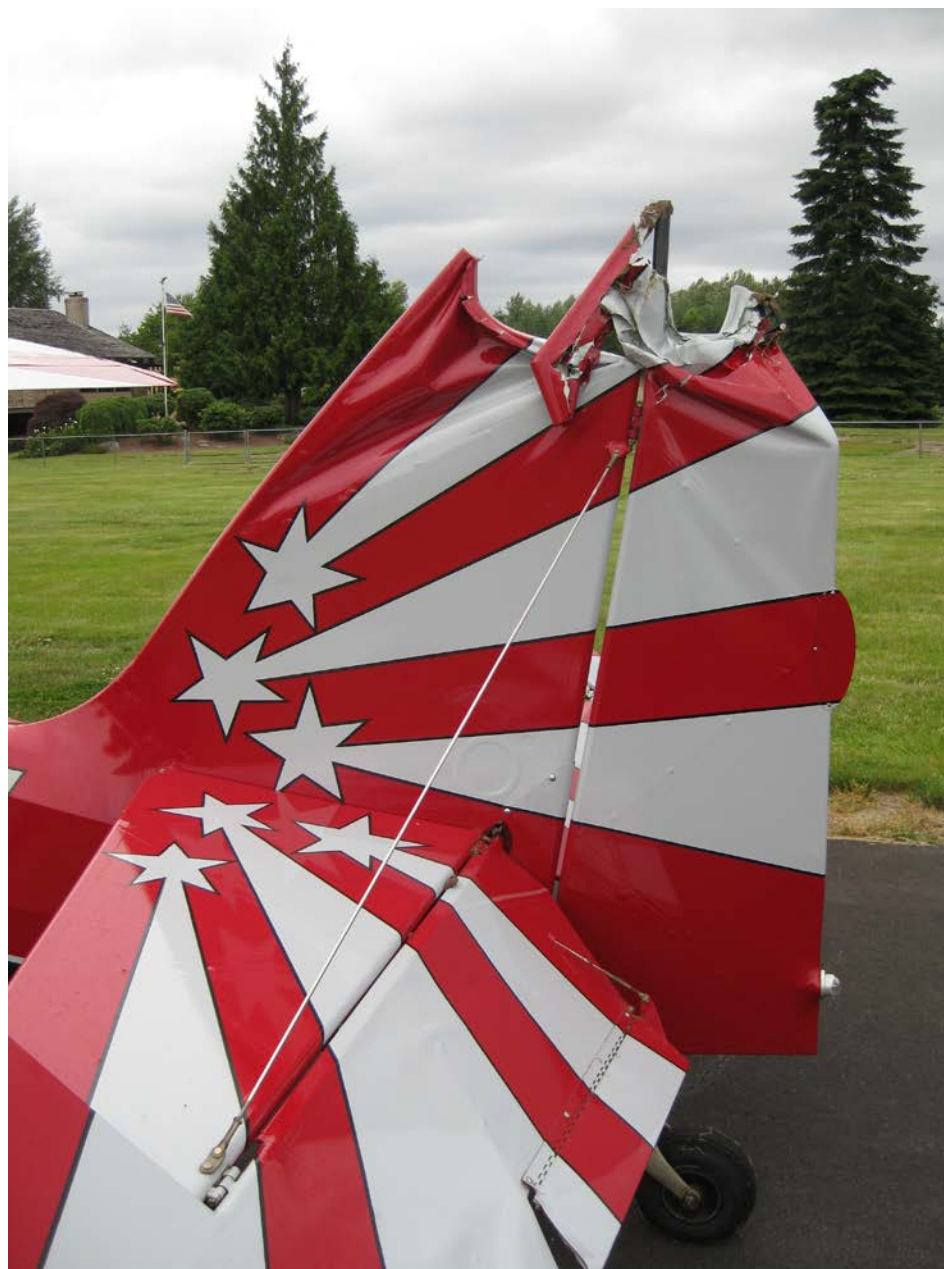
**Photo 1 – View of damaged empennage (photo courtesy of the FAA)**
