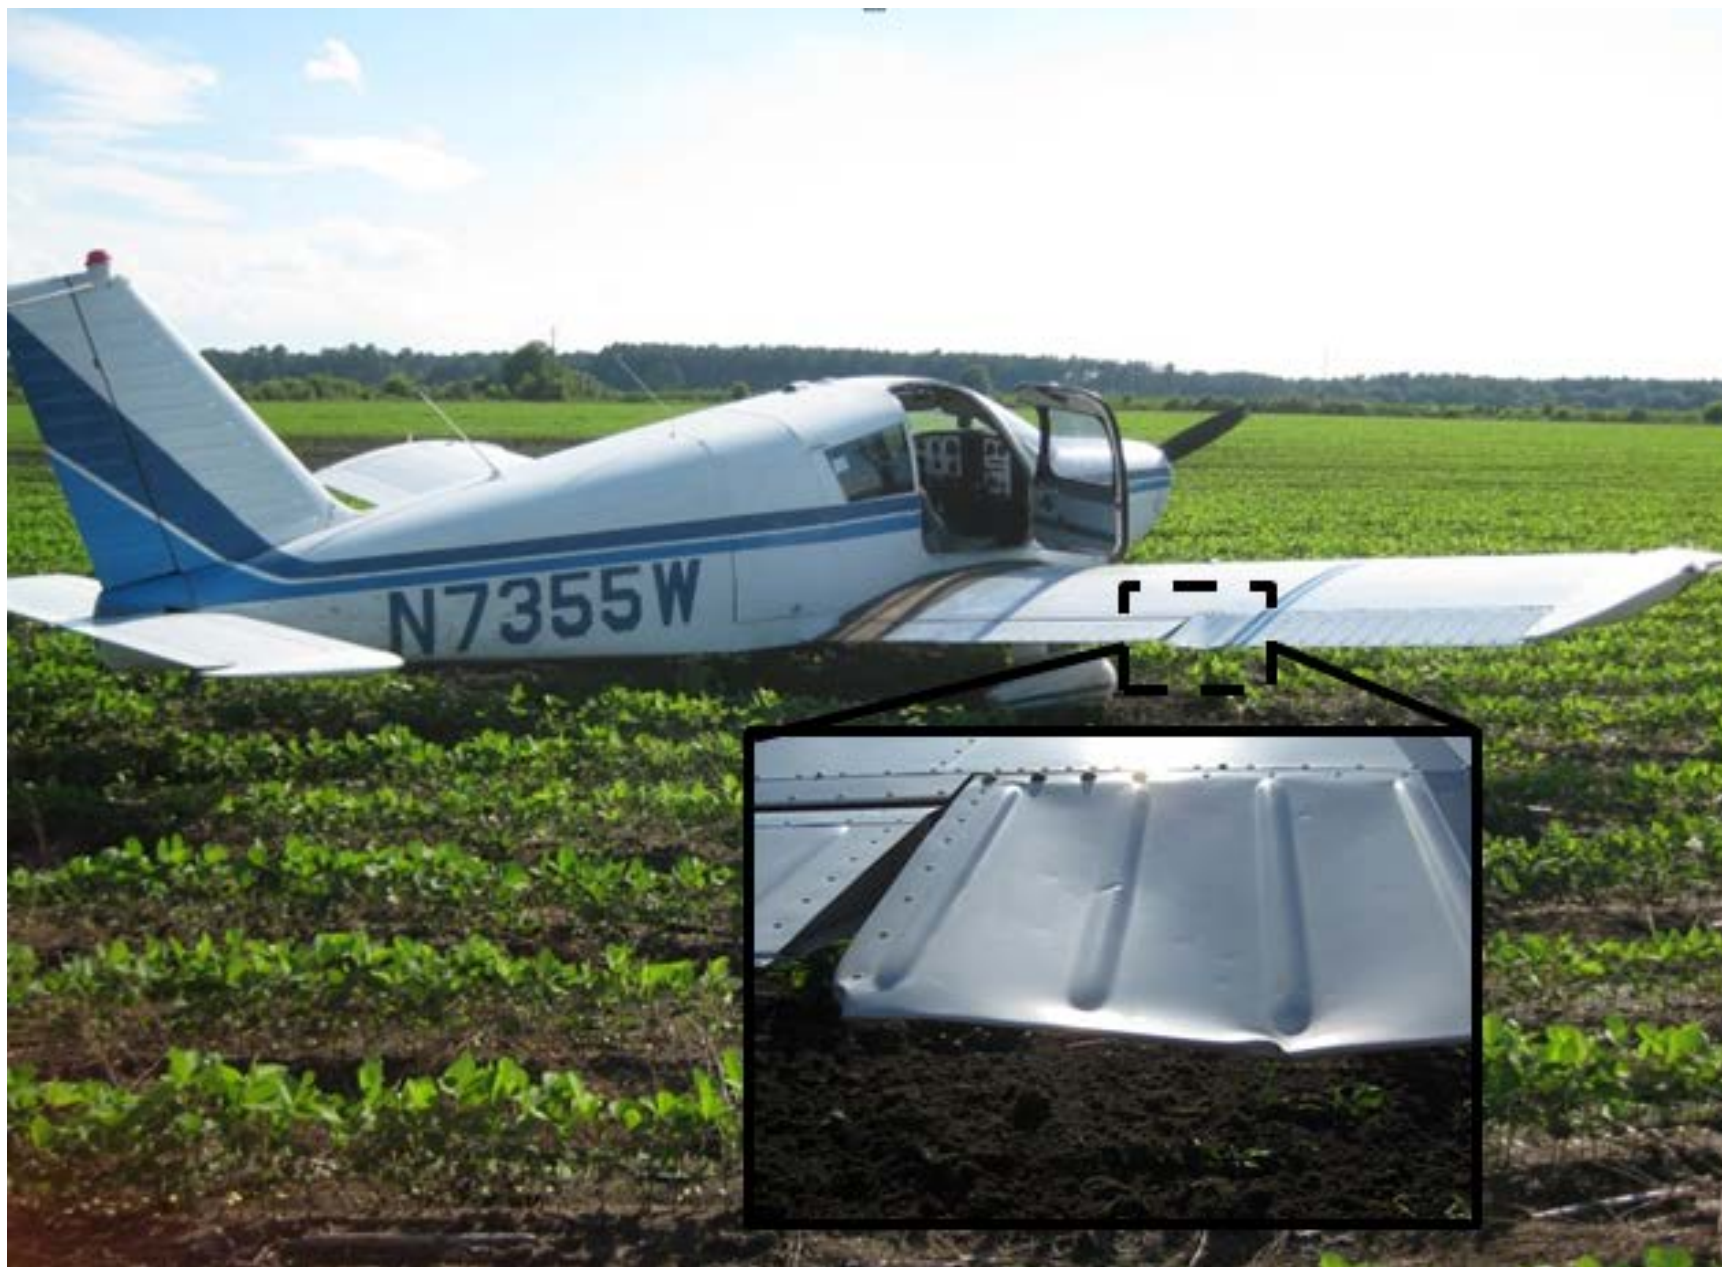
**Photo 1 – View of damaged right aileron (photo courtesy of the FAA)**

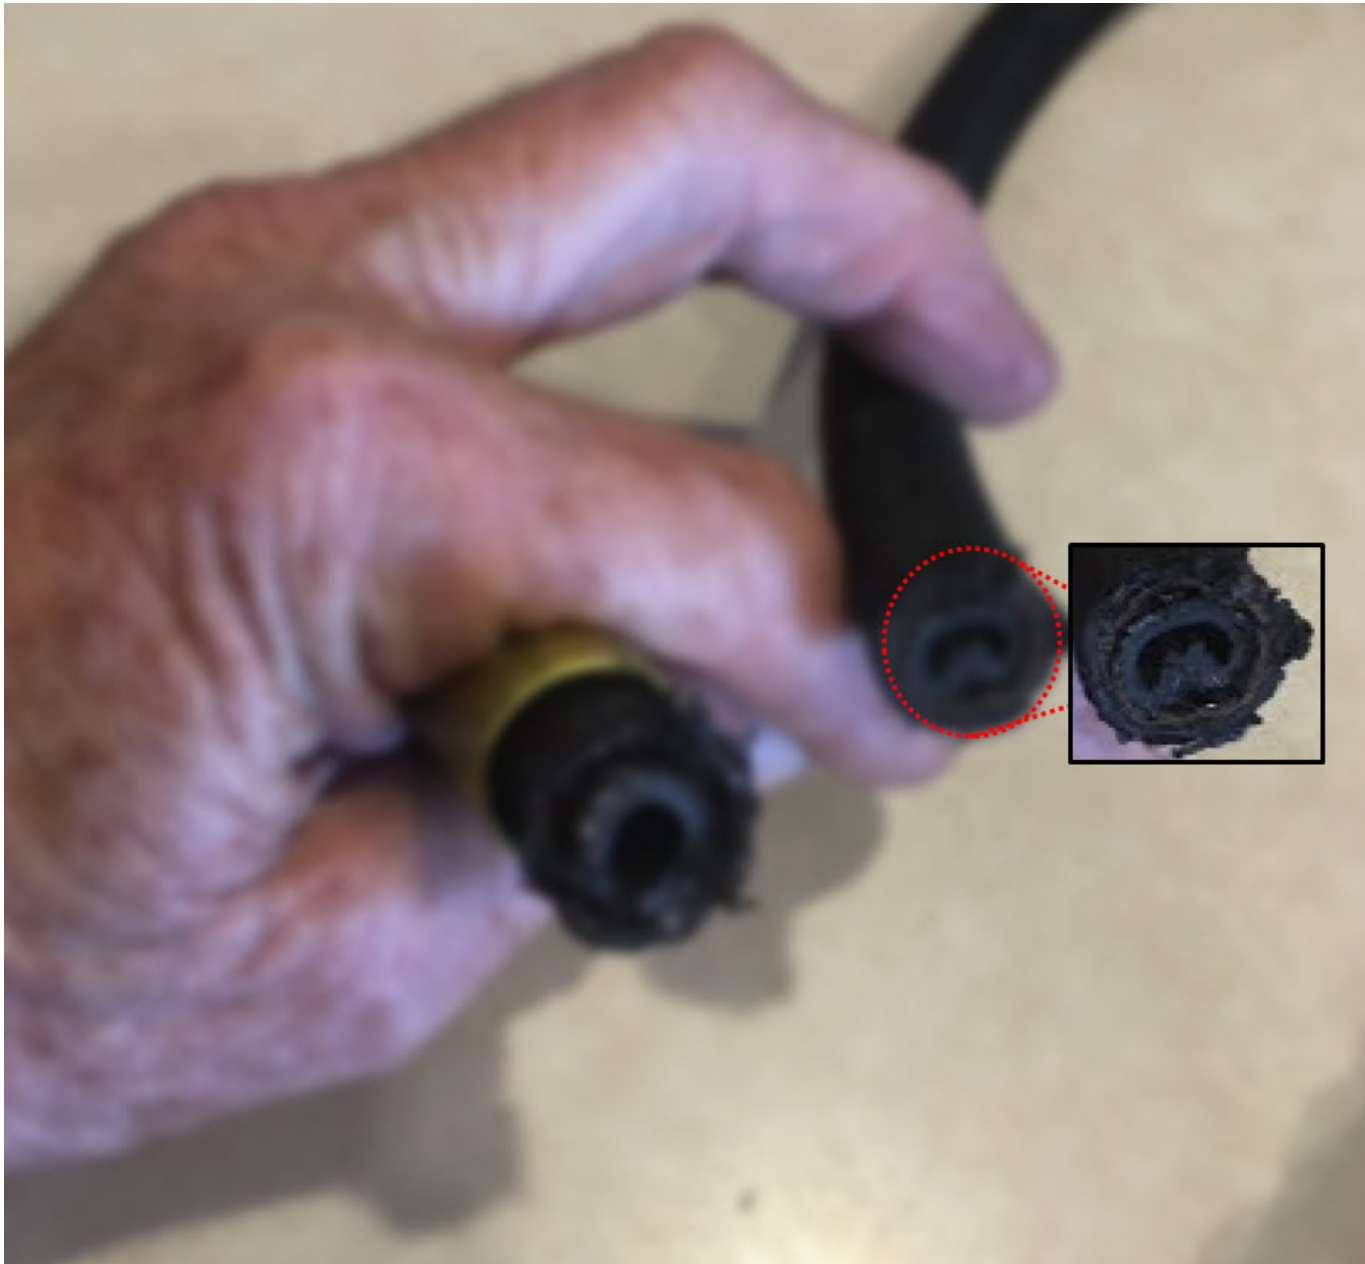
**Photo 2 - View of damaged fuel line (photo courtesy of the FAA)**
