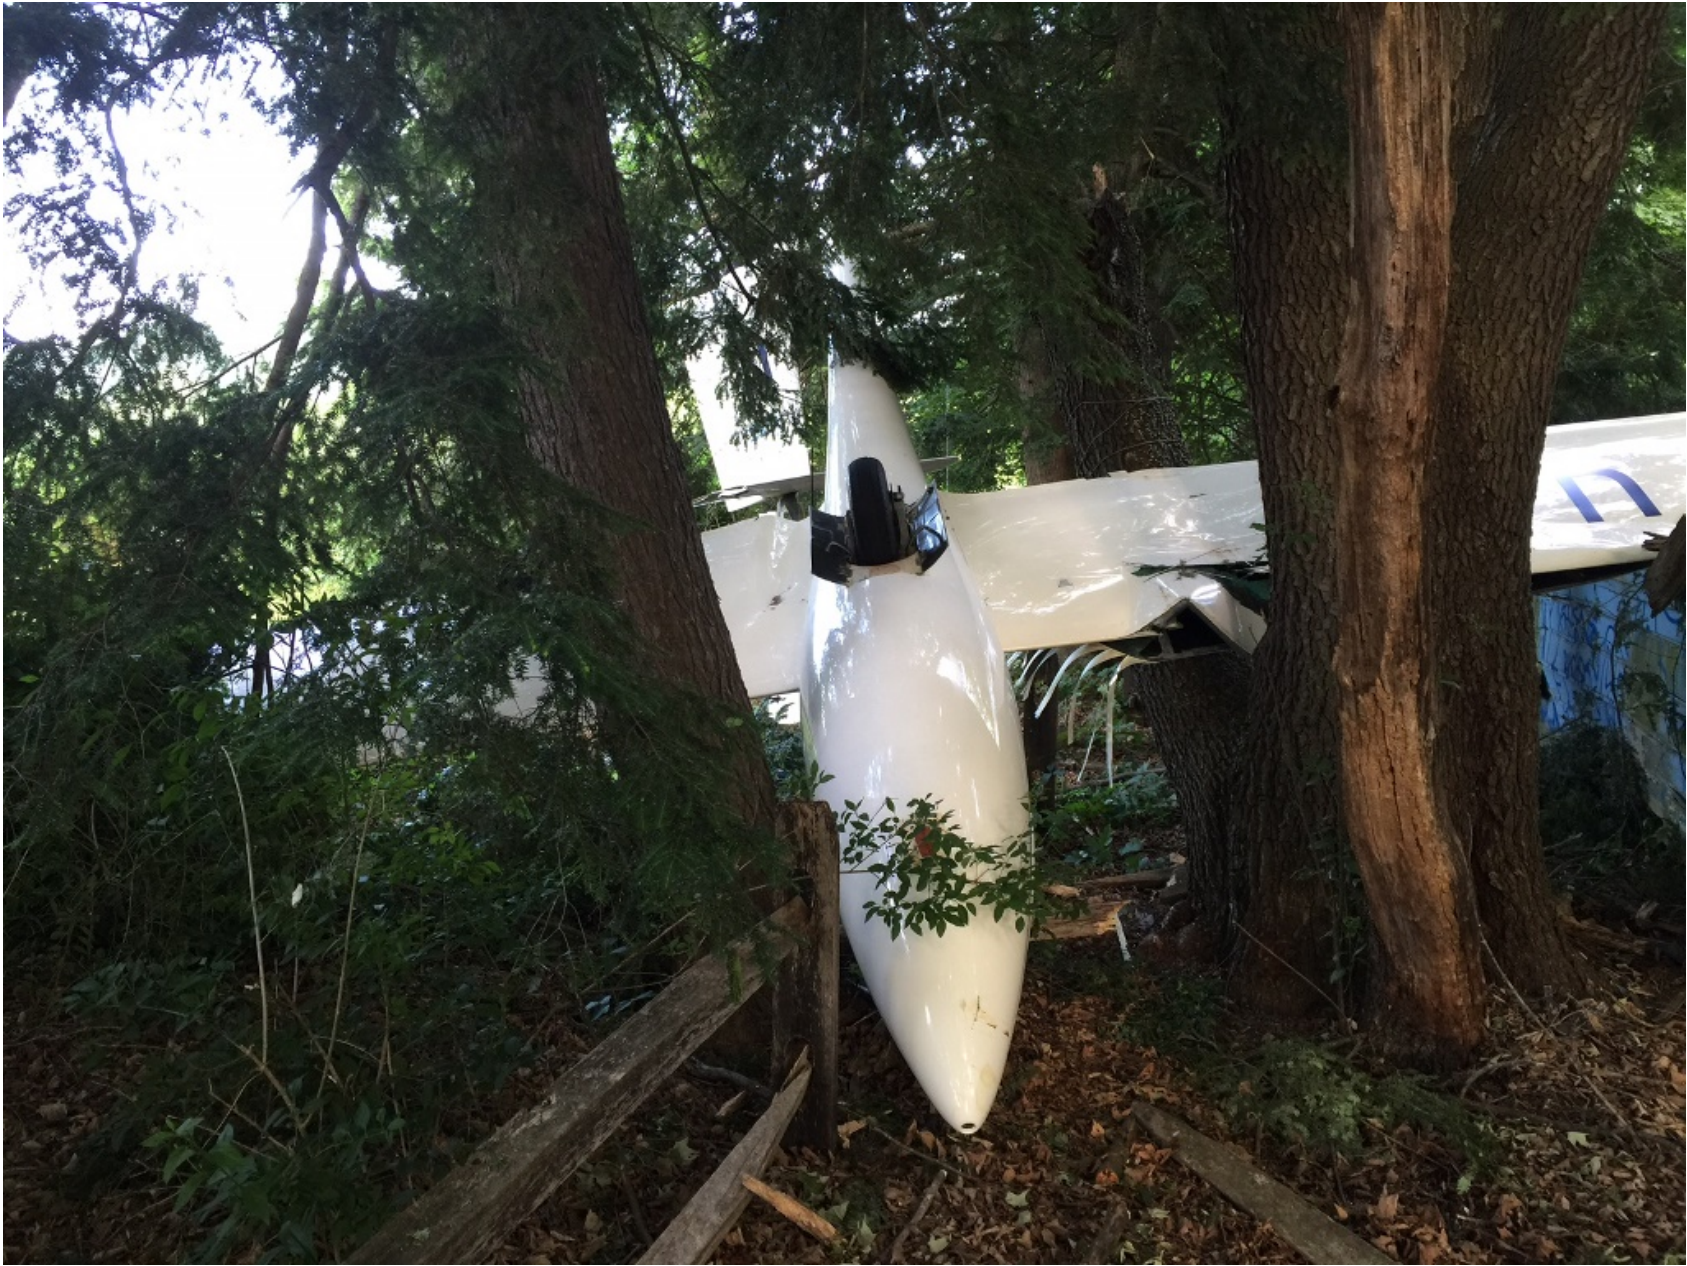
**Photo 1 – View of inverted glider with damage to right wing and empennage (Courtesy of FAA)**

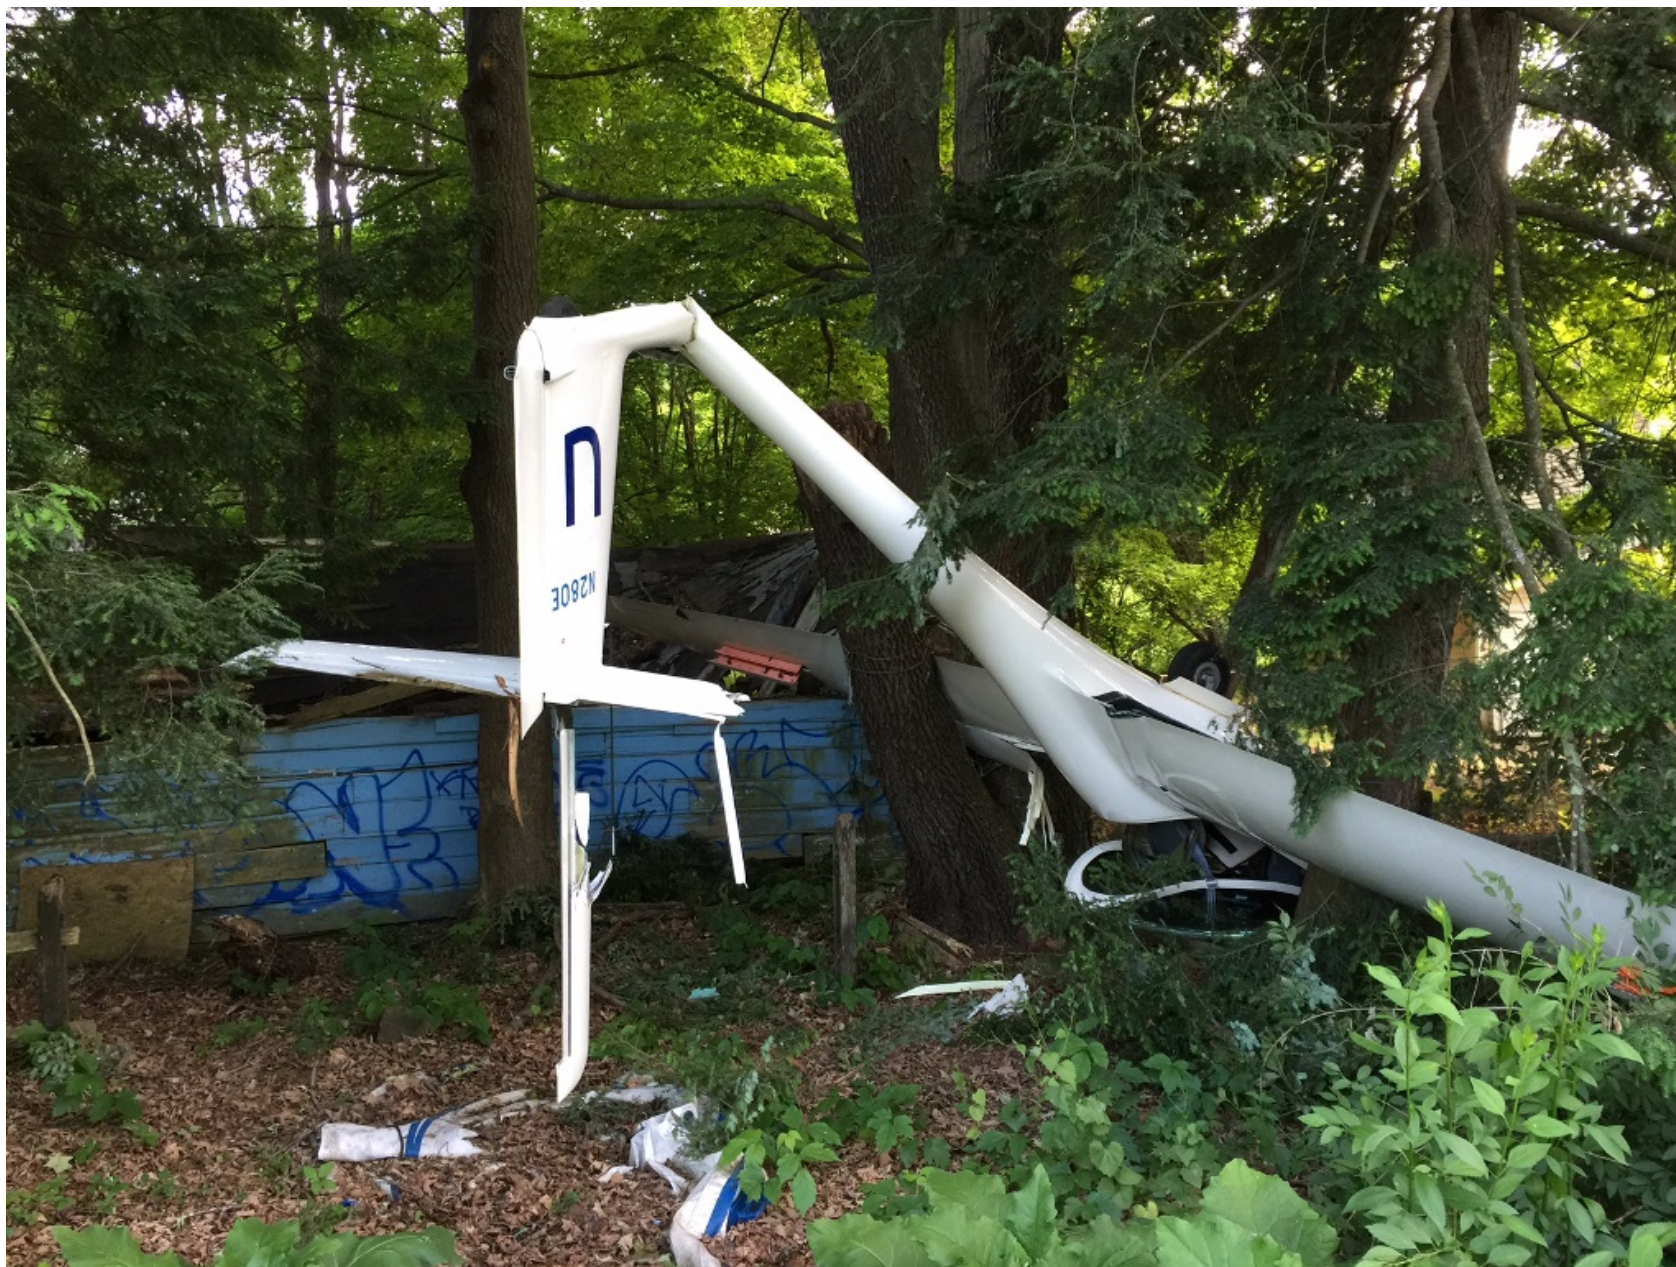
**Photo 2 – View of damage to both wings and empennage (Courtesy of FAA)**
