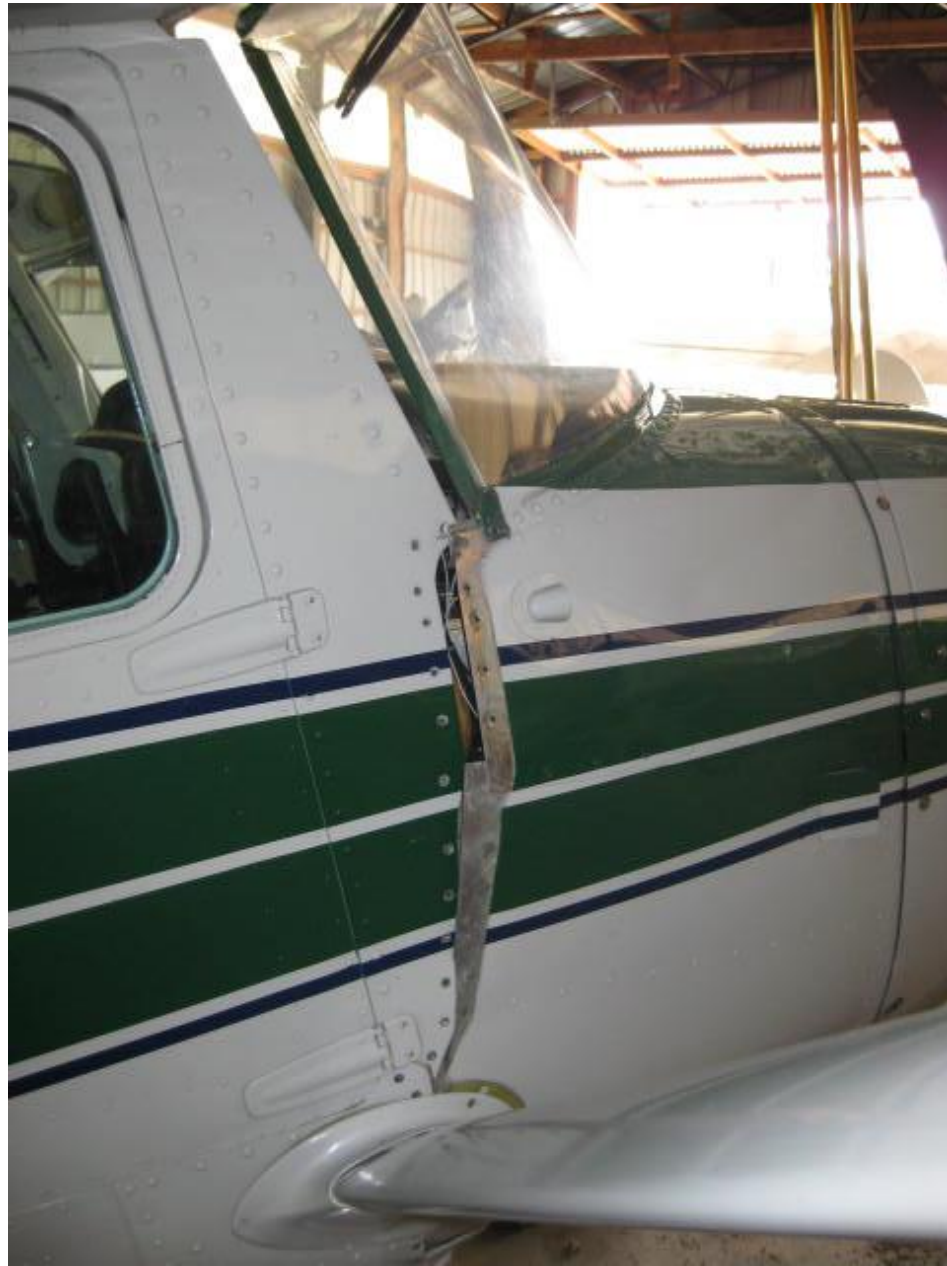
**Photo 1 –View of right side fuselage separation (Courtesy of the FAA)**

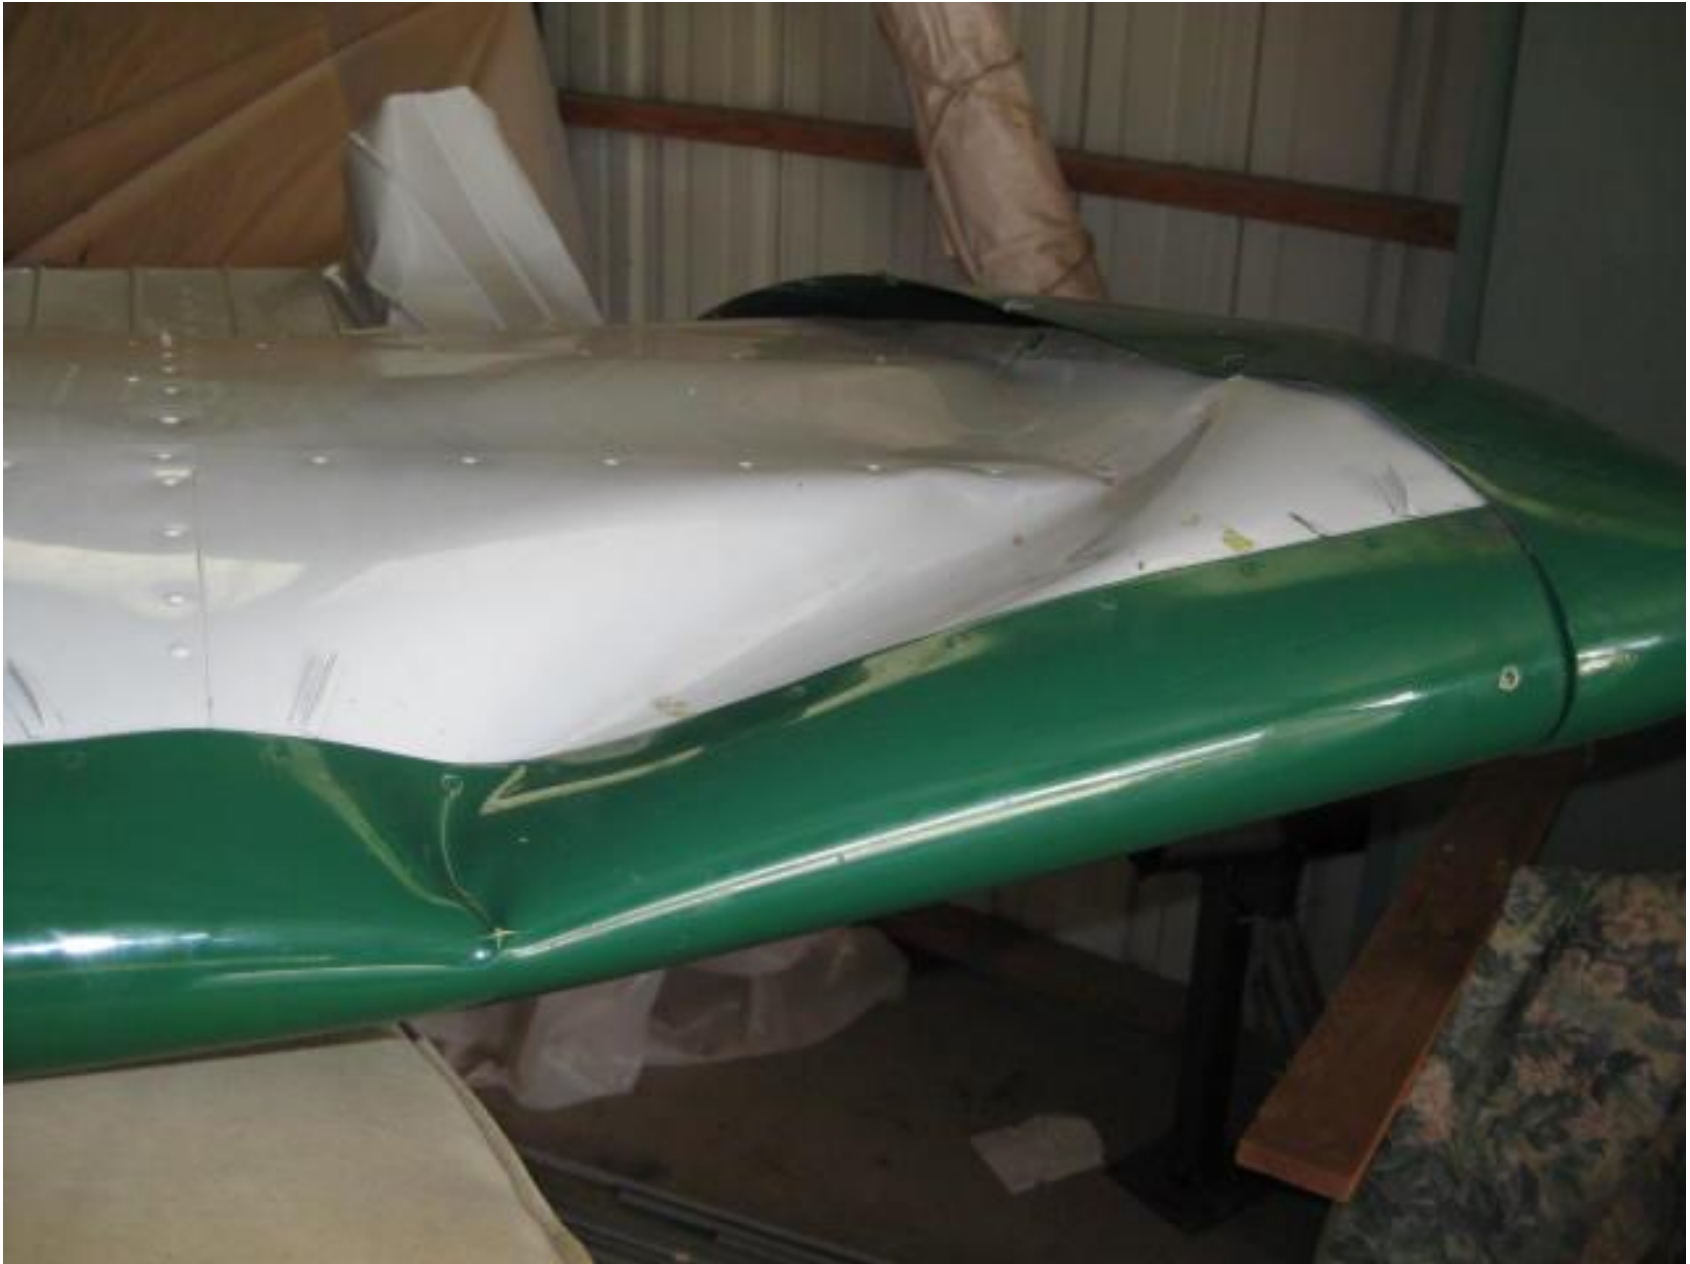
**Photo 2 – Left wing leading edge damage (Courtesy of the FAA)**

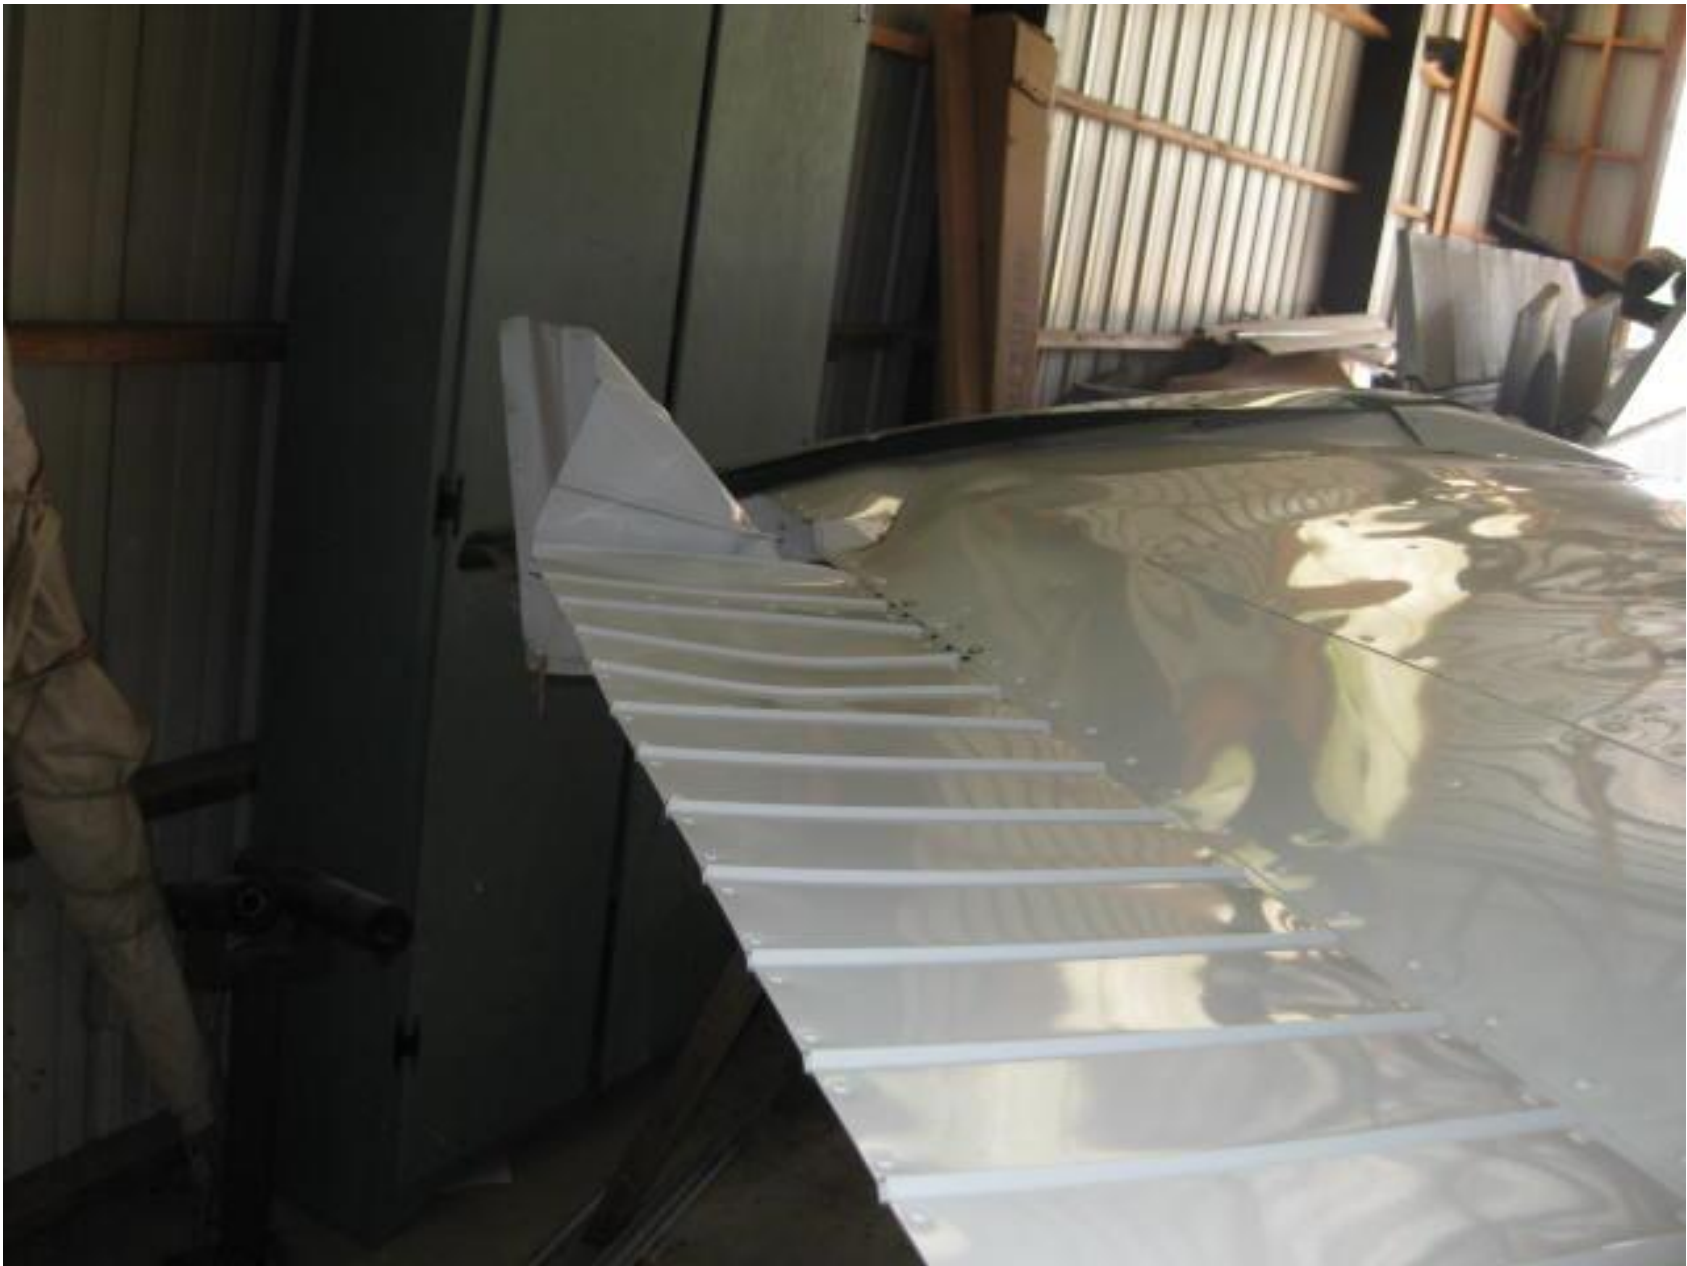
**Photo 3 – Left wing trailing edge and aileron damage (Courtesy of the FAA)**

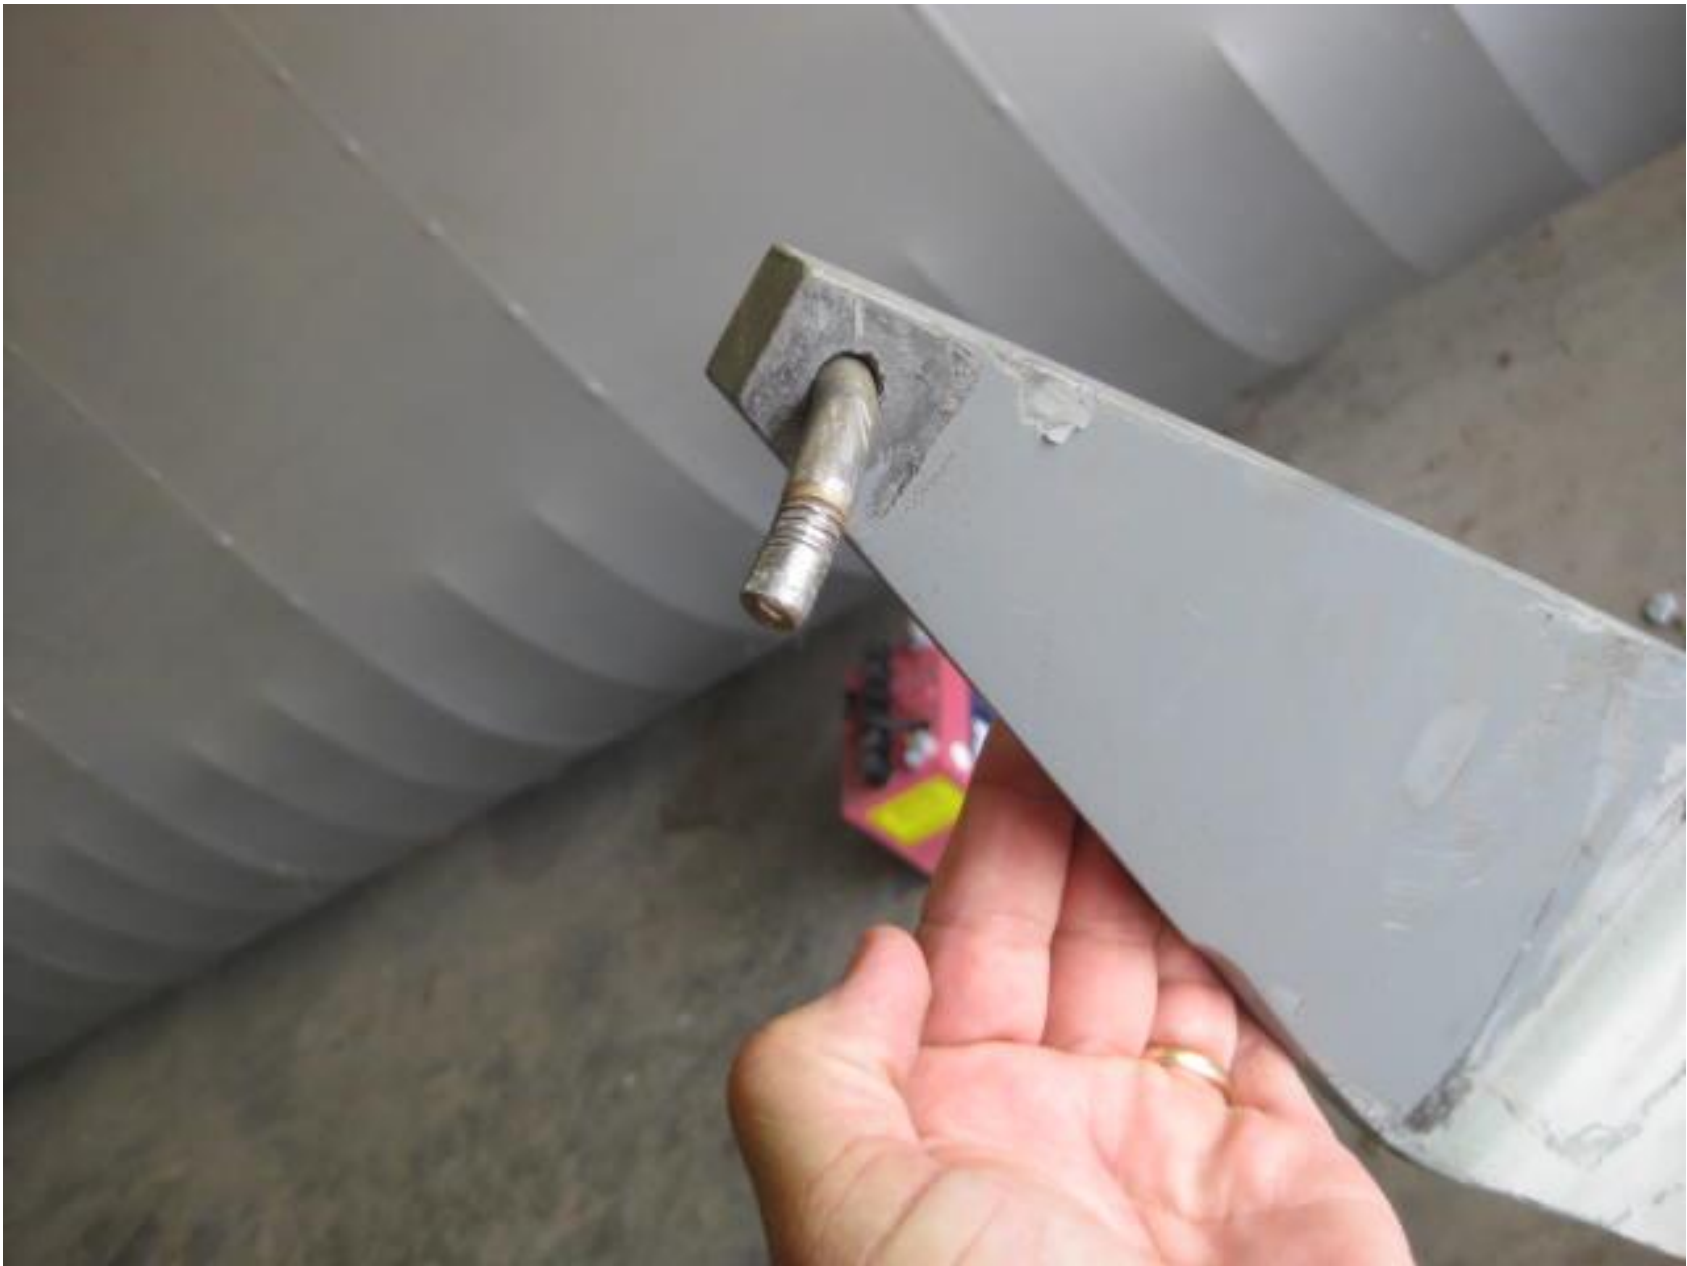
**Photo 4 – Left landing gear attach bolt (Courtesy of the mechanic)**

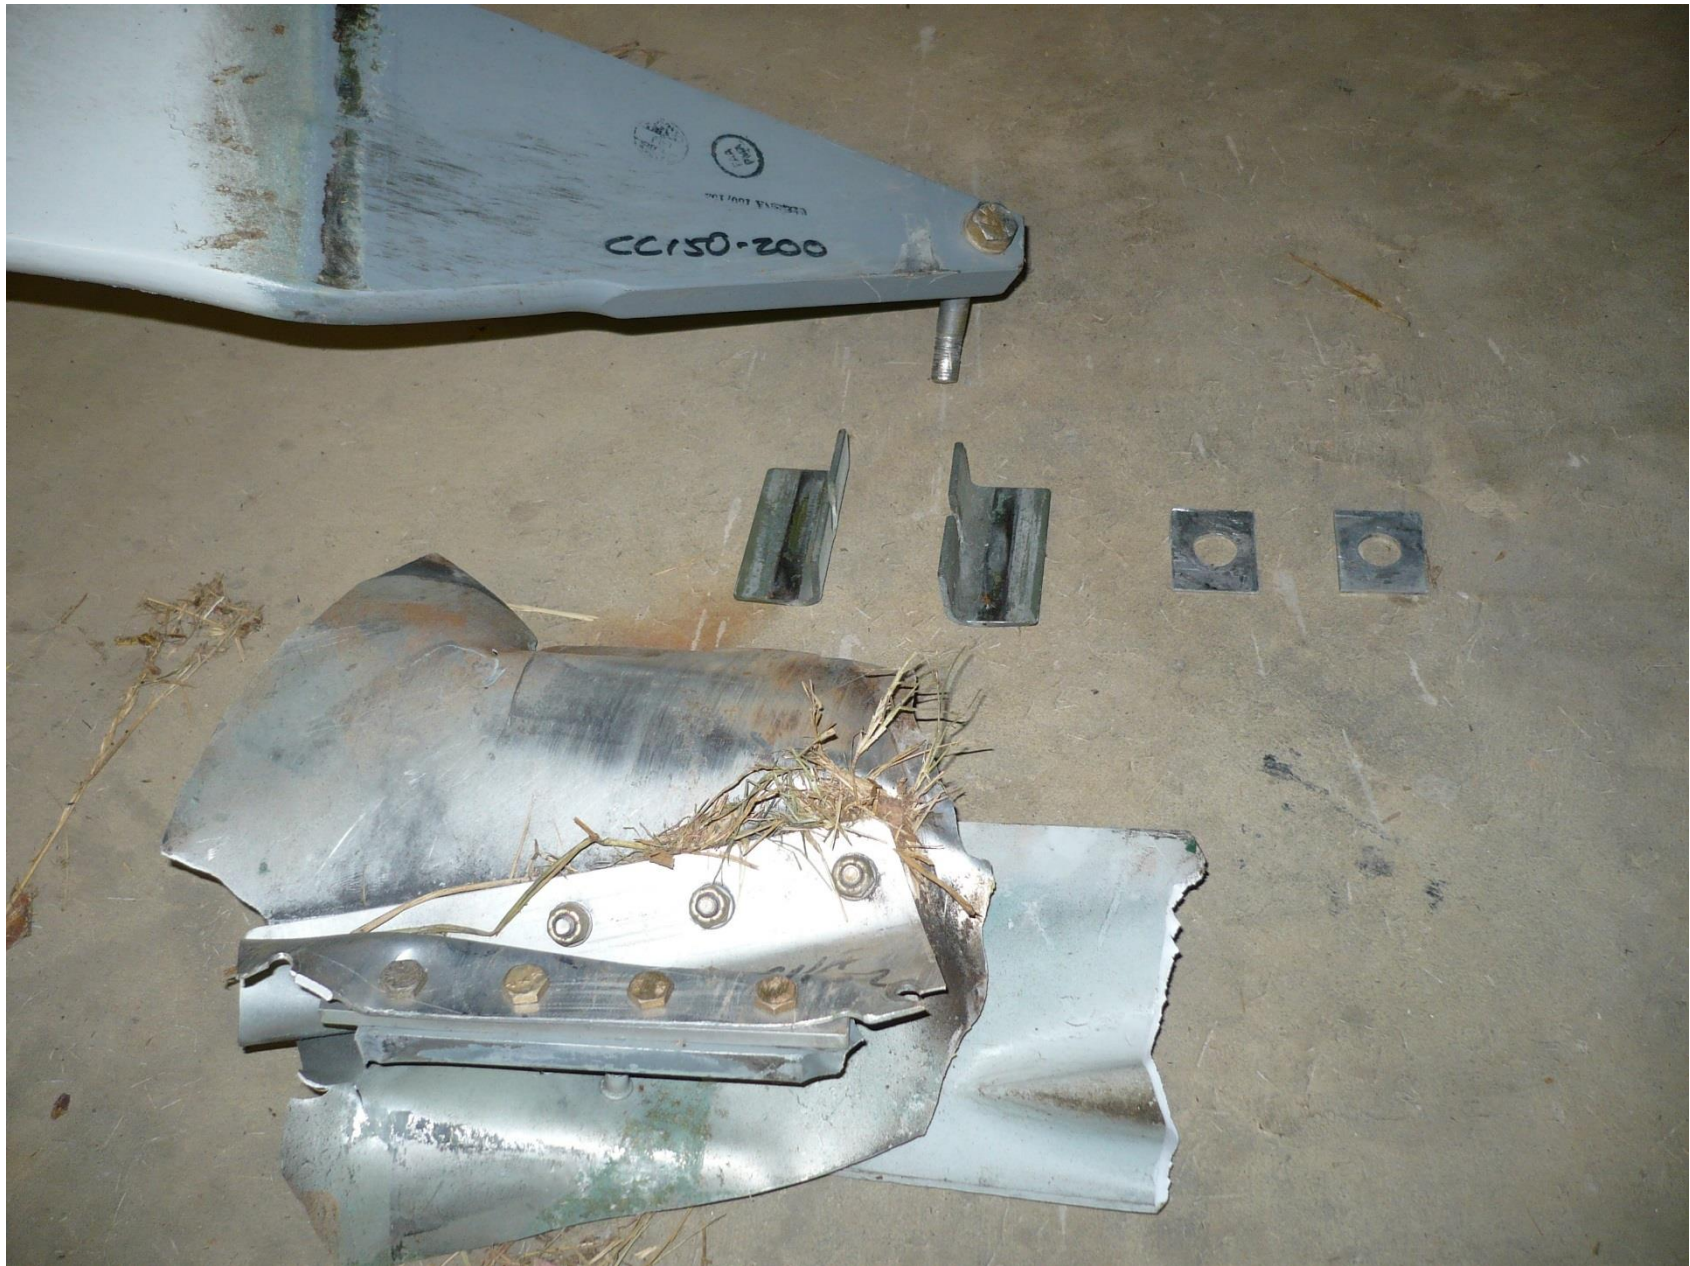
**Photo 5 – Torn left landing gear support and gear leg (Courtesy of the mechanic)**
