## Accident Report N801G occurring 07/16/2016

Samuel S McNair, Jr PE, CMRP, A&P, COM/INSTR ASME

### Summary:

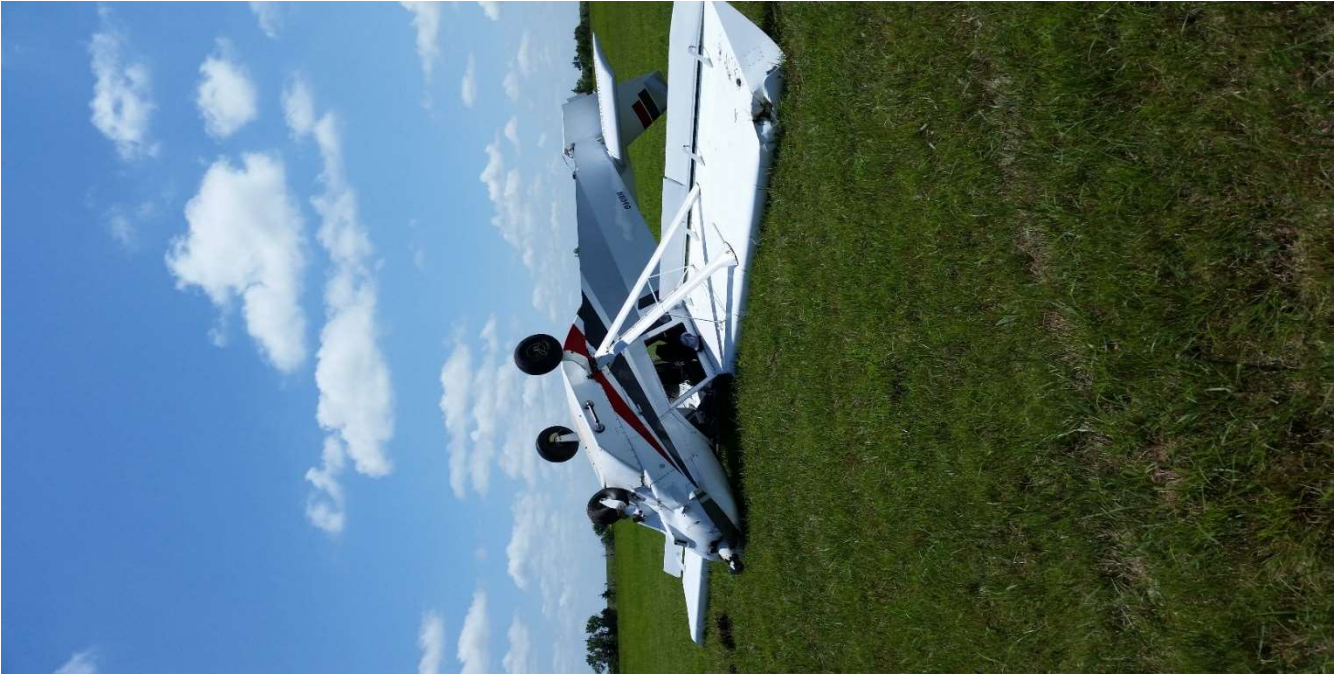
The second touch down was at about a 20 to 30 degree angle to the direction of travel at stall speed in a 3 point to possibly nose first contact. The nose went down much lower than usual on contact, followed by prop strike, almost immediately nose gear collapse. I held back full stick and kept the upwind wing down as we slid. After a short slide, the elevator lost authority, and from the marks in the sod (soft but acceptable) the nose began to slice into the turf and gradually over a distance of possibly 25 to 30 feet in dug in and the plane flipped over onto its back with substantial damage as it slid for a short distance until the rudder dug into the ground, bent and stopped it. This would have happened at about 12:30 PM CDT.

**Photo of aircraft in situ**

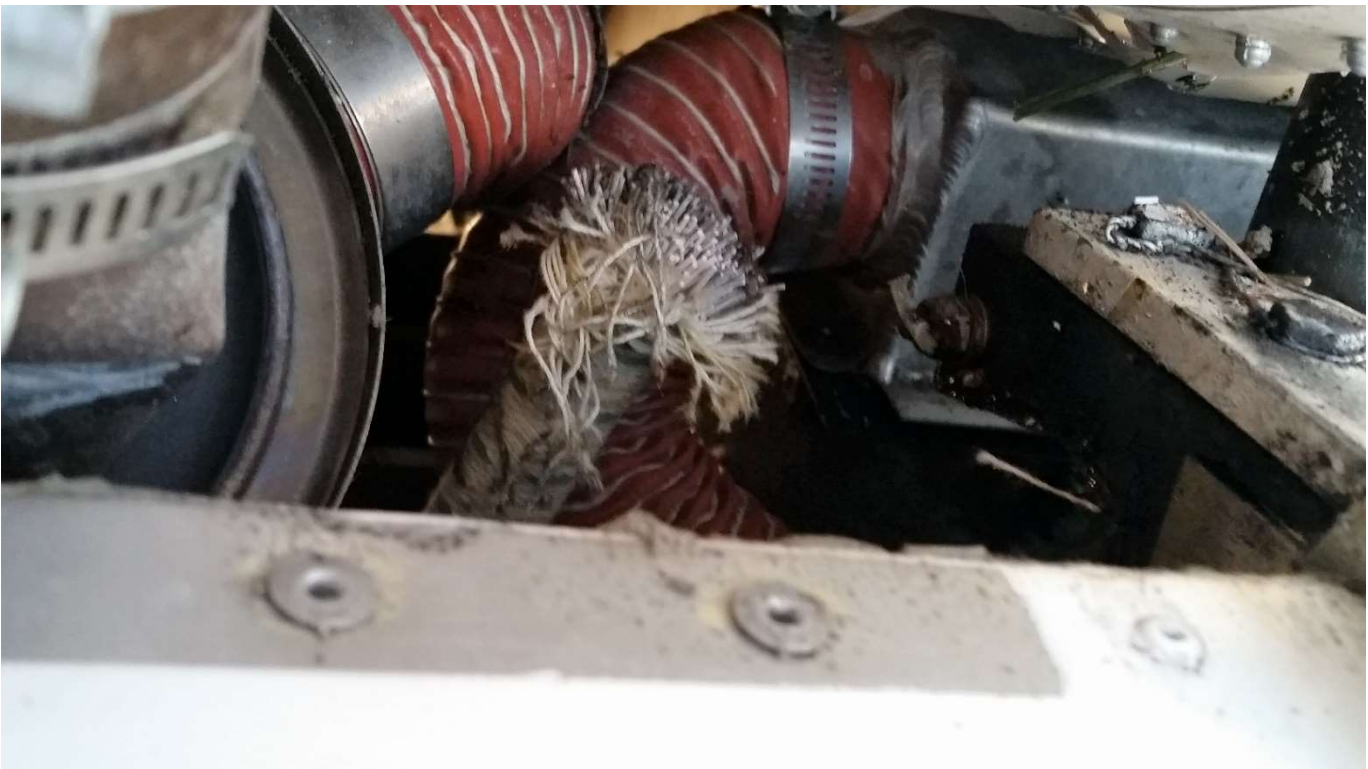
**I believe that the bungee failed on the initial bounce, and that a rudder lock up is what prevented rudder action, directly contributing to the nose over. A hard landing in the gusting cross wind was the contributing factor. I believe that what I perceived to be lack of rudder authority was in fact a locked control.** The post crash examination of the rudder, which was locked into its last position when the AC flipped indicated that it had been deflected only 10 degrees or so to the left. This is not consistent with an attempted full left application of rudder.

**Photo of failed bungee in situ** at scene of the accident. Notice oil residue discoloration on front strands.

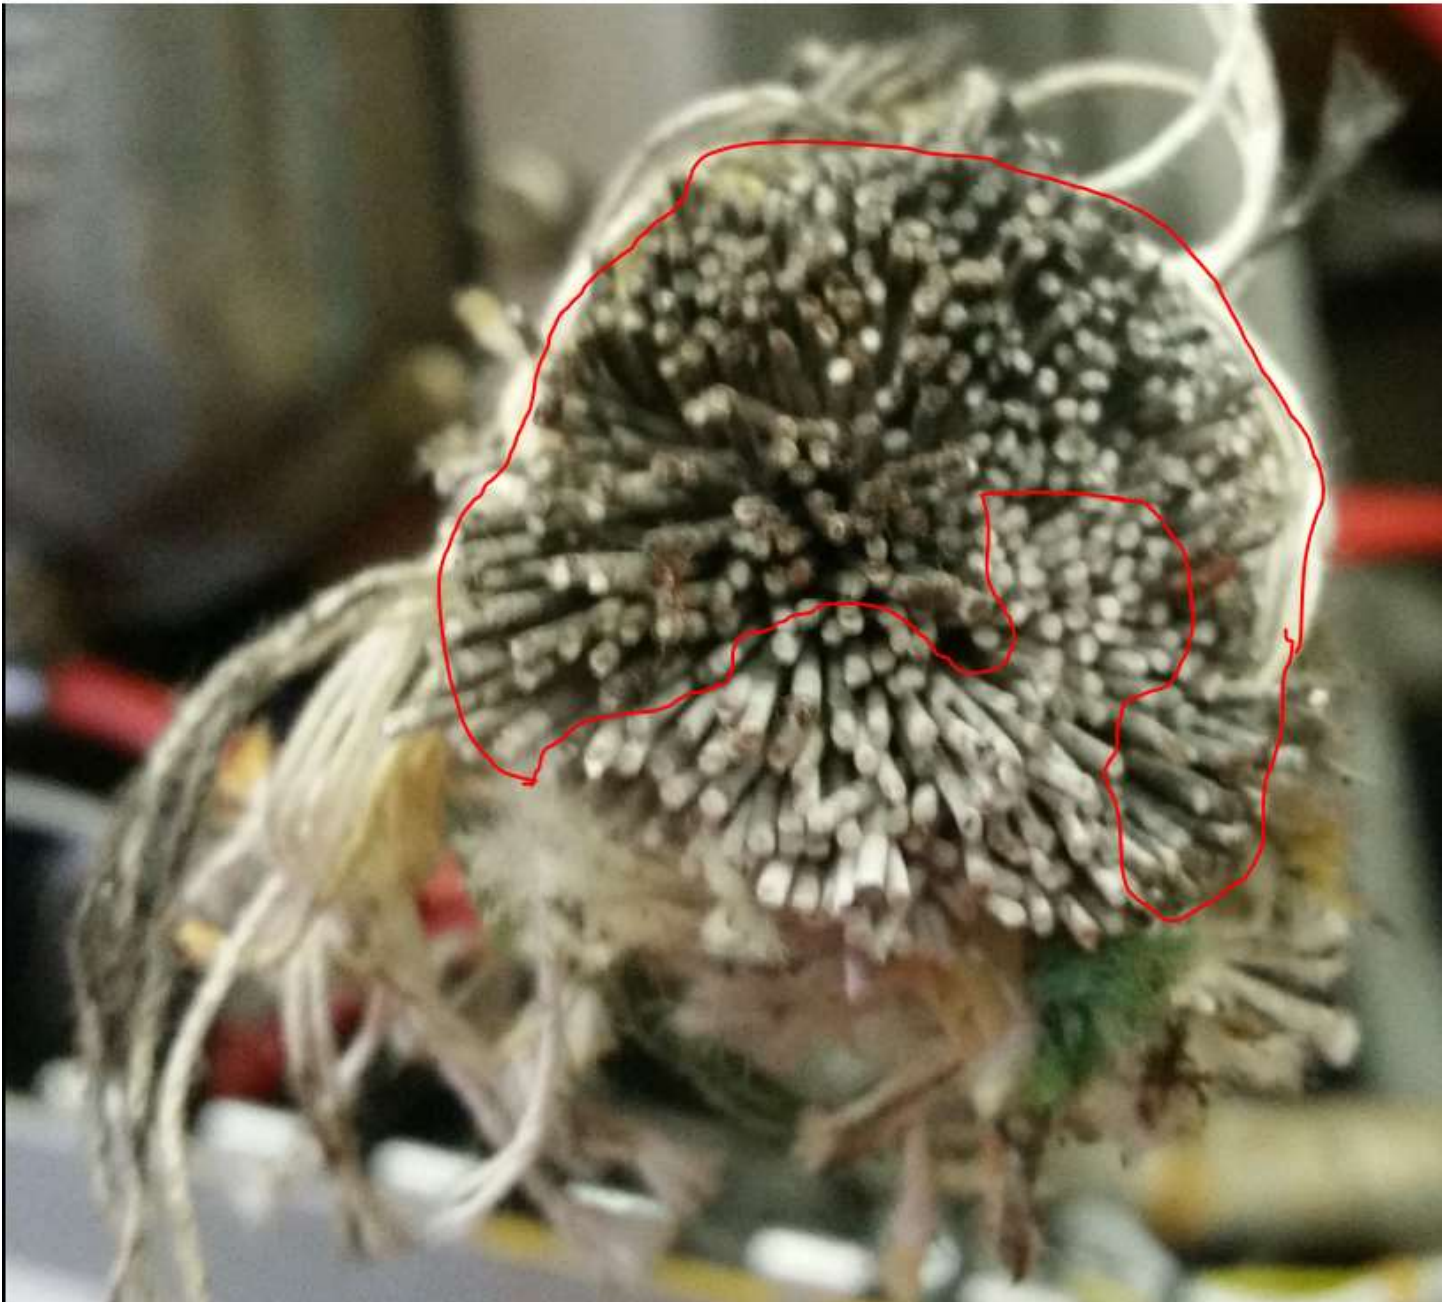
Upon closer examination of the failed bungee it was observed that the broken rubber strands for about 1/2 to 2/3 of the diameter on one side have oil on them. (see photo) The bungee is located in the cooling exhaust air stream so they collect oil on exposed surfaces. As the Zenith Builders Web thread indicates temperature is a contributing factor to deterioration. This AC is equipped with a cargo pod which causes the engine to operate about 50°F hotter than usual resulting in hotter exhausted cooling air. This may have been a contributing factor to deterioration of the bungee.

The remaining strands were clean. **This indicates that the bungee was already partially failed when I first landed.** There is no mandatory replacement time in service for this part. Reports of from 10 years to as little as a few weeks in service before failure have been reported on the builder's web site. The general consensus is that it should be looked at frequently and replaced after about 2 years in service. For this AC that would have occurred during the upcoming Oct 2016 condition inspection (moved forward from December to synchronize with my BFR and Medical). In my written AC project plan I had intended to replace this with the steel spring bungee upgrade. It is nearly impossible to do a full inspection with the AC cowed. It is my practice to visually inspect it and the strut height (an indicator of aging) whenever the cowl is off for oil change or other service. This visual check was last done on 05/15/2016 when the cowl was removed to take out the oil cooler winterization plate (see logbook) and I observed no abnormalities. But the AC has made on the order of 50 landings since them, about 1/3 on sod strips.

**Photo of Bungee after AC recovered** and bungee removed. Note area outlined in RED having fibers with oil / exhaust stains
