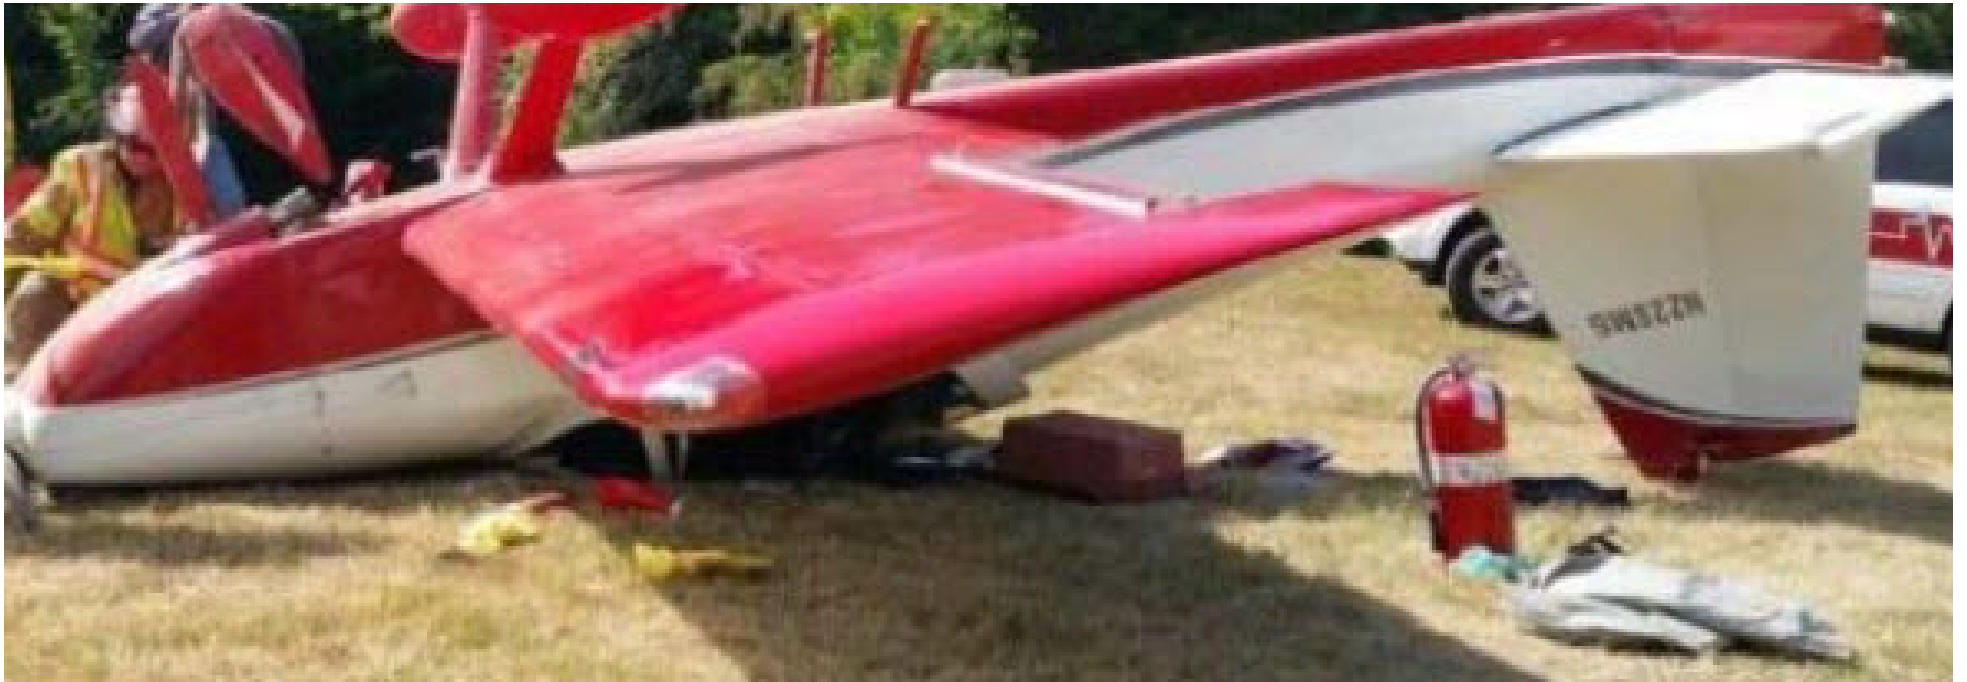
**Photo 1 – View of airplane from side (photo courtesy of the FAA)**

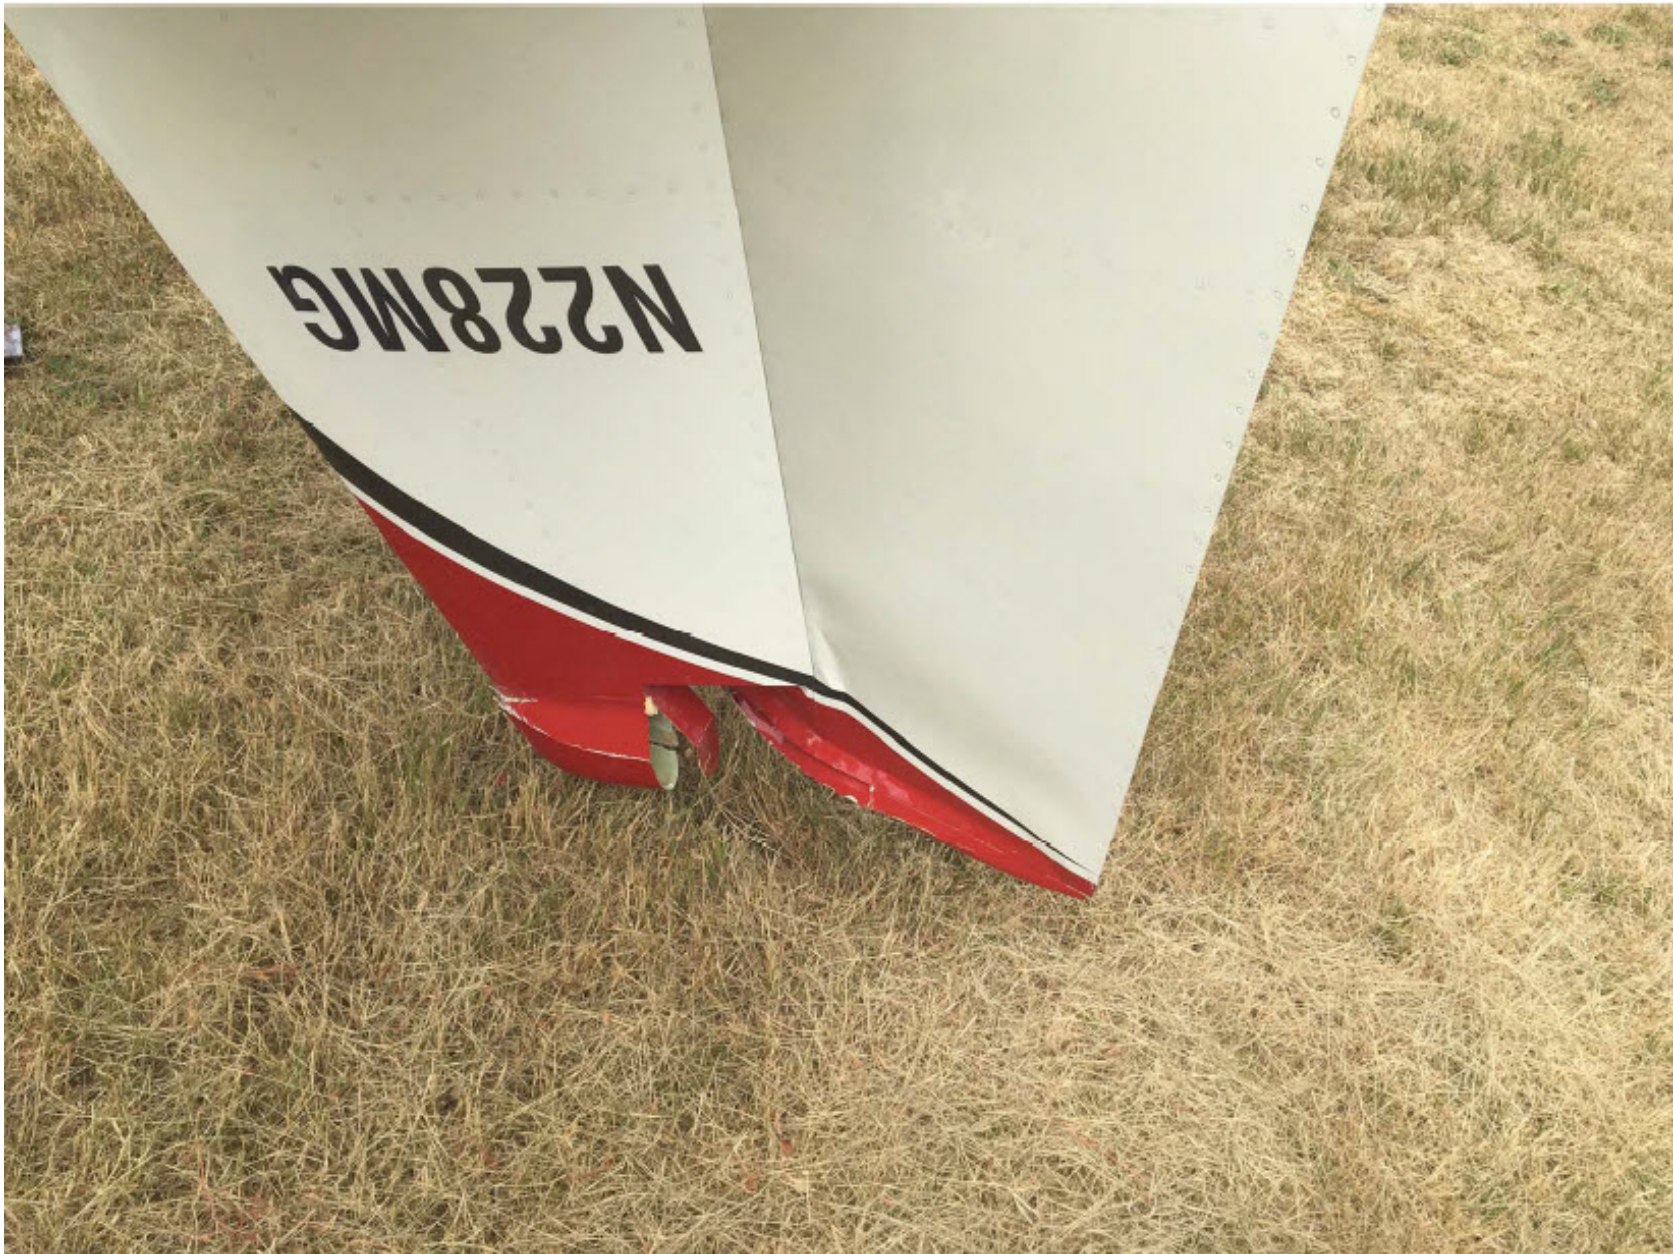
**Photo 2 - View of empennage damage (photo courtesy of the FAA)**
