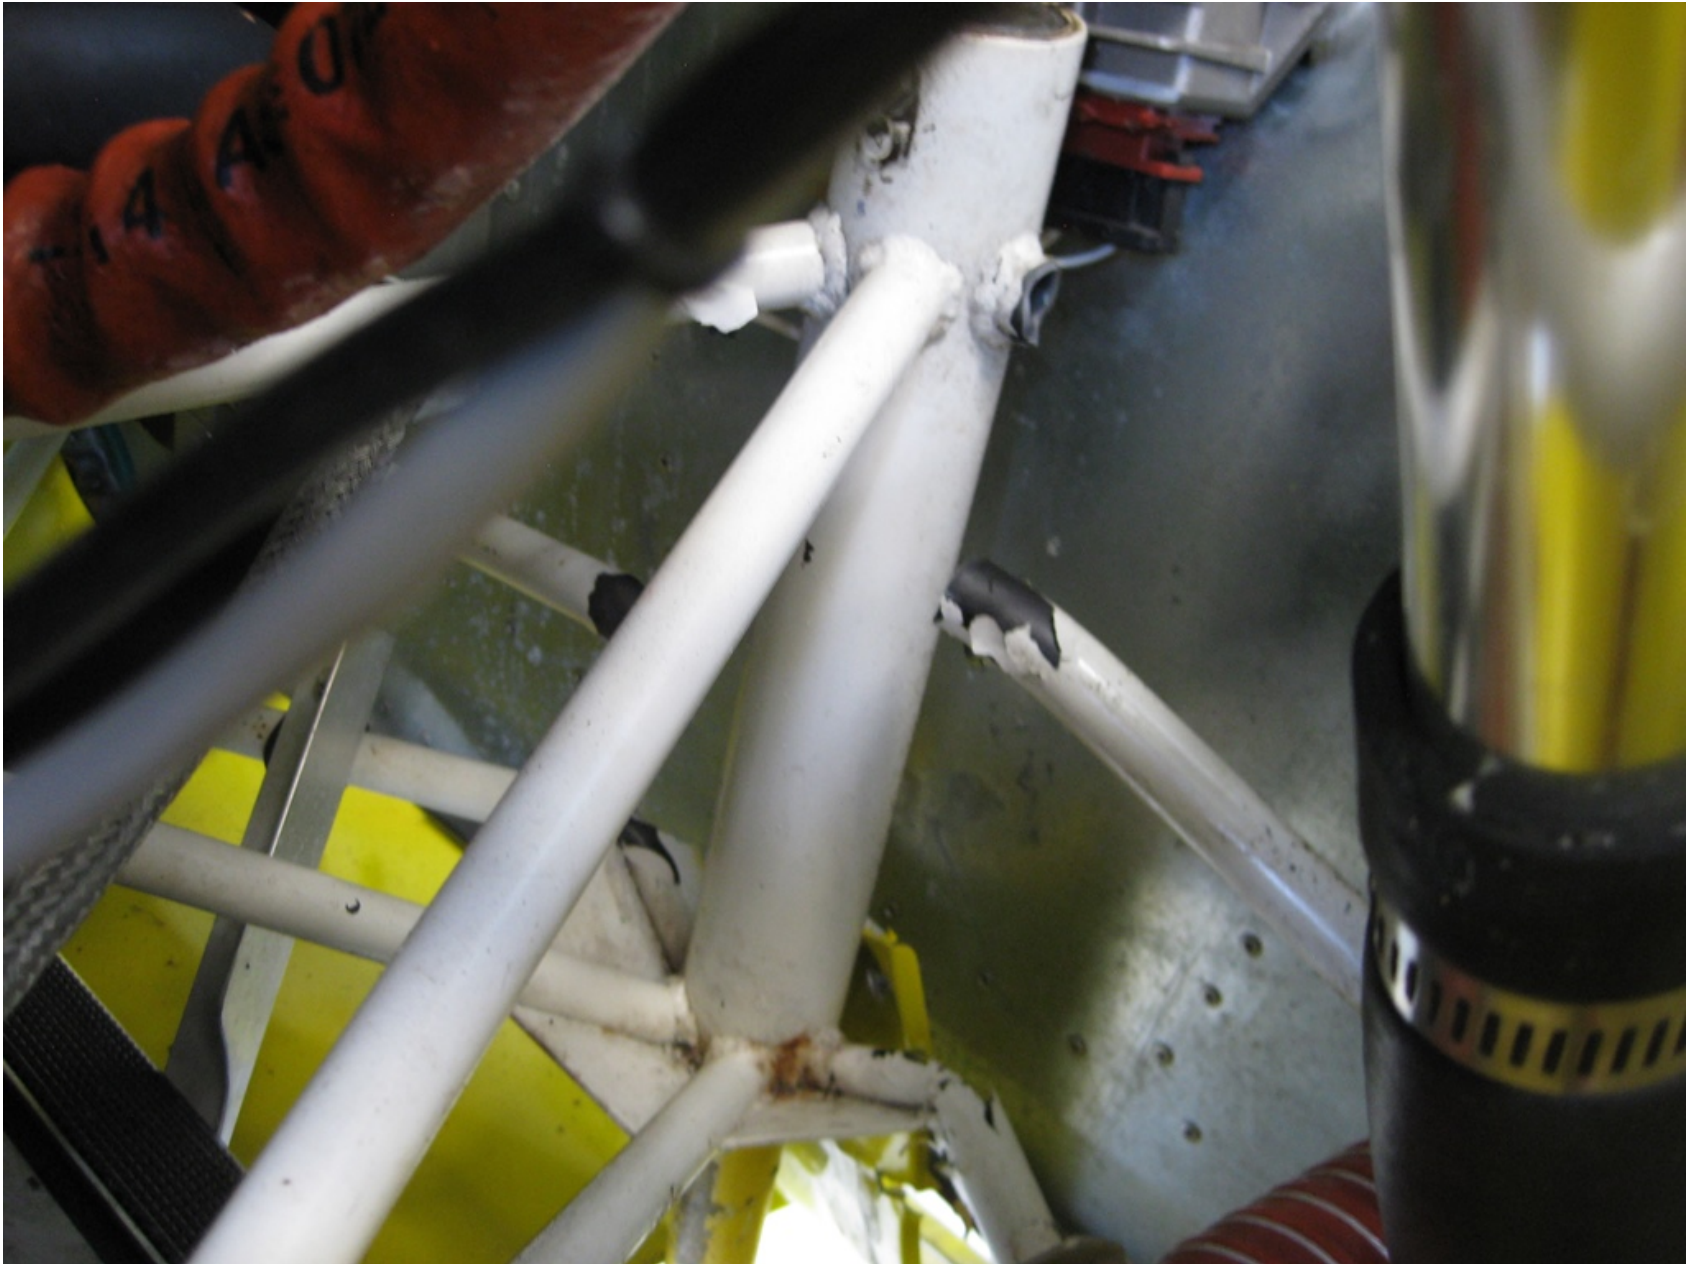
**Photo 1 – View of damage to engine mounts (Courtesy of FAA)**

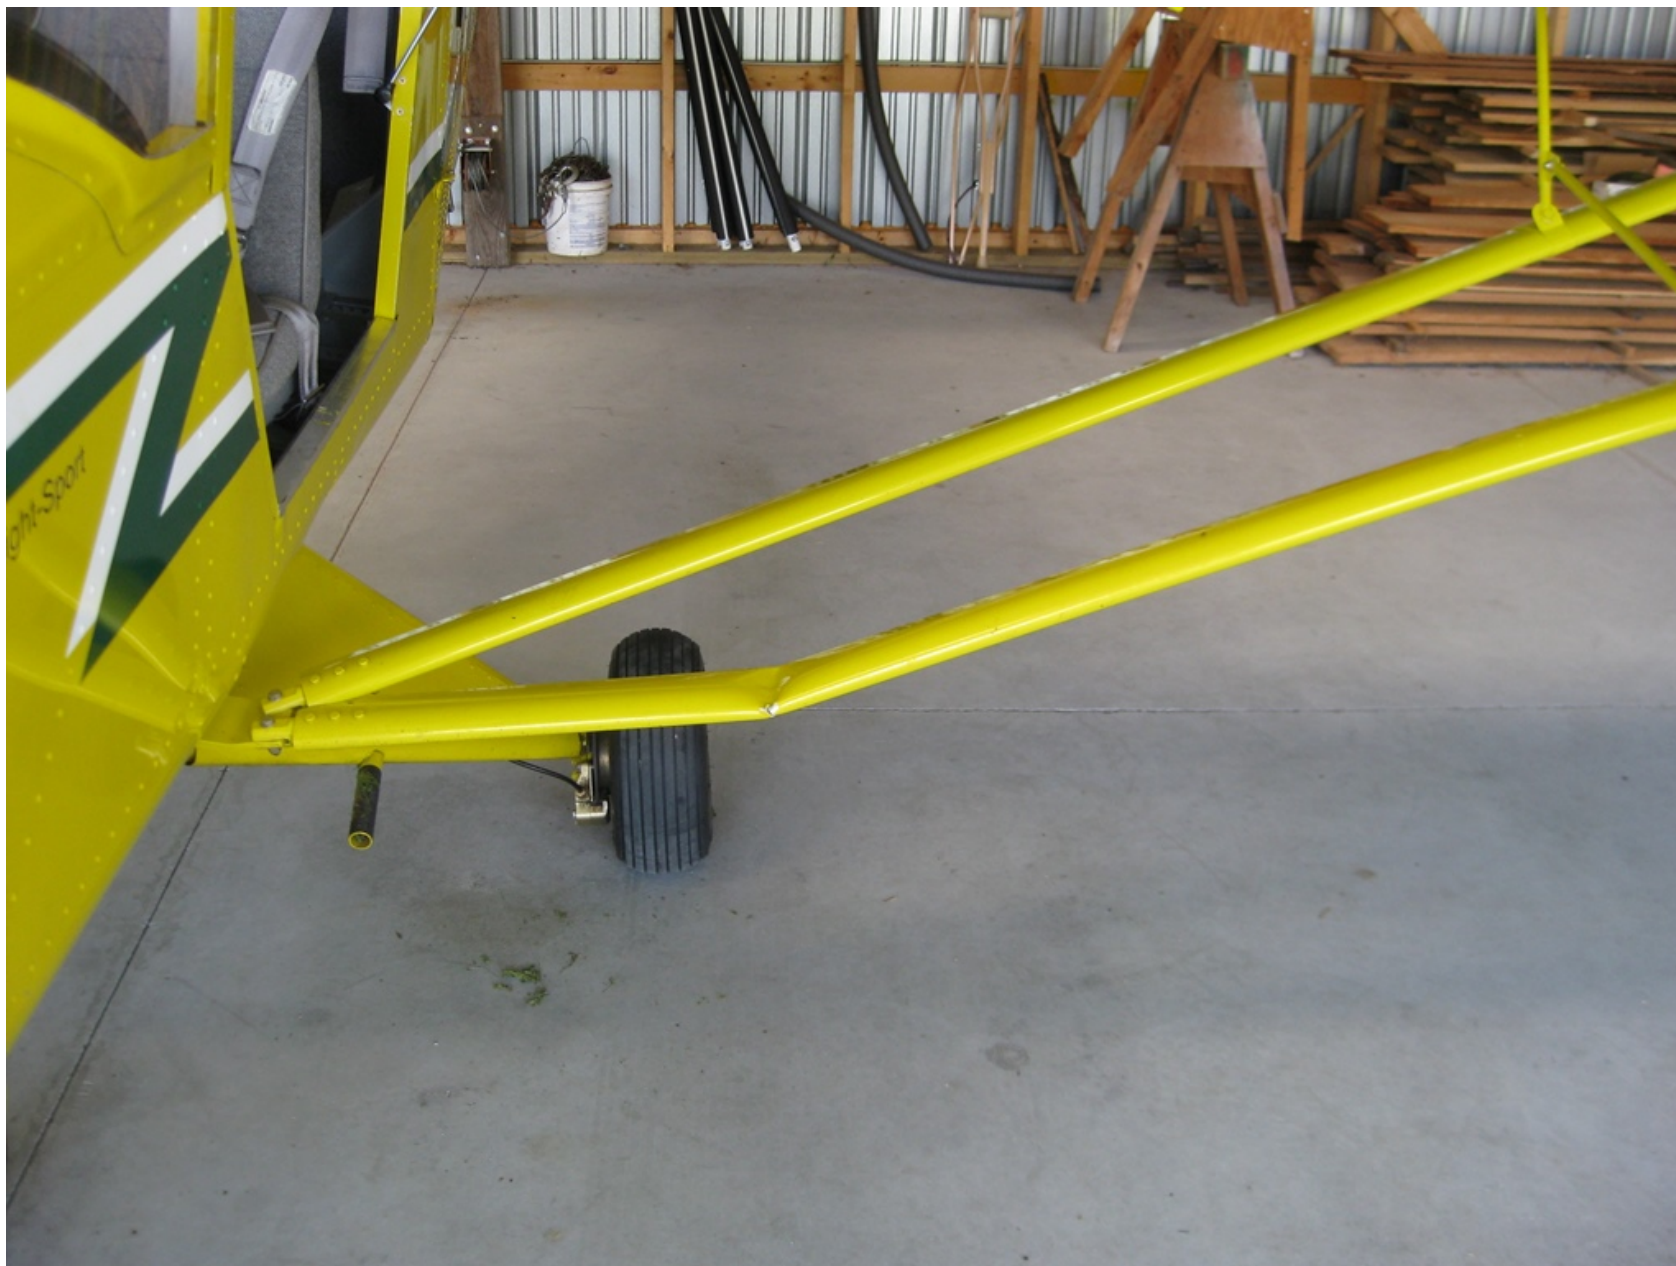
**Photo 2 – View of damage to left wing strut (Courtesy of FAA)**
