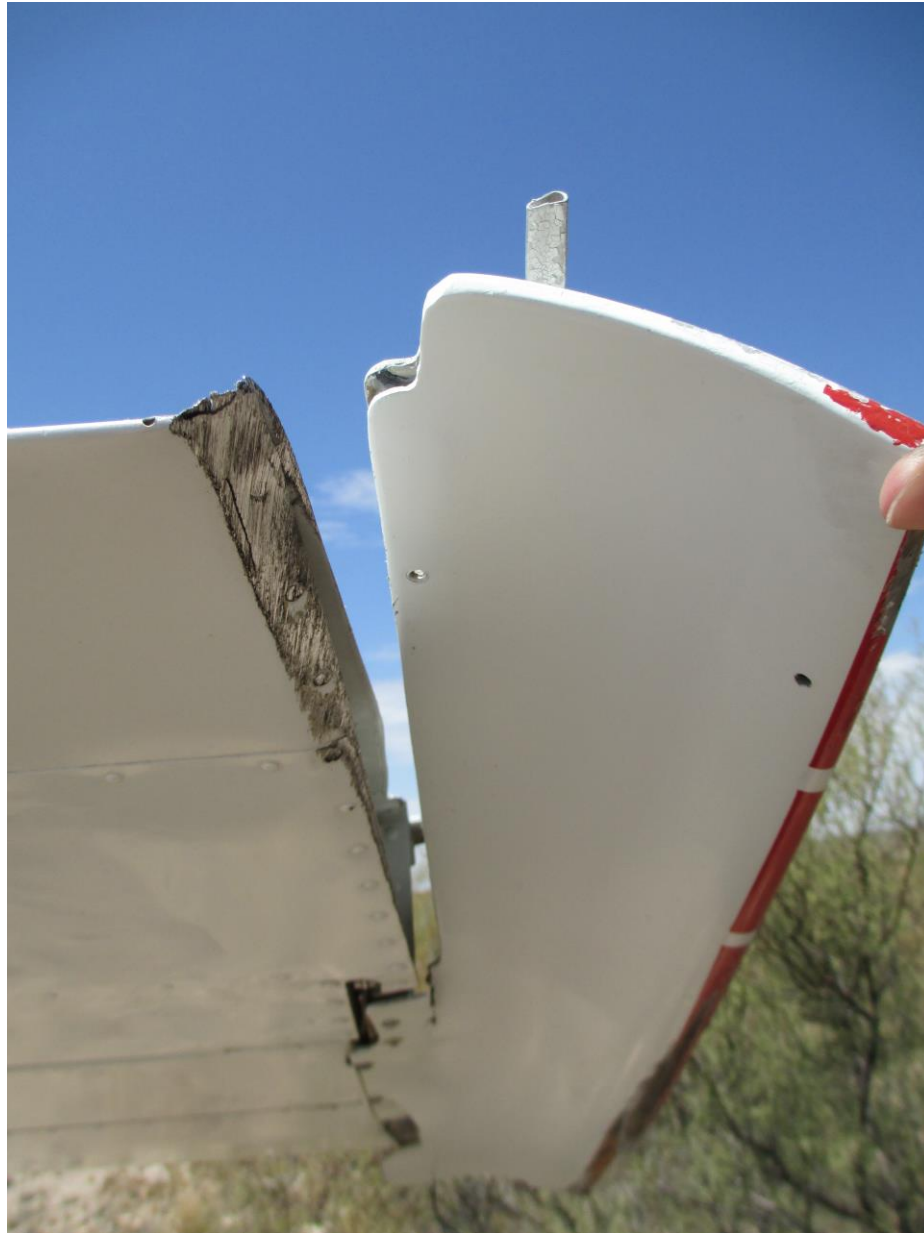
**Photo 1 – View of right aileron damage (photo courtesy of the FAA)**

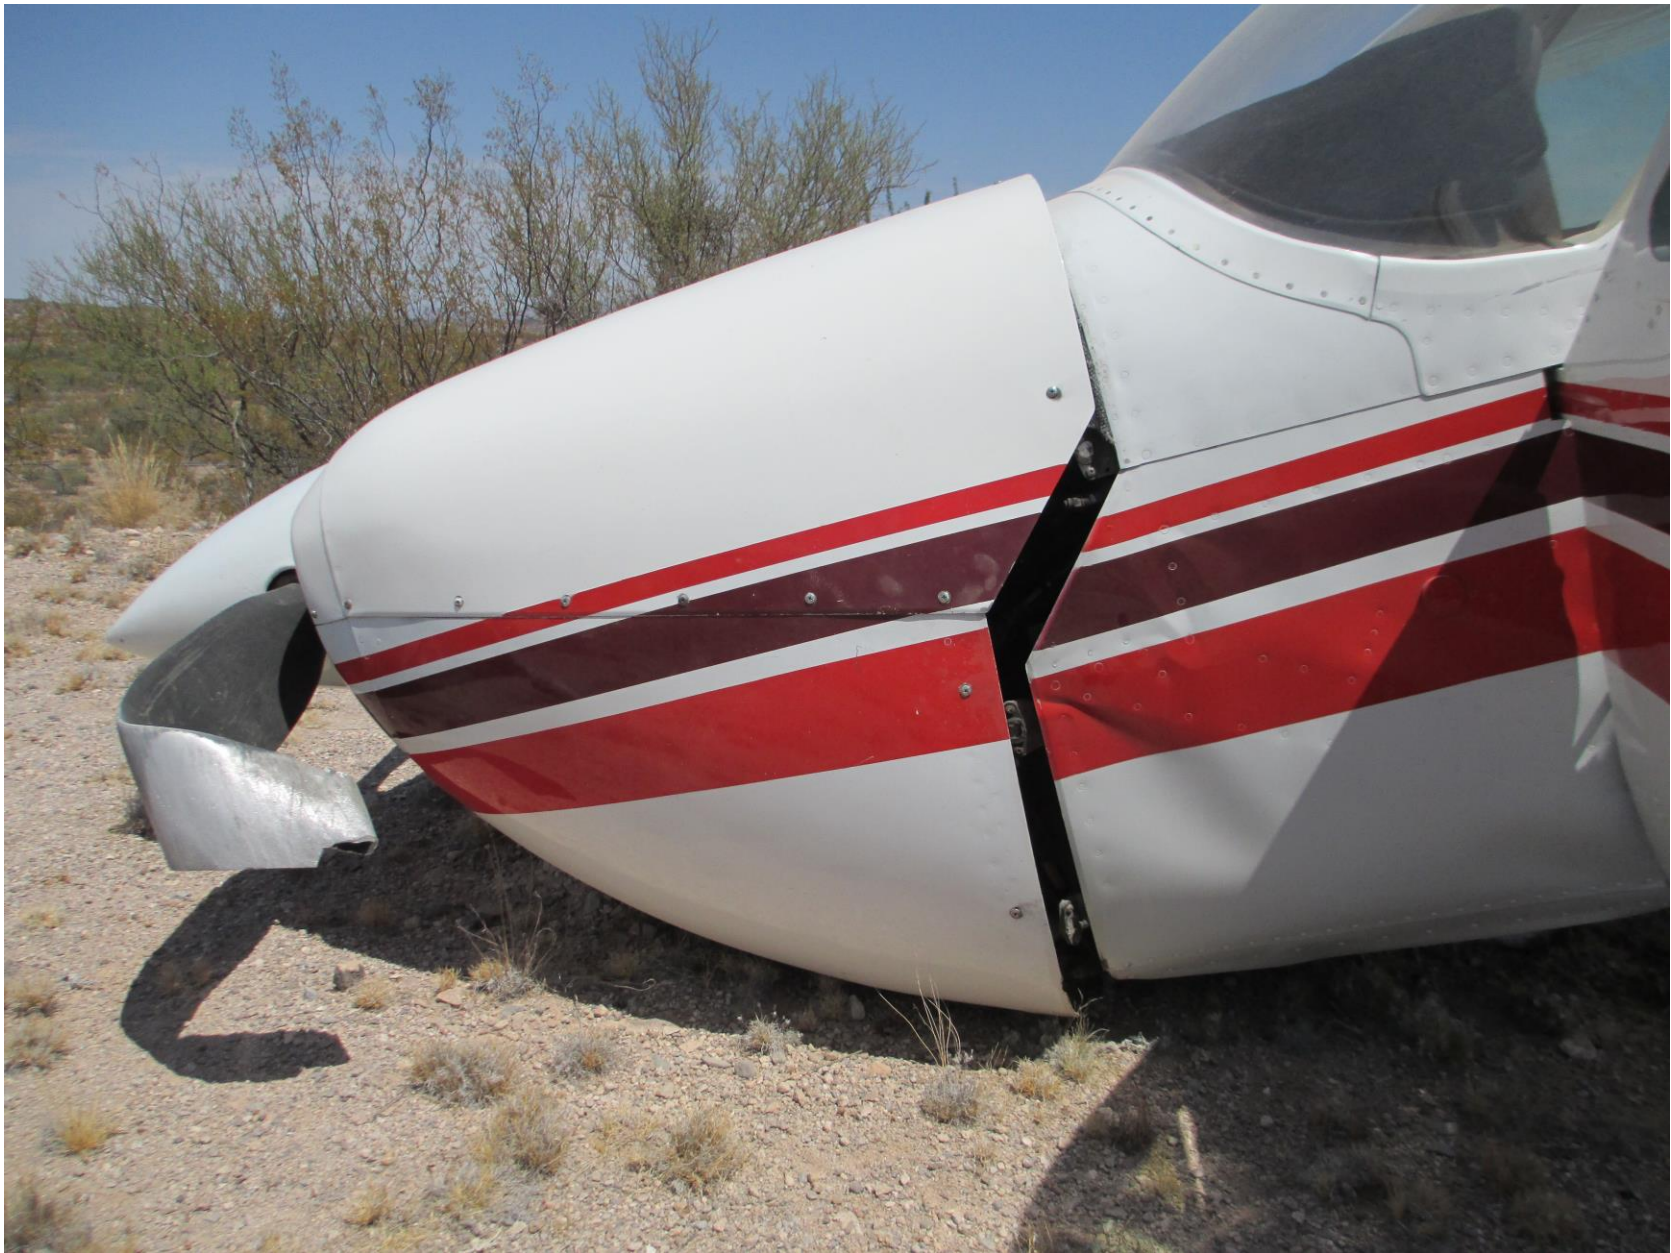
**Photo 2 – View of fuselage damage (photo courtesy of the FAA)**

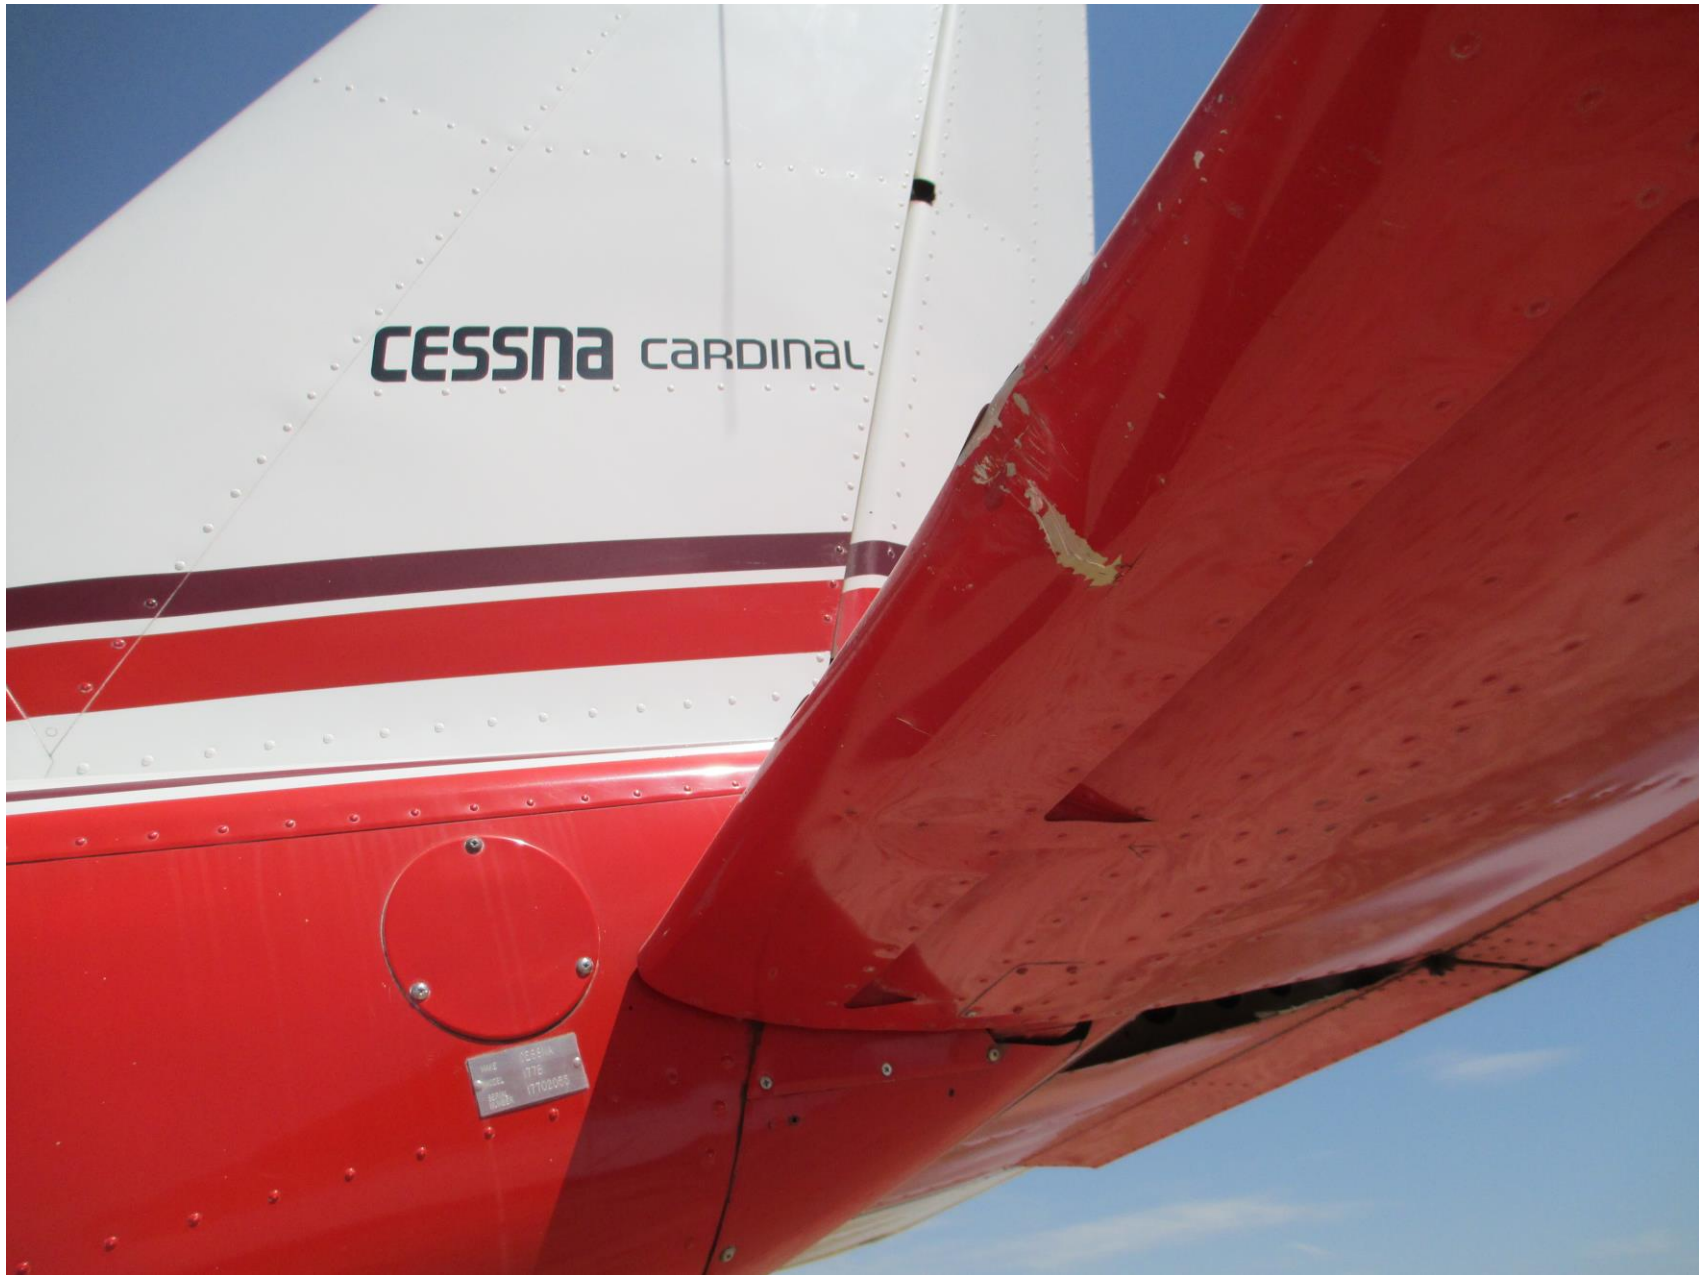
**Photo 3 – View of empennage damage (photo courtesy of the FAA)**
