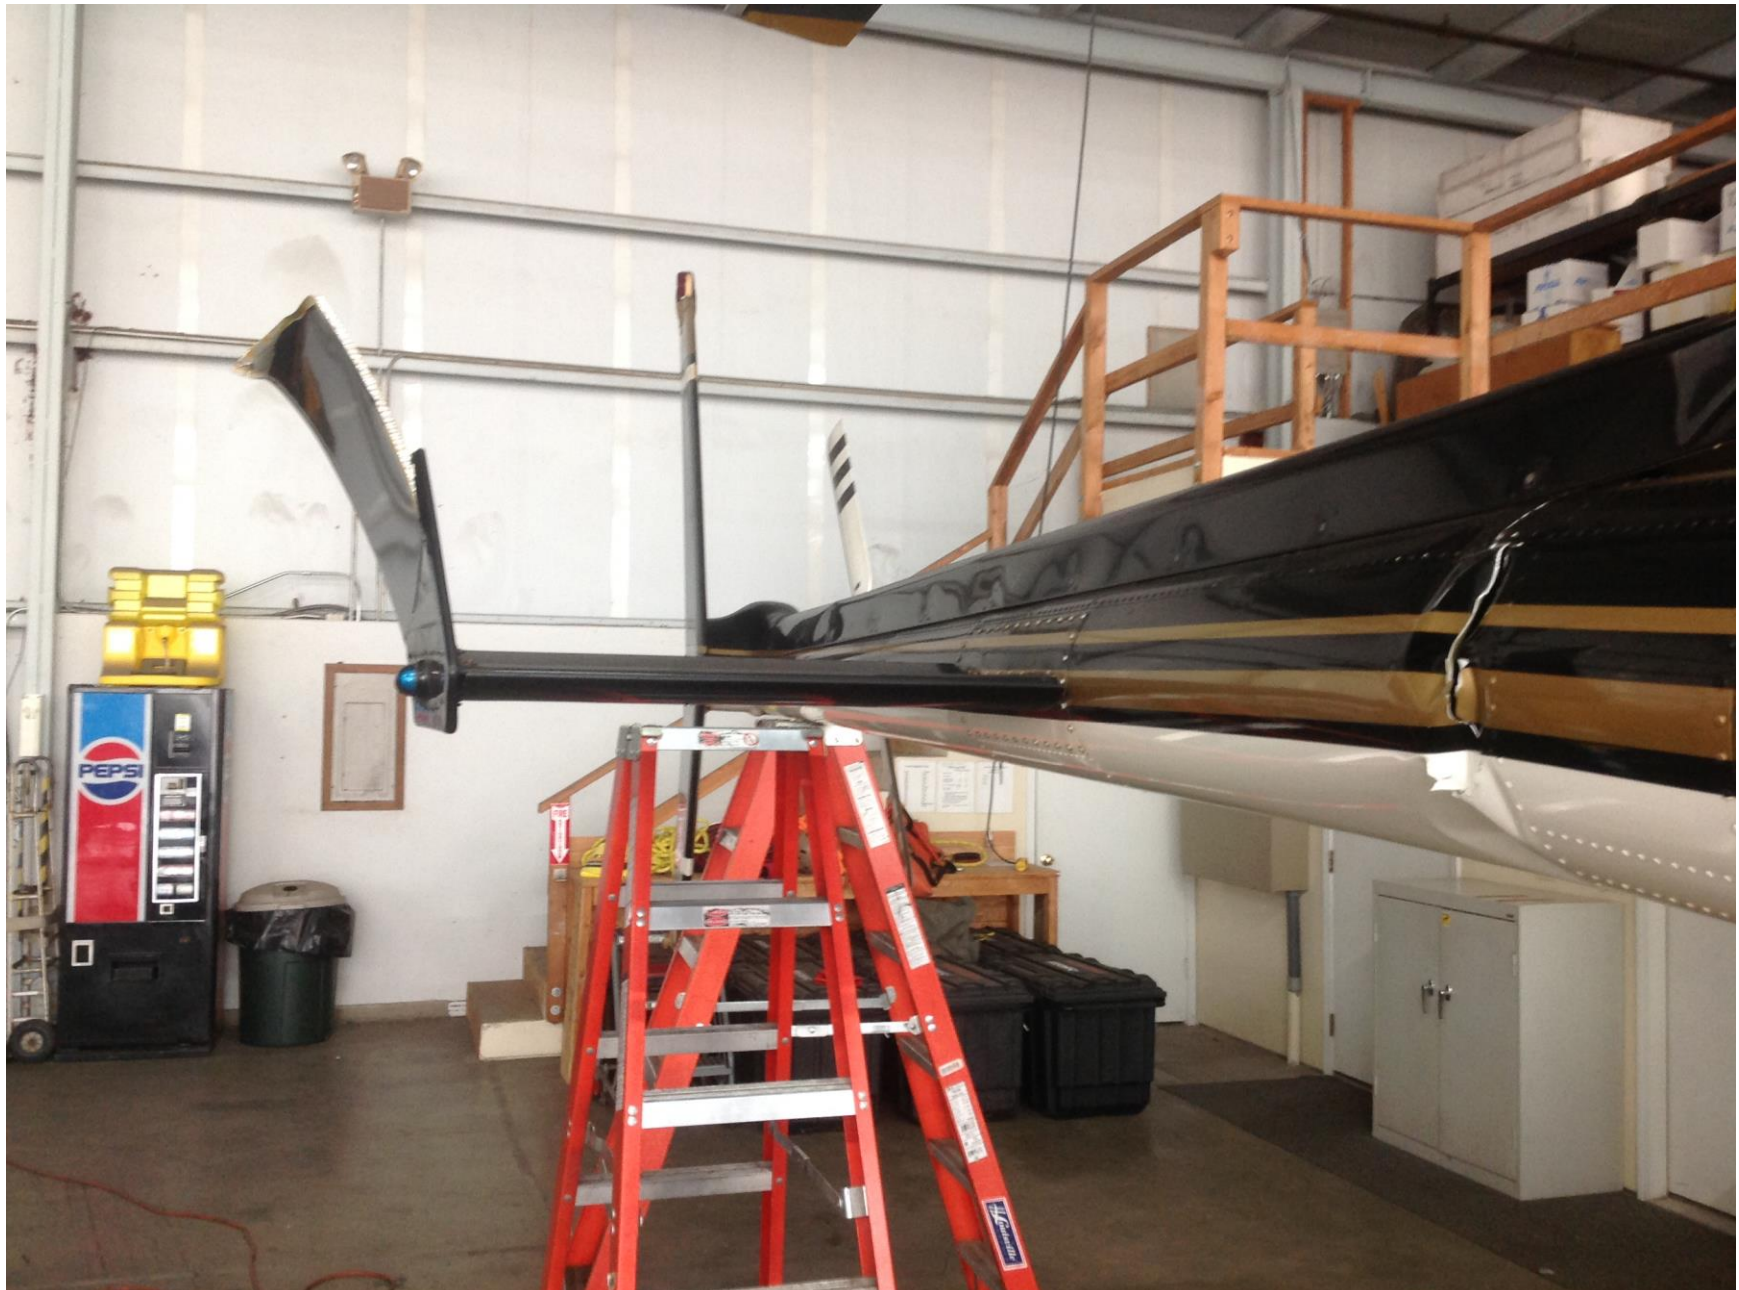
**Photo 1 – View of tail boom damage (photo courtesy of the owner)**
