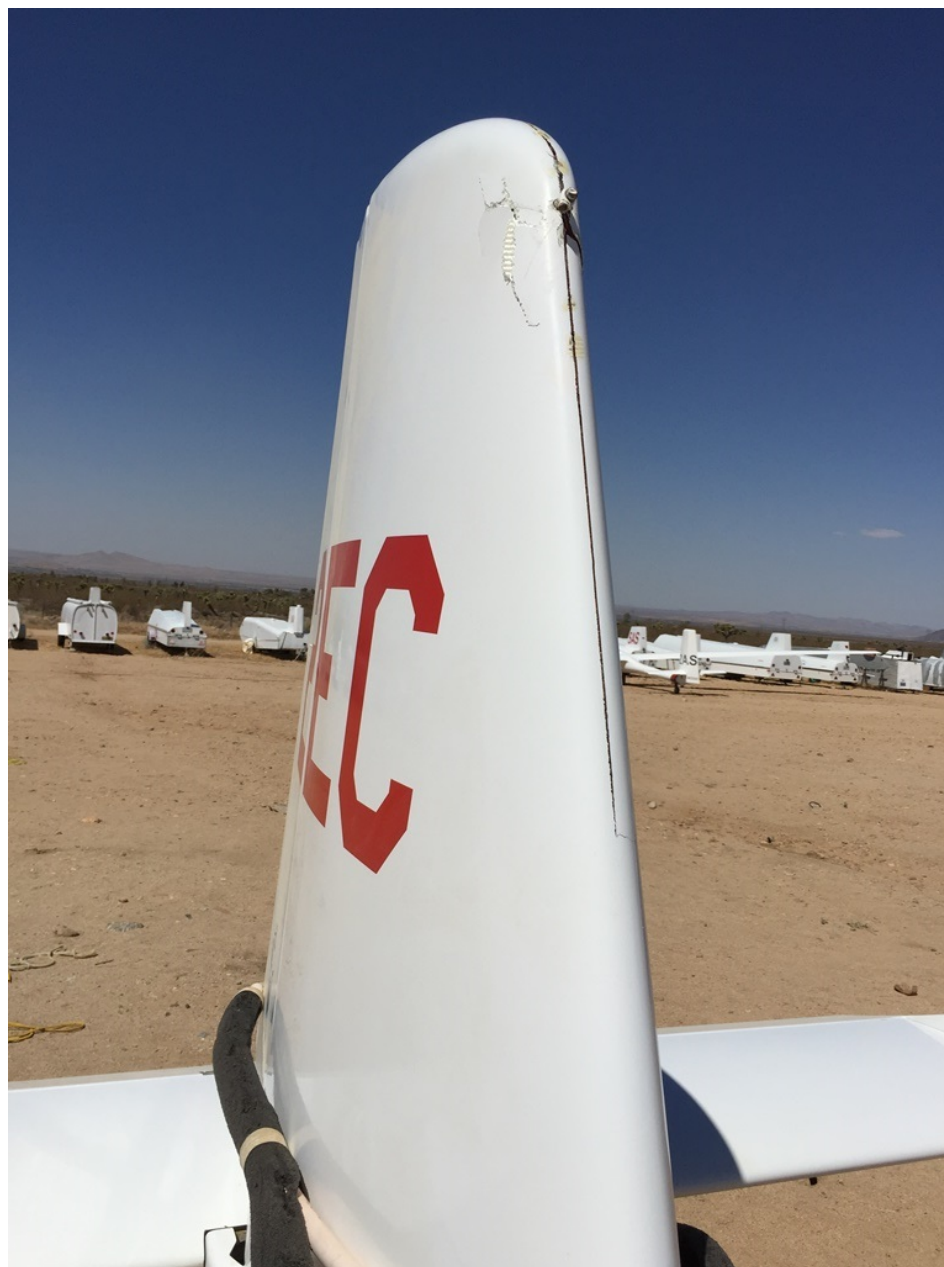
**Photo 1 – View of damage to vertical stabilizer (Courtesy of Operator)**

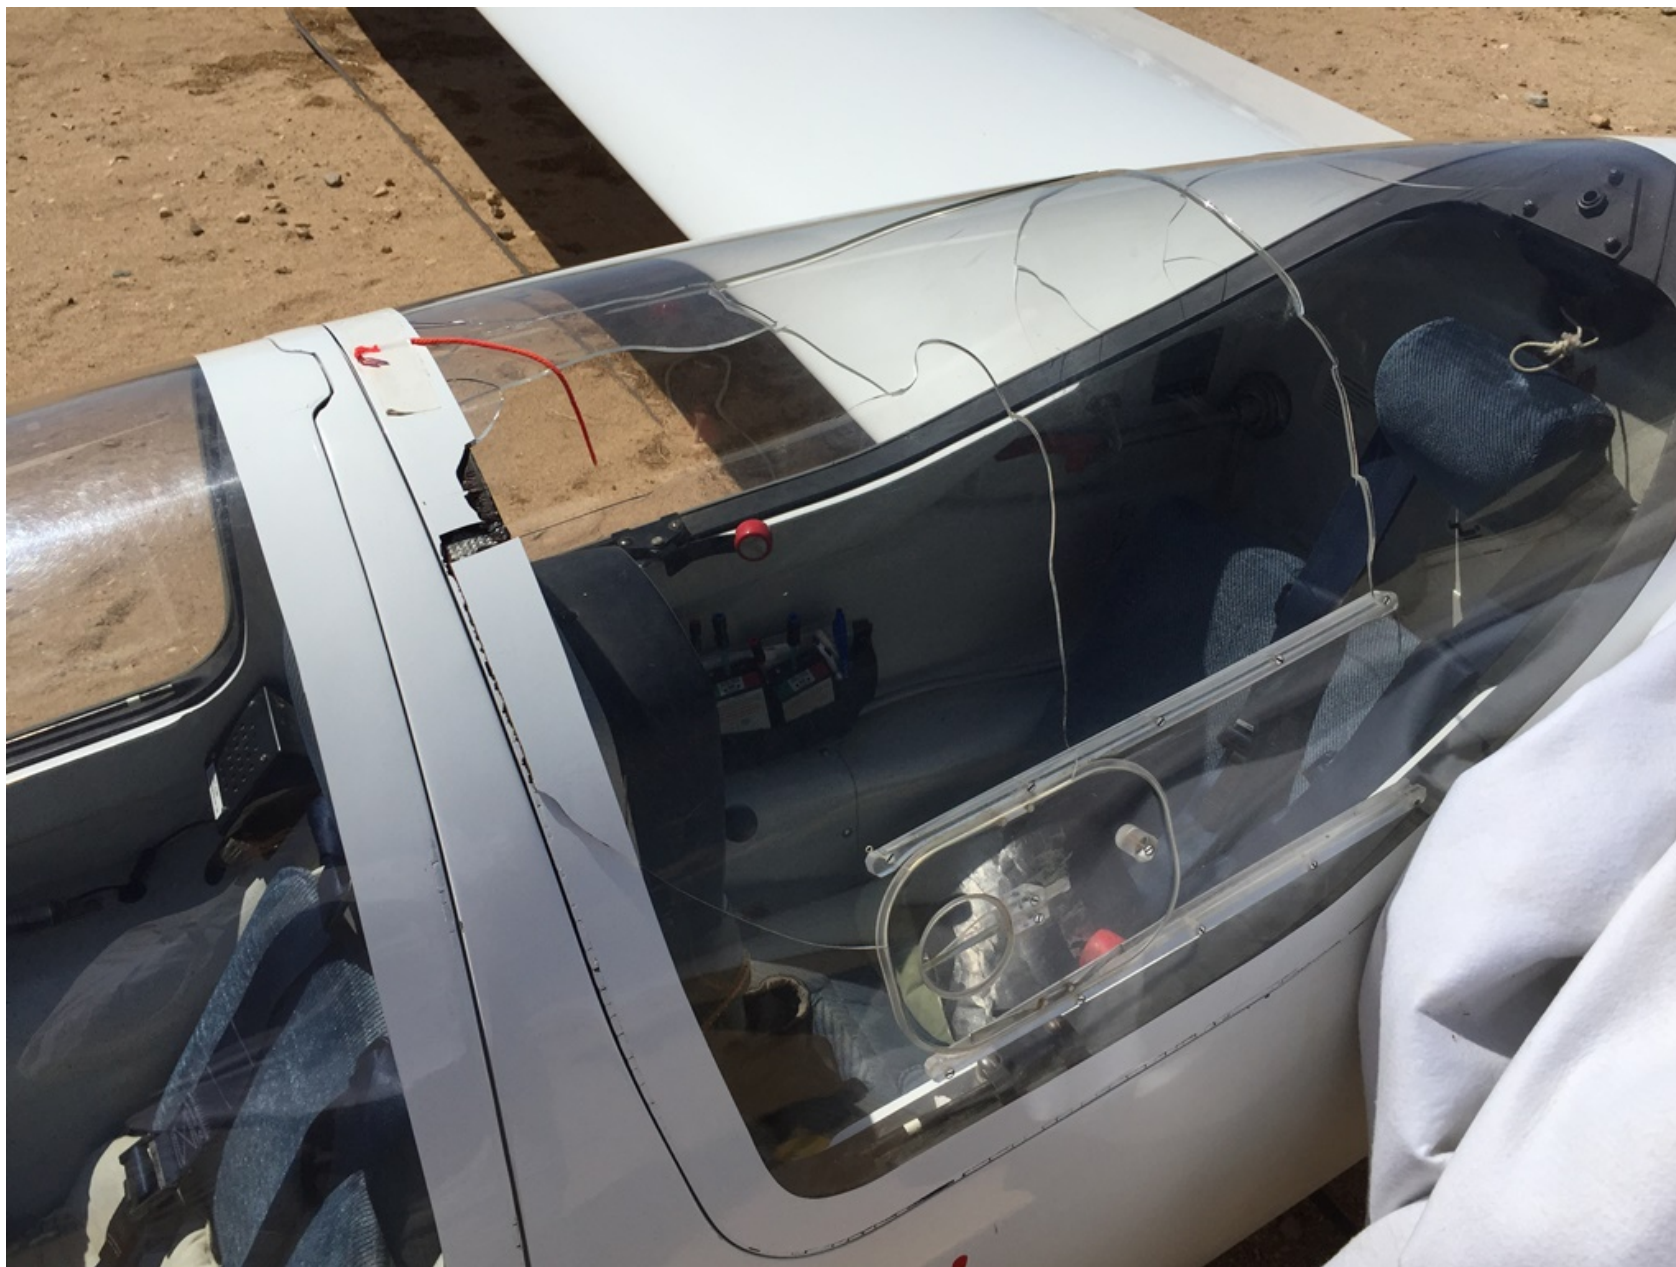
**Photo 2 – View of damage to aft canopy (Courtesy of Operator)**
