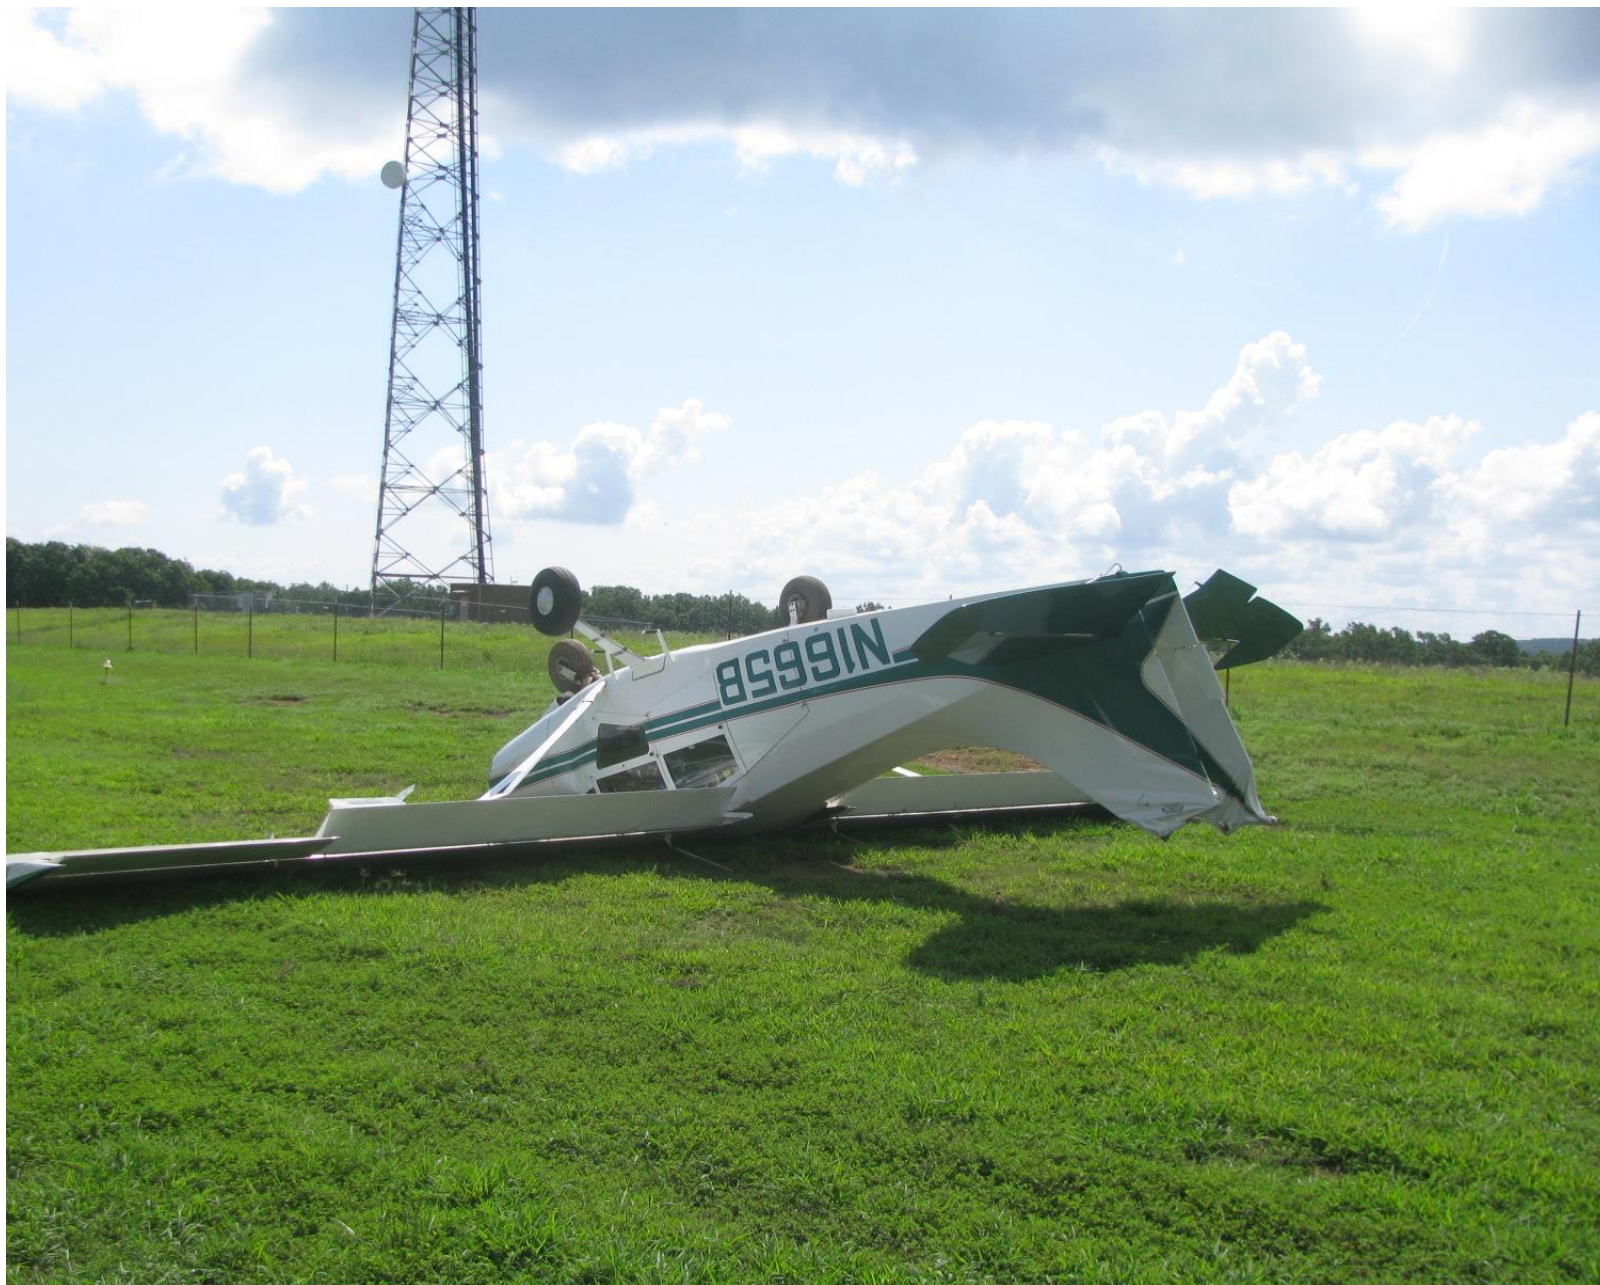
**Photo 1 – View of airplane inverted (photo courtesy of the FAA)**

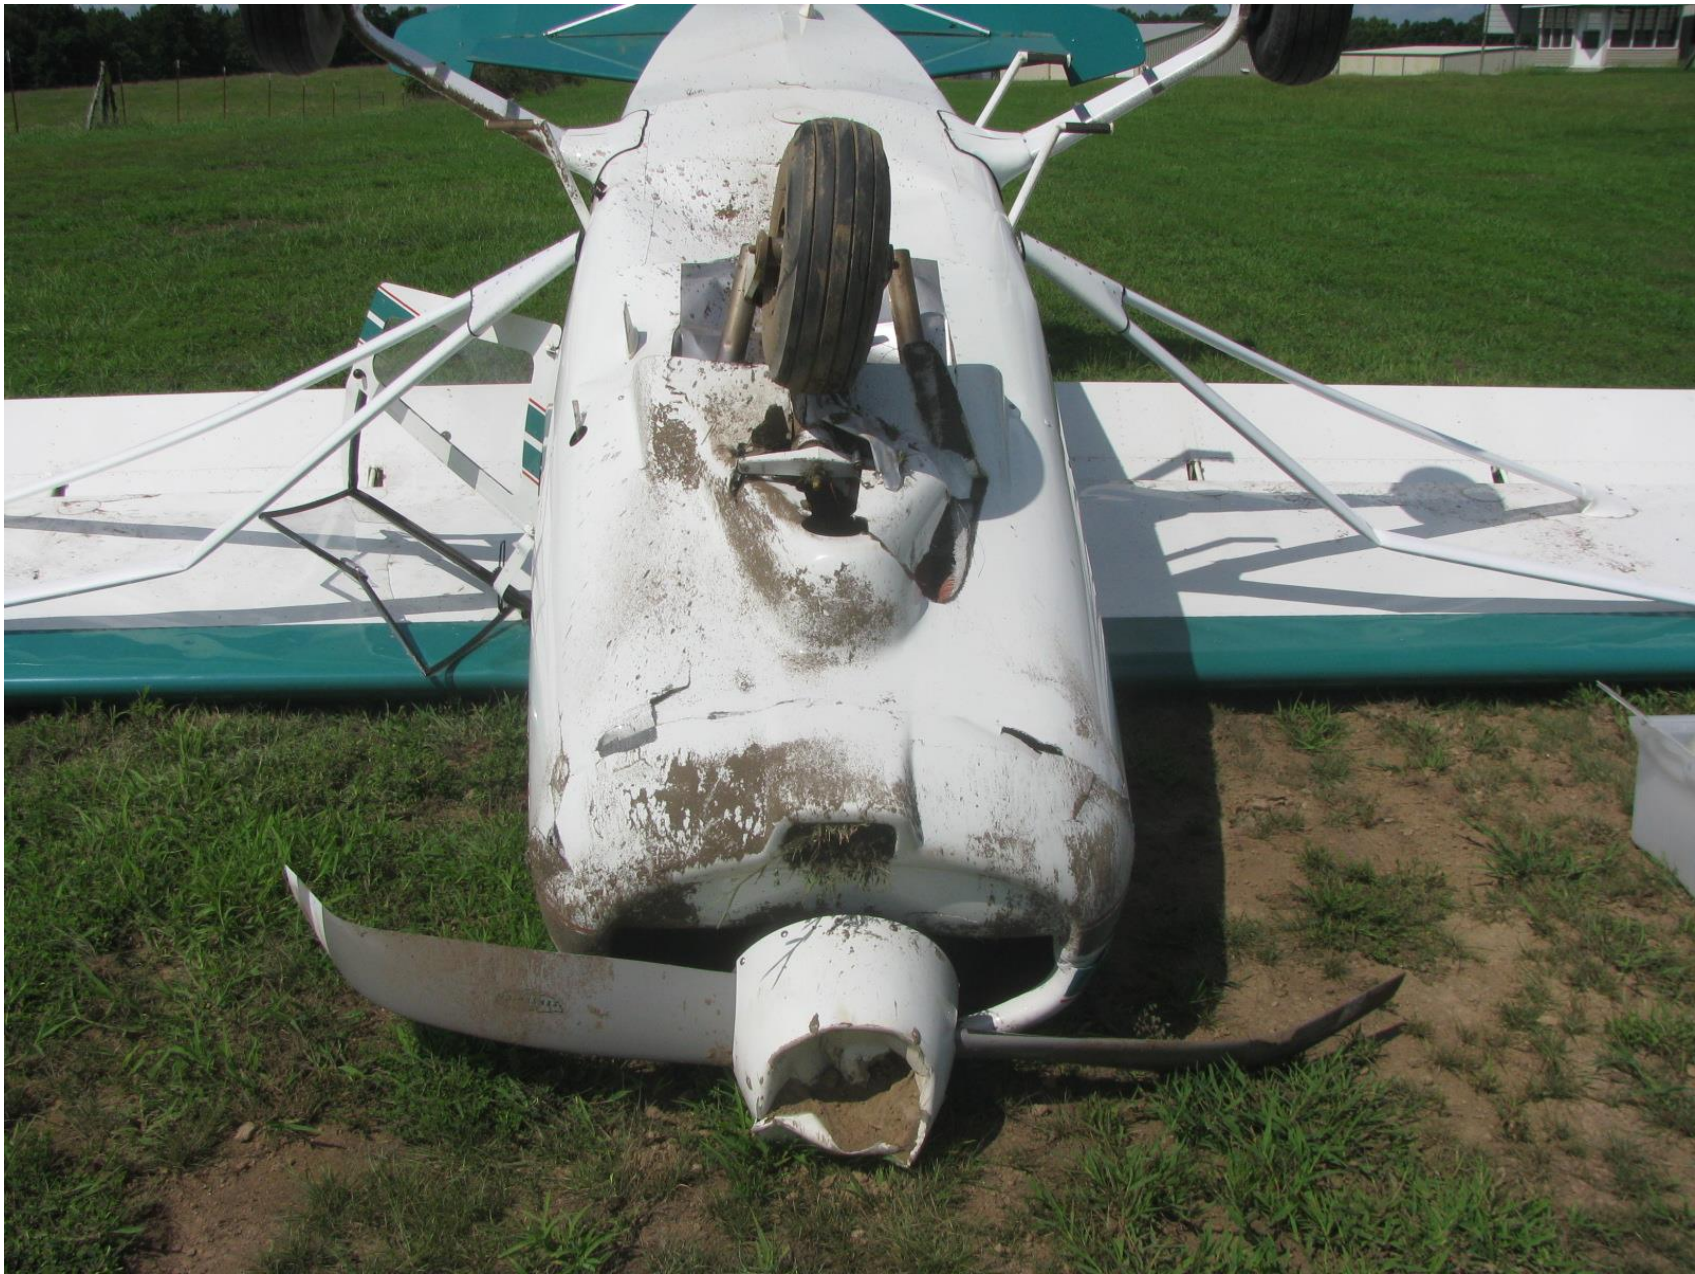
**Photo 2 – View of damaged wing struts (photo courtesy of the FAA)**
