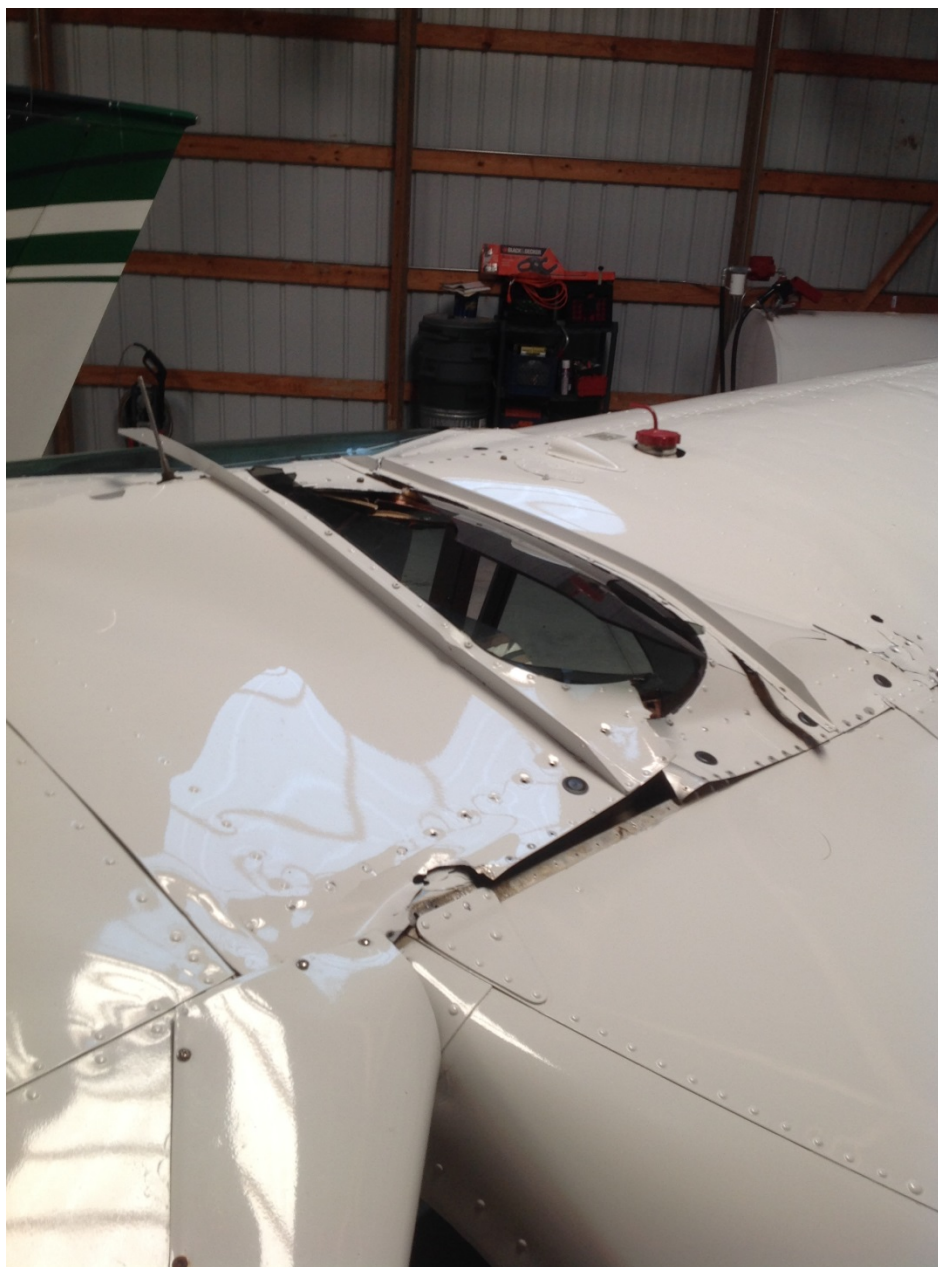
**Photo 1 – Substantial Damage to Left Wing (Photo Courtesy of FAA)**

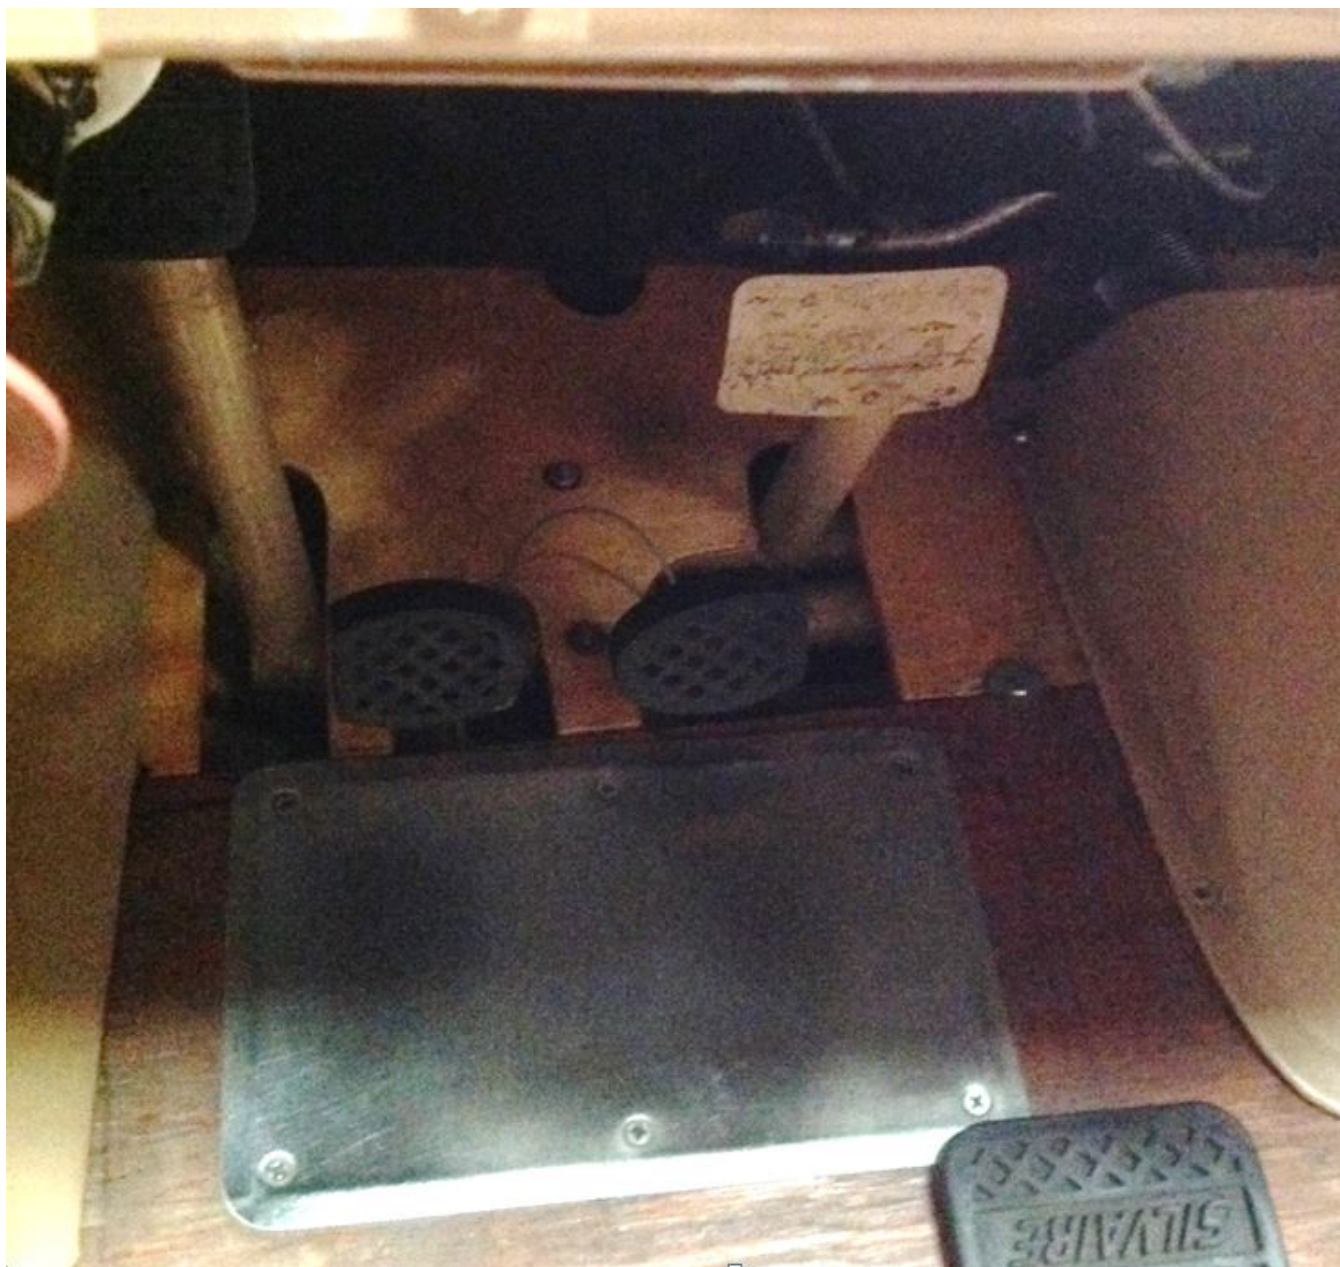
**Photo 2 – Rubber Foot Pedal Next to Rudder Pedal (Photo Courtesy of Operator)**
