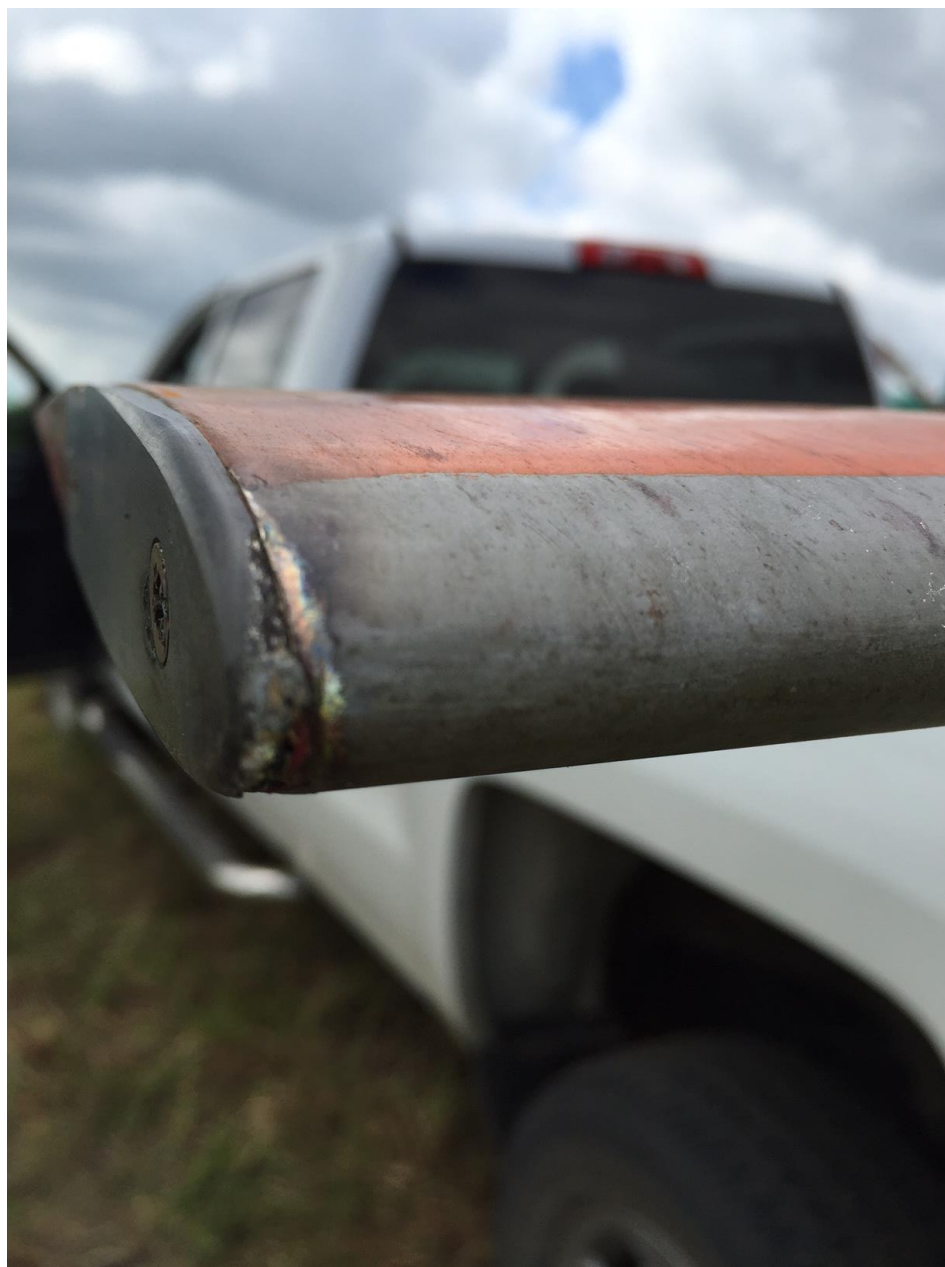
**Photo 1 – View of damage to the leading edge of the main rotor blade (photo courtesy of the operator).**

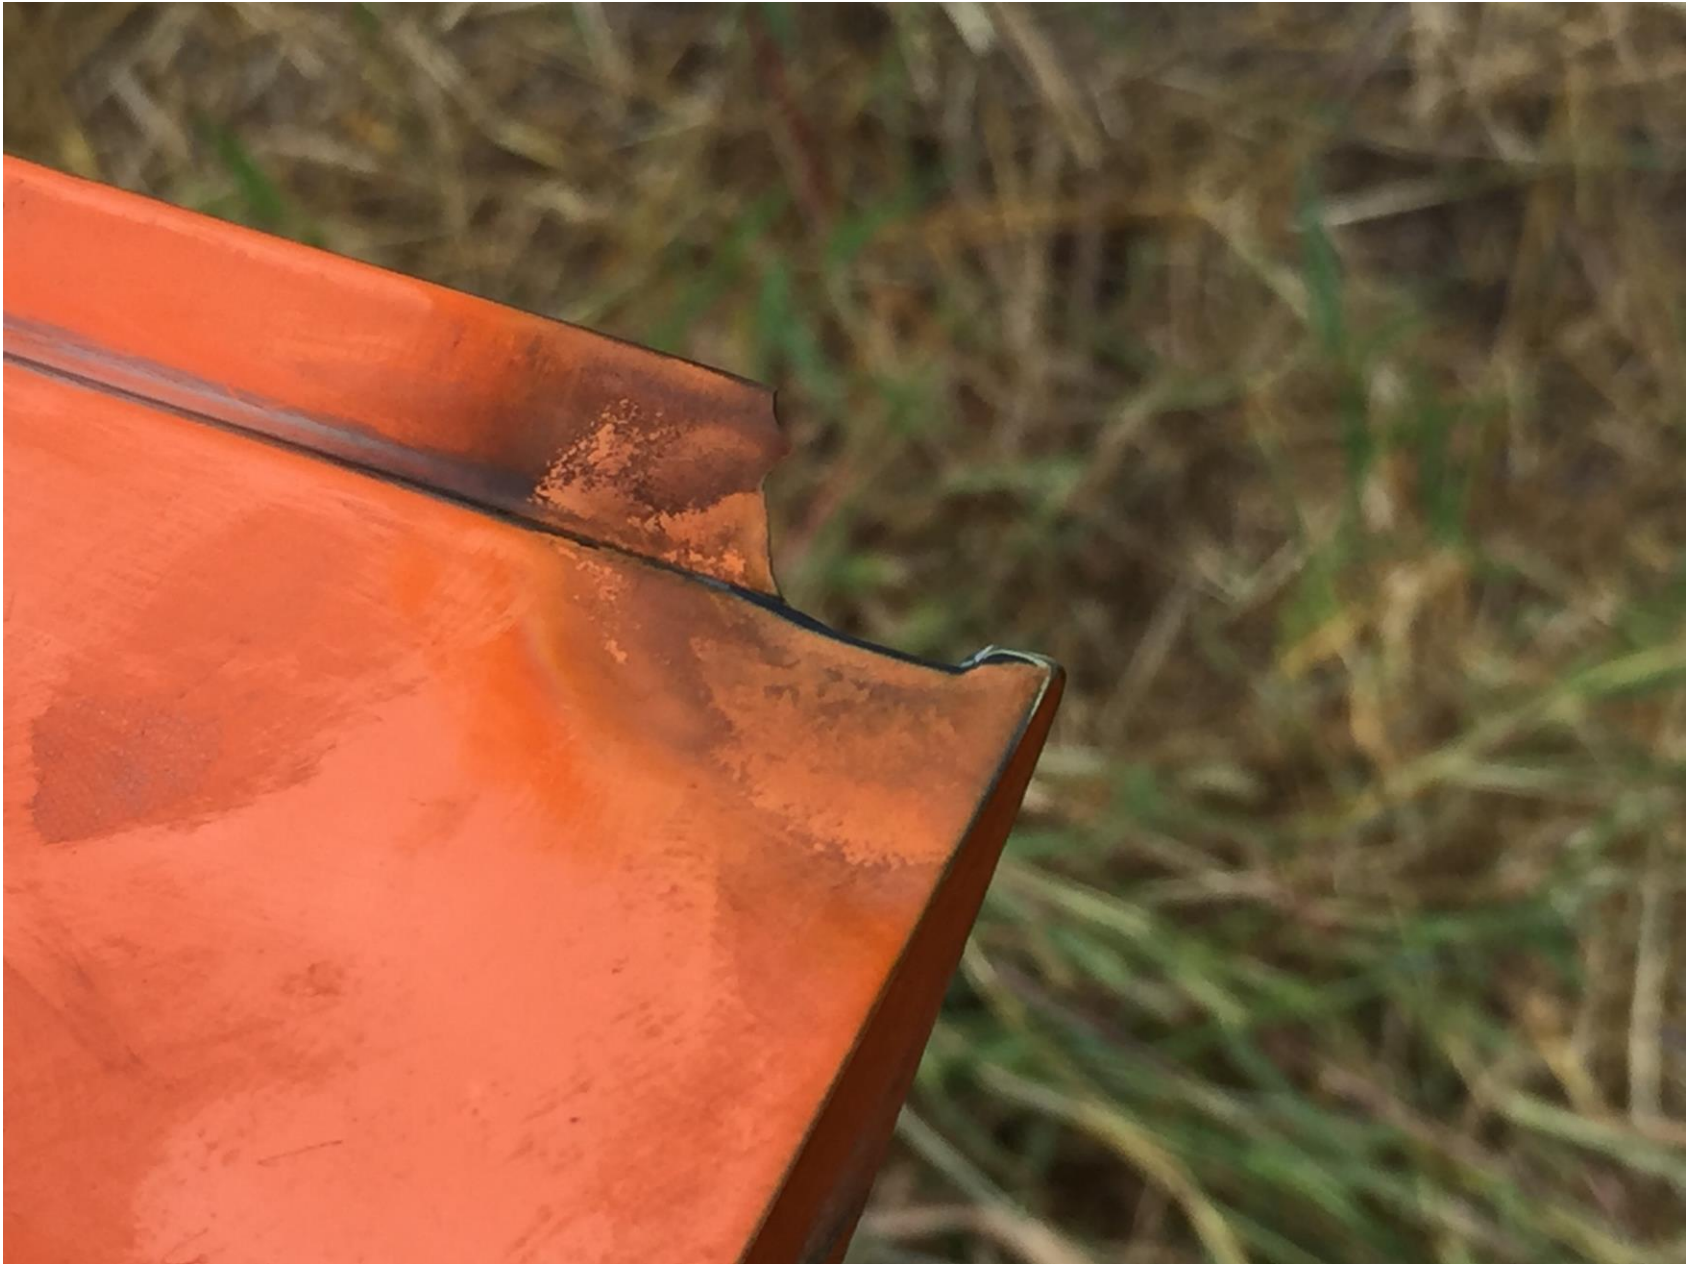
**Photo 2 - View of damage to the trailing edge of the main rotor blade (photo courtesy of the operator).**
