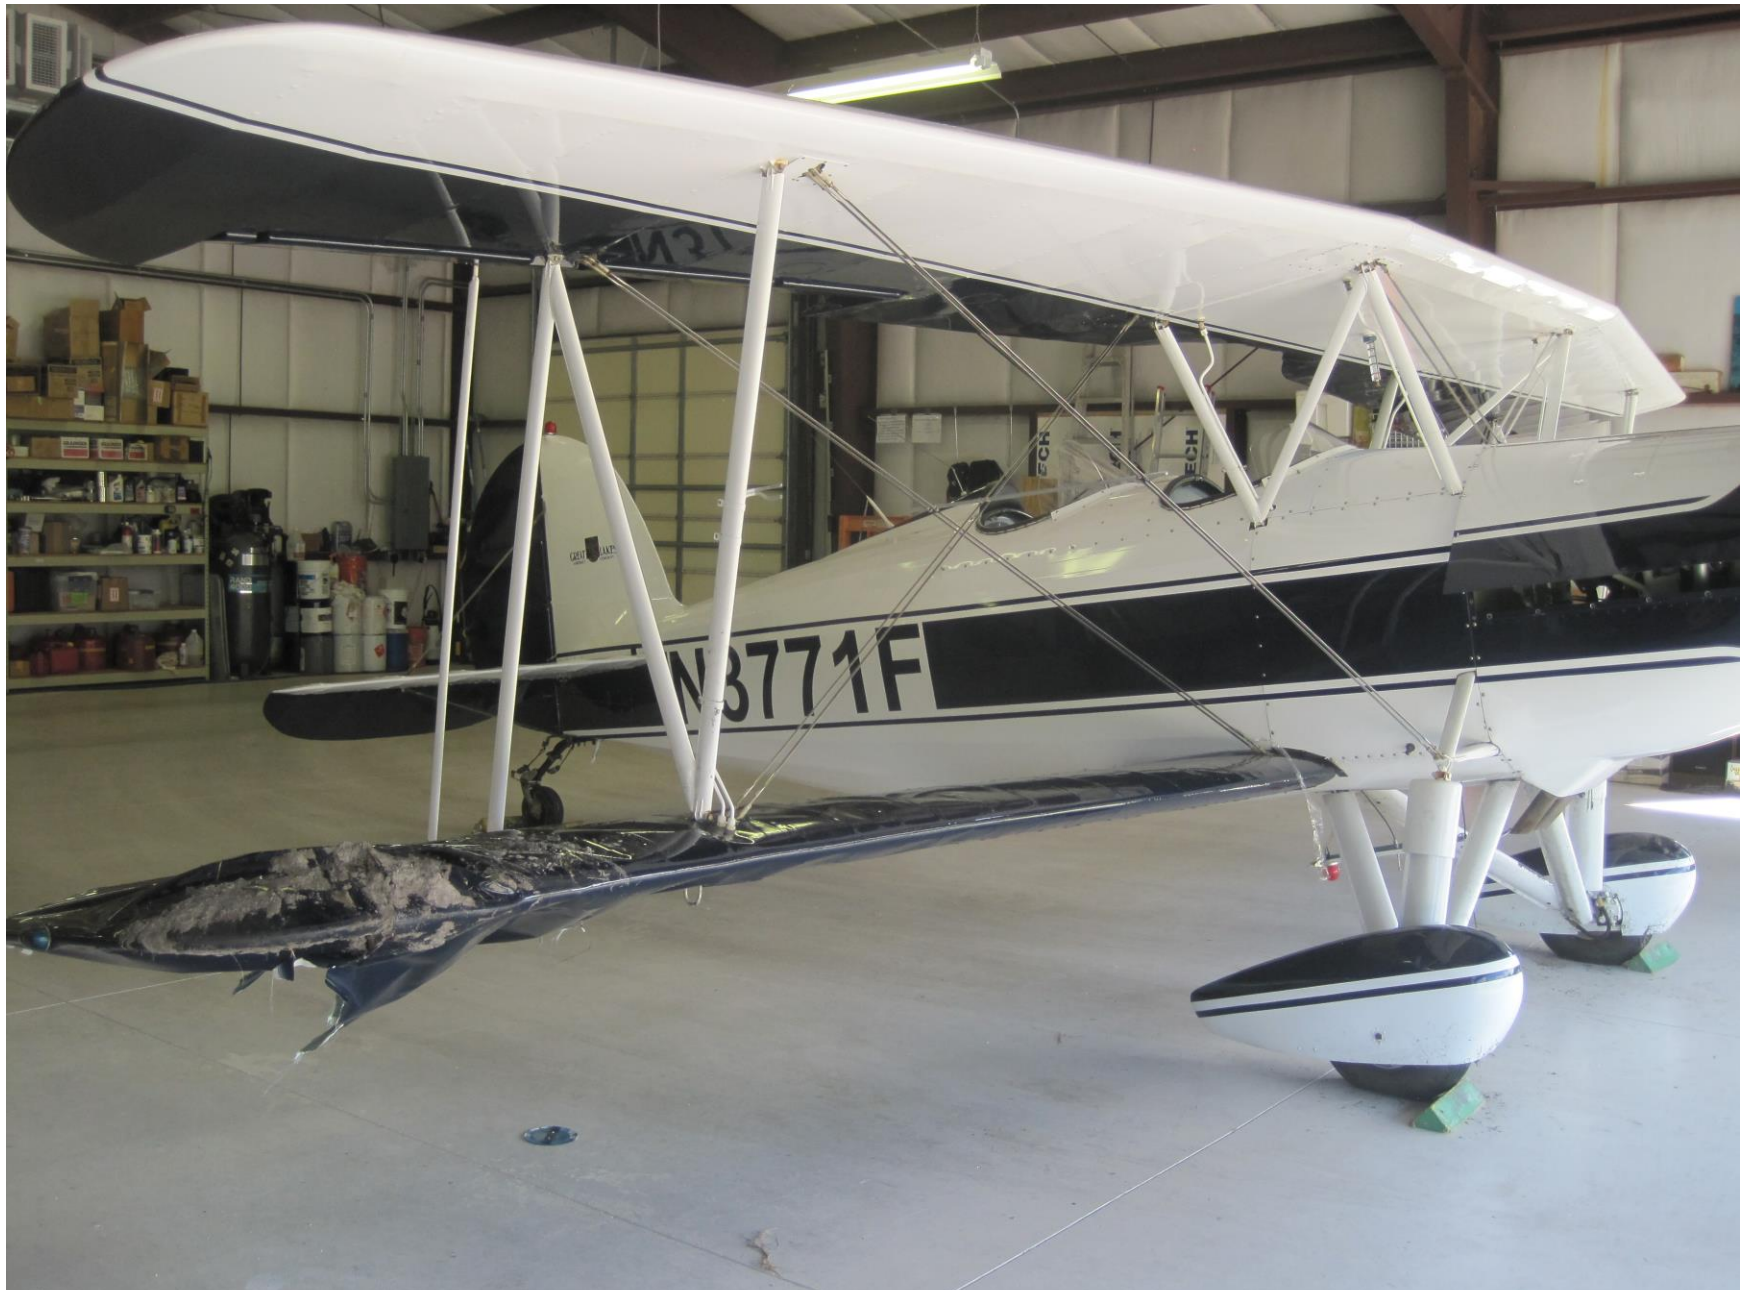
**Photo 1 – View of lower right wing damage (photo courtesy of the FAA)**

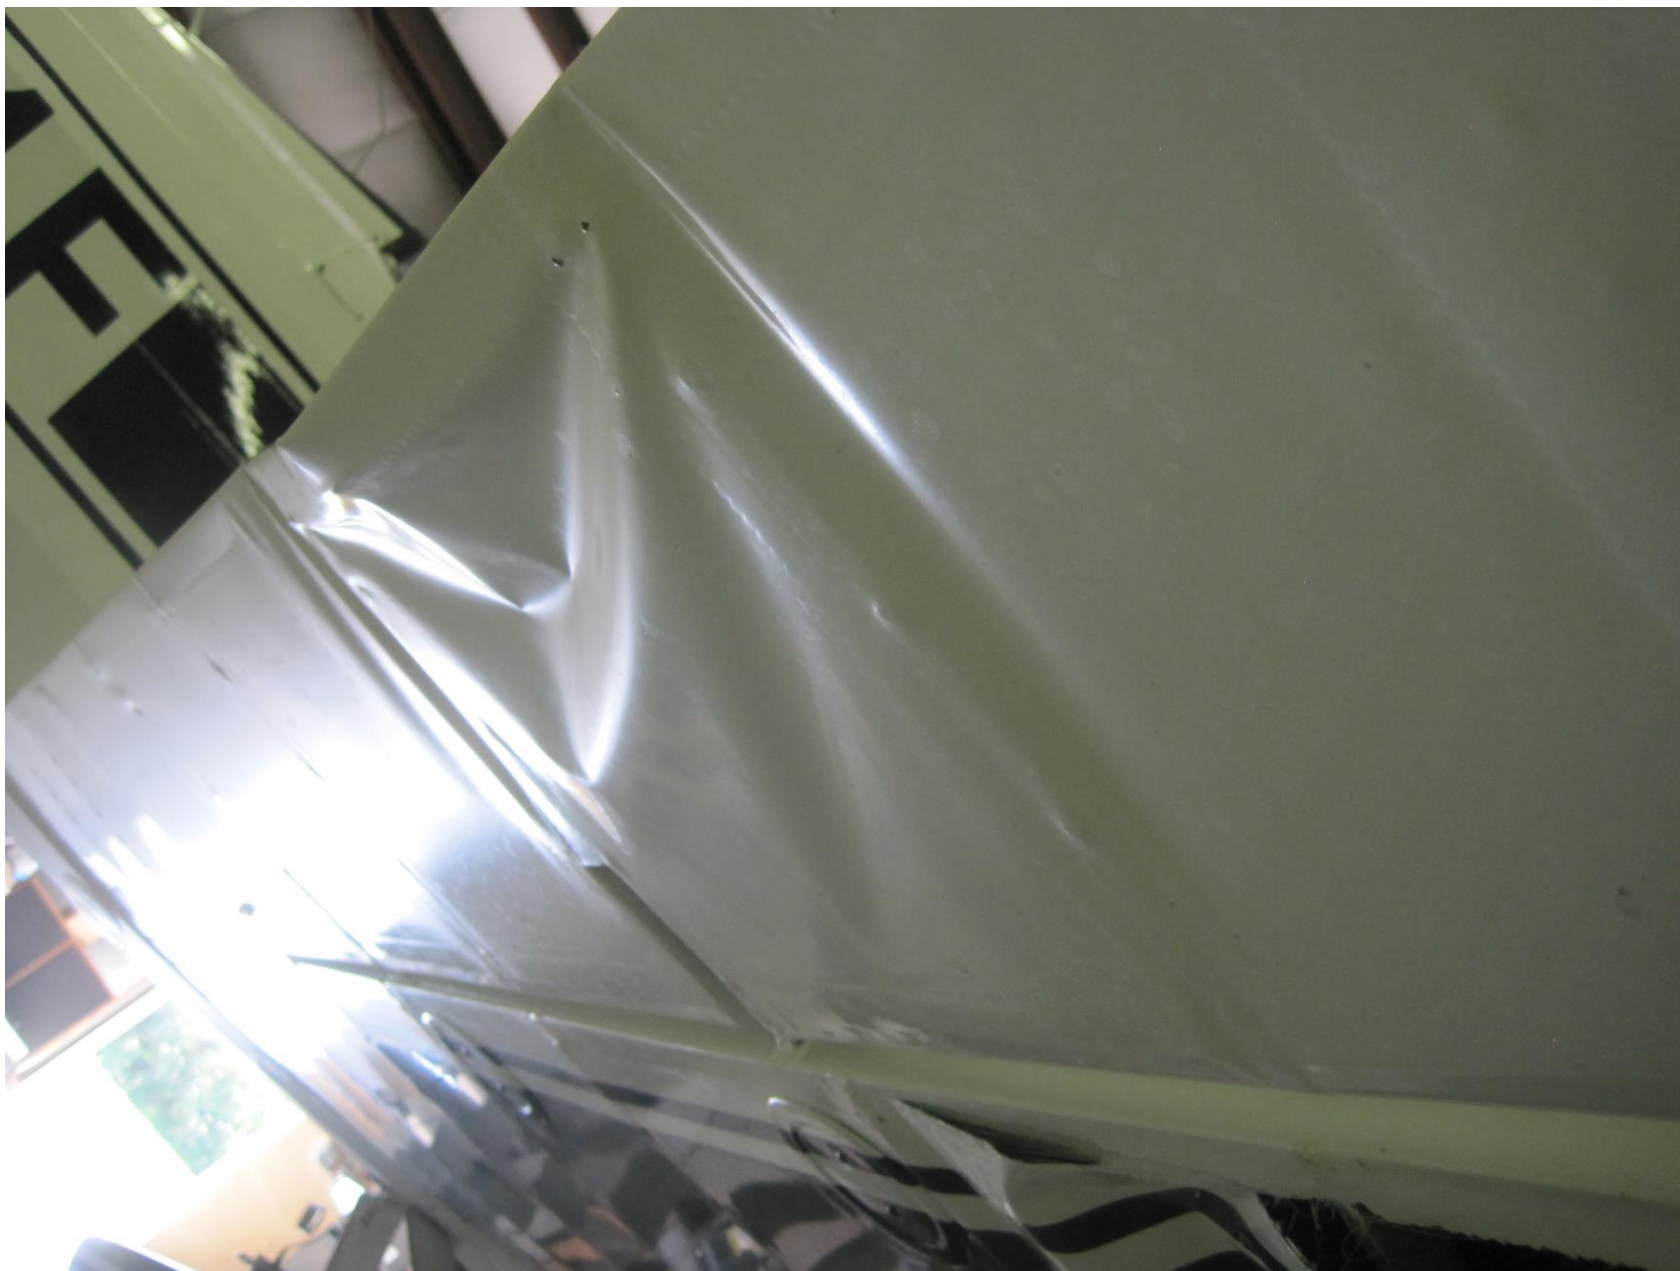
**Photo 2 – View of lower right wing aileron damage (photo courtesy of the FAA)**
