## *Accident Report*

Date: September 16, 2016  
Student Pilot: Skye P. Merriam  
Aircraft: Cessna 172S Skyhawk  
Registration: N461SP  
Location: Tooele Valley Airport, Utah

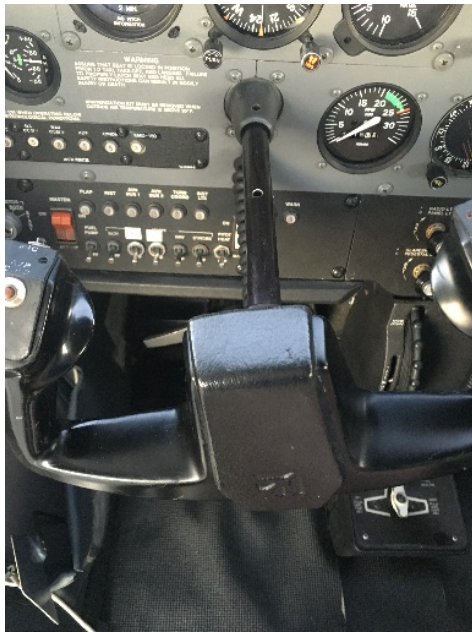
b. Aircraft Yoke.

The plane bounced off the runway immediately after touching down. After the first bounce, the yoke was locked in the aft position, and I could not pull it any further back to me. The aircraft bounced another three or four times after the first bounce. I used the rudder pedals briefly to stay centered on the runway and then switched to the brakes to slow the aircraft down and steer as best I could. Each time the plane bounced, the noise was noticeably loud inside the aircraft. I did not feel or hear anything that indicated to me that the propeller struck the runway.

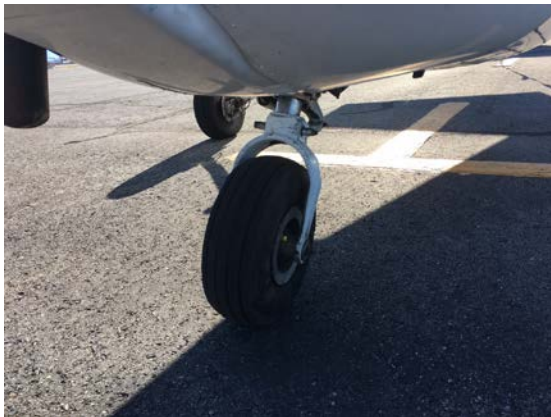
c. Aircraft Front Landing Gear.

(1510 hours) I arrived at the aircraft. I was accompanied by my father, Scott A. Merriam, since I asked him for assistance in pushing the aircraft out of the tie-down position. I noted from the Aircraft Flight Log that N461SP had been flown once earlier in the day on September 16<sup>th</sup>. I performed my pre-flight inspection as normal. I called TAC Air during pre-flight and requested fuel. A fuel truck arrived about 5 or 10 minutes later, and the driver added a combined 26.4 gallons of fuel to fill both tanks. The nose landing gear appeared to be a little under-inflated, but I did not check

the air pressure, so I do not know the air pressure reading. I noted no discrepancies during my pre-flight inspection. Upon completion of pre-flight, I escorted my father back outside the secure area and walked back to the aircraft.

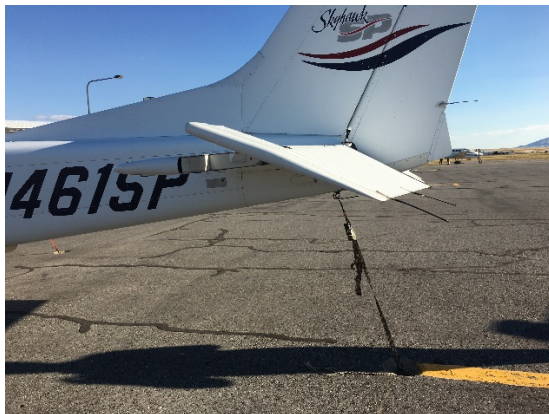
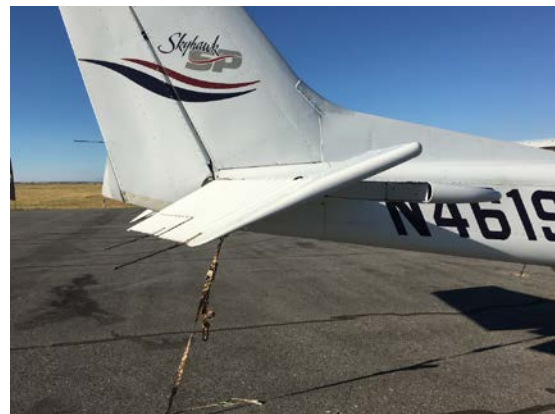
d. Aircraft Elevator.

(1645 hours) I then called another of my flight instructors, Philip Williamson. He answered, and I explained briefly what had happened. He said to turn the plane off, take a look at the elevator for any damage and then get back in the plane and wait for assistance. I hung up the phone, went through the aircraft Shut-Down Checklist and turned off the plane. I got out the left side door and walked around to the tail end of the plane to look at the elevator. I did not see anything wrong, so I got back into the plane.

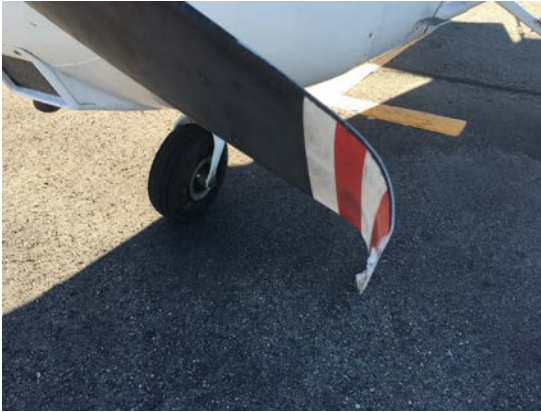
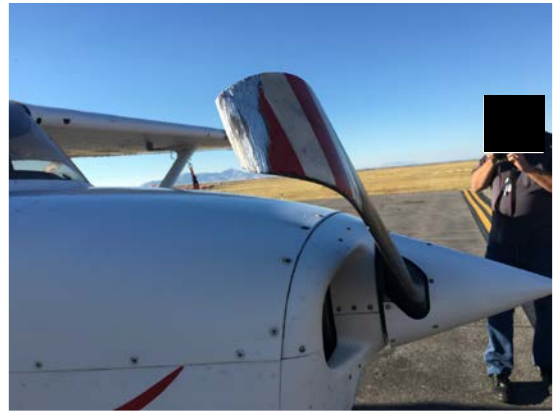
e. Aircraft Propeller.

(1659 hours) A white pickup truck with a yellow blinking warning light approached my aircraft. Two men got out of the truck and approached me. I exited the plane again and walked to the front of the plane, at which point I saw that the propeller blades were bent. One of the men said his name was Patrick, and I do not remember the other man's name. The men asked what had happened, which I told them. They then walked around the plane with me, and one of them pointed out that the front landing gear was not straight. At this point, I also saw that there was a gap between the right side engine cowl and the aircraft.
