# NATIONAL TRANSPORTATION SAFETY BOARD

## MATERIALS LABORATORY FACTUAL REPORT

Report No. 17-049

Place : Brainerd, MN  
Date : June 17, 2016  
Vehicle : MD Helicopter 369E, N155NR  
NTSB No. : GAA16LA325  
Investigator : Michael Hicks (AS-20)

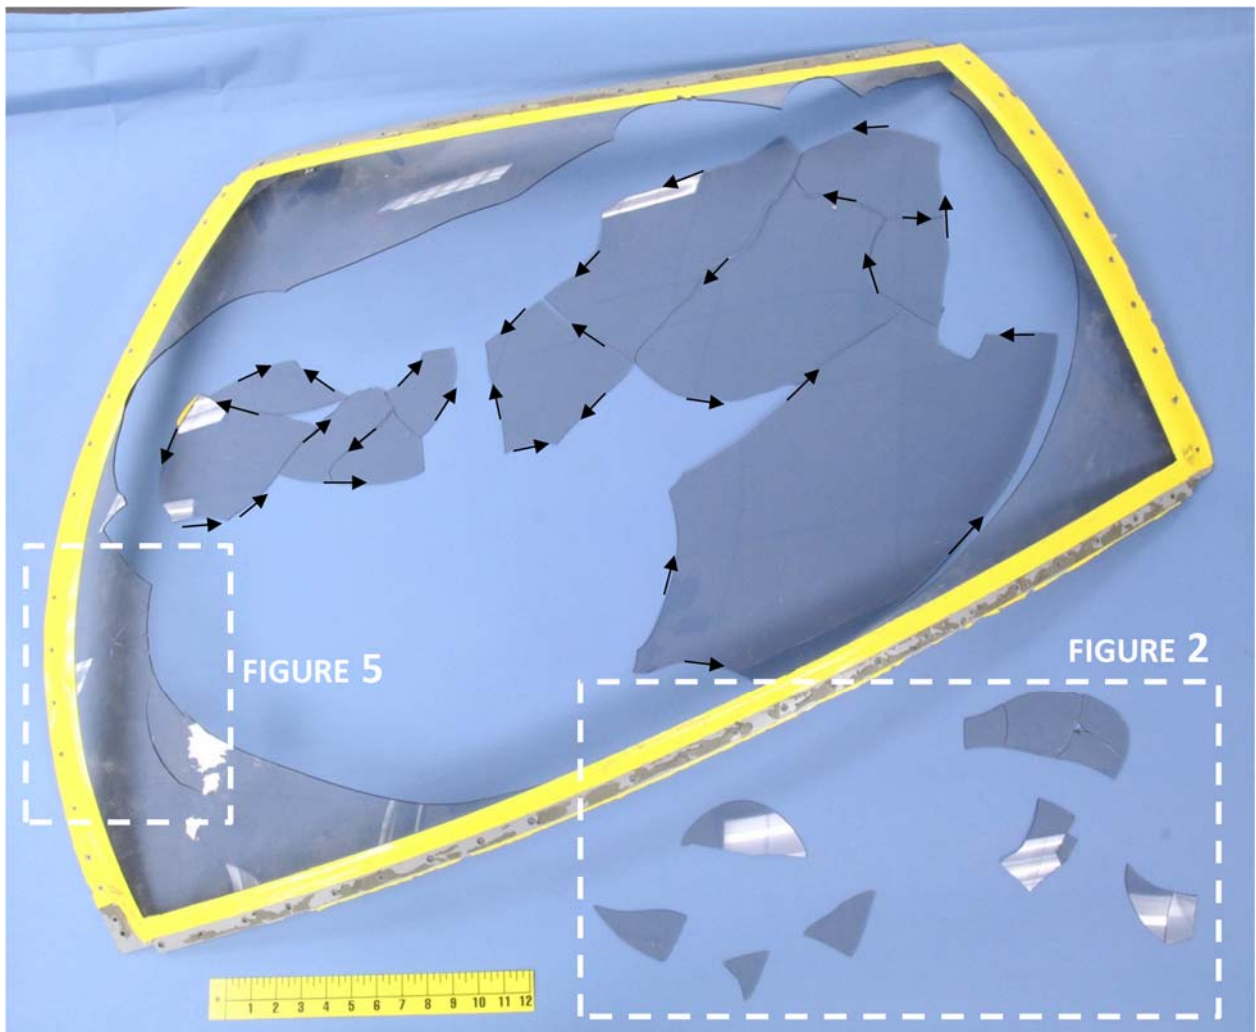
The windscreen was submitted with the clear polymer shattered into numerous pieces. Figure 1 shows all of the submitted windscreen pieces. As many mating pieces as possible were matched up by examining the fracture surfaces features. A few of the pieces could not be matched to any of the other recovered pieces, and a few groups of pieces could not be matched within the larger collection of the overall windscreen set. The unmatched pieces and groups of pieces are shown in Figure 2. Based on the submitted pieces, a significant portion of the windscreen was not recovered.

The black arrows in Figures 1, 2, and 5 indicate the direction of crack propagation based on analysis of the fracture surface features. The features on the pieces were consistent with fracture occurring from the external surface of the windscreen, rather than the internal surface that faced into the helicopter cabin. Figure 5 shows cracks that had not progressed far enough to result in discrete windscreen pieces. The tips of the cracks had not propagated through the thickness of the windscreen, and portions of uncracked windscreen were visible adjacent to the internal surface.

The cracks shown in Figure 5 emanated from the center of the windscreen and propagated towards the outer edge of the windscreen. Similarly, the overall pattern of the cracking (illustrated in Figure 1) appeared to be from the center of the windscreen towards the outer edge. No cracks were observed emanating from the bolt holes circling the outer edge of the windscreen.

The pattern of crack propagation and the cracks emanating from the external surface was consistent with the windscreen separating due to impact force applied from outside the aircraft.

**Figure 1:** Overall photo of the submitted pieces of the windscreen. The black arrows indicate the direction of crack propagation.

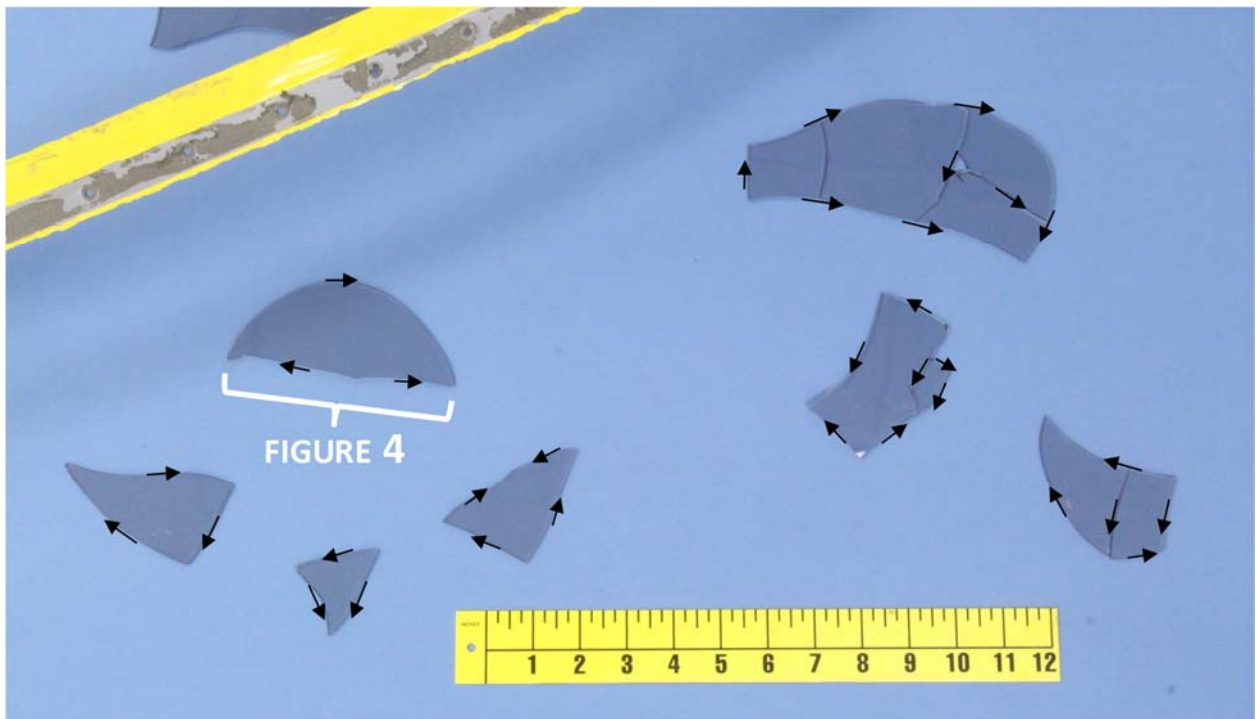
**Figure 2:** Close-up photo of pieces of the windscreen that could not be matched up with the larger collection of puzzled together pieces. The black arrows indicate the direction of crack propagation.

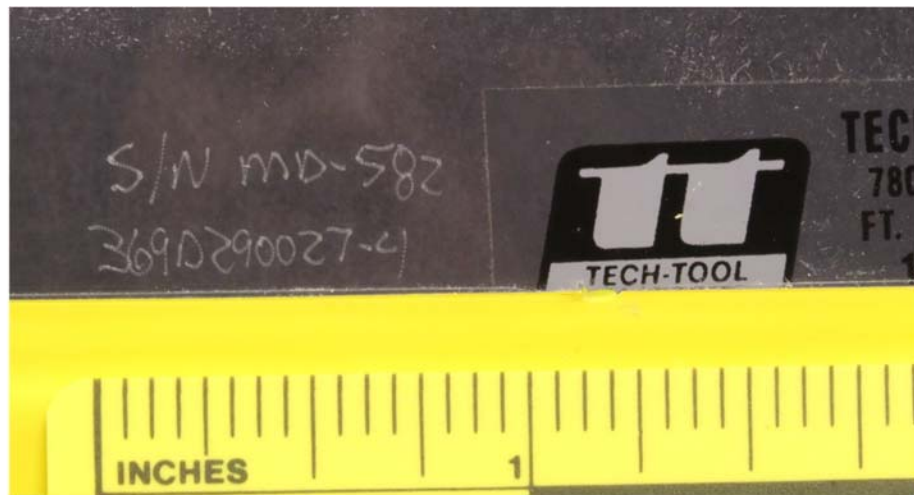
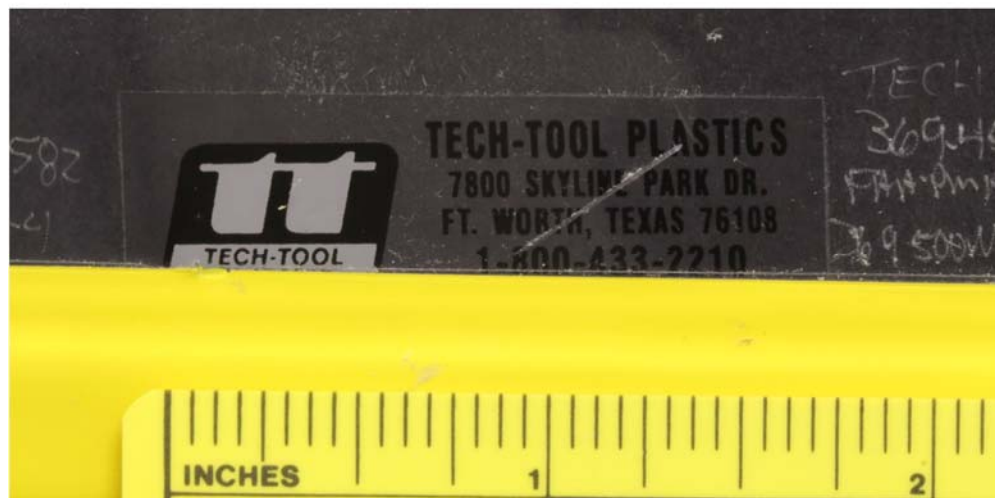
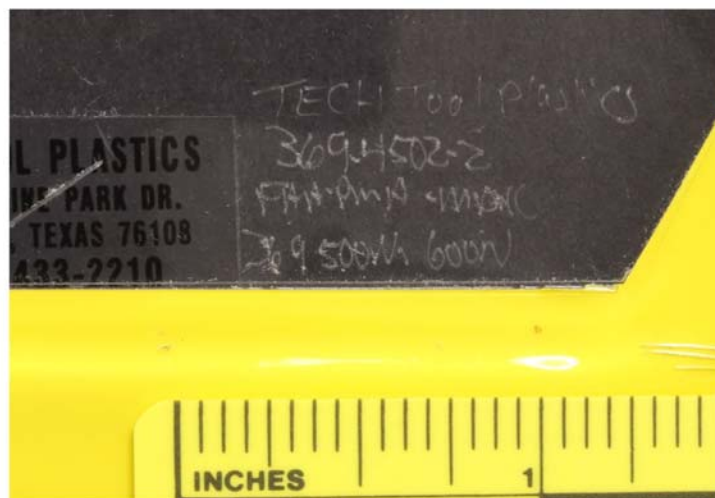
The following part markings, shown in Figure 3, were observed in one corner of the windscreen, on a portion still attached to the border:

S/N MD-582  
369D290027-4

TECH-TOOL PLASTICS  
[REDACTED]  
Ft. Worth, Texas 76108  
[REDACTED]

TECH Tool Plastics  
3694502-2  
FAA PMA MONC  
369 500N 600N

**Figure 3:** Close-up photos of the part markings on one corner of the windscreen.

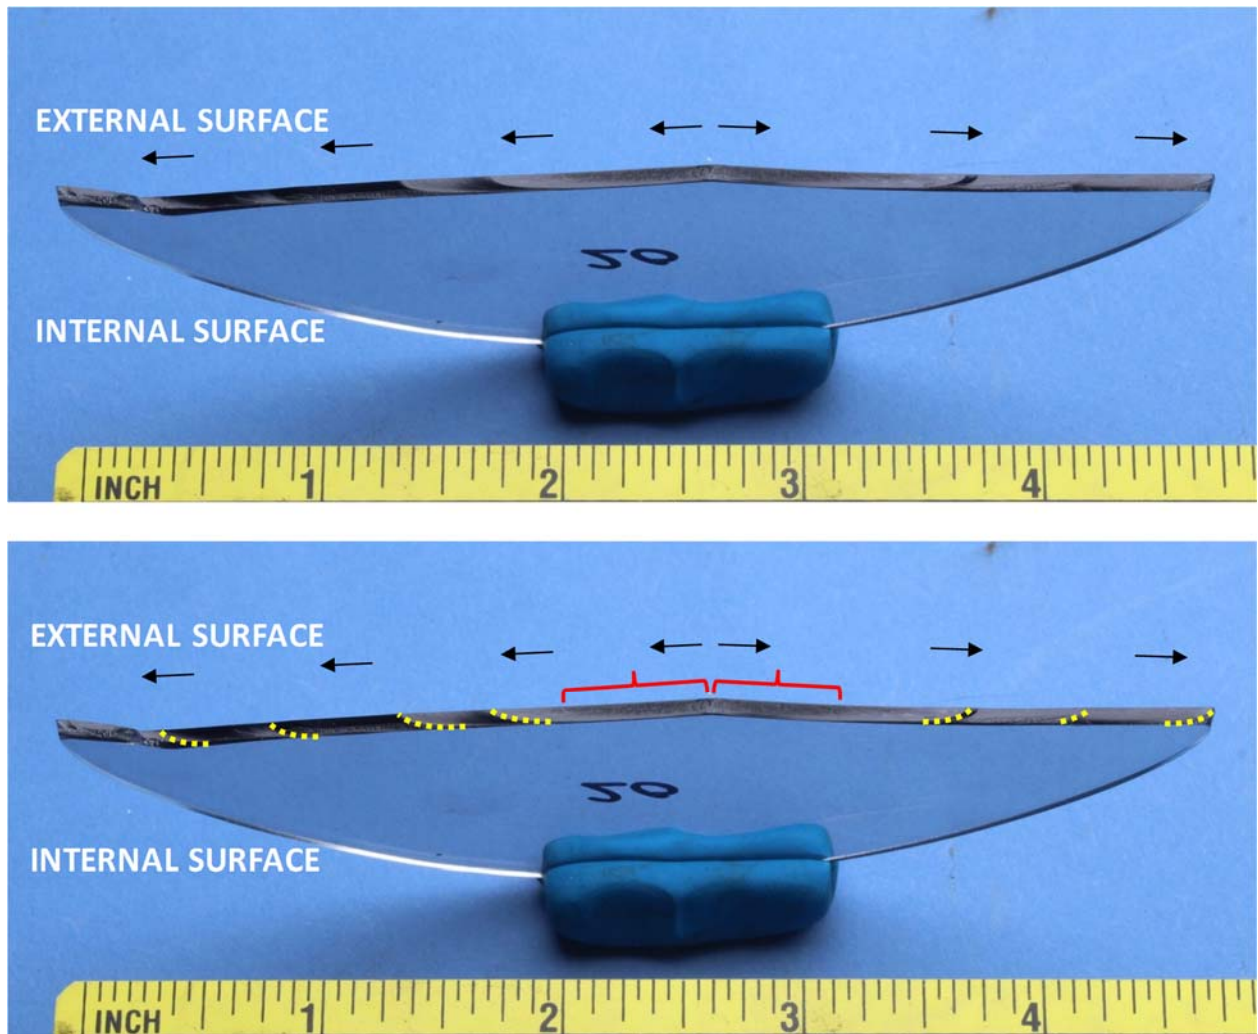
The fracture surfaces had features consistent with fast, brittle fracture in a polymer. A fracture surface on a representative piece is shown in Figure 4. This piece had cracks that progressed in opposite directions, as indicated by the black arrows. Mist regions on the fracture surface are indicated by the red brackets and rib markings are indicated by the yellow dotted lines<sup>12</sup>.

**Figure 4:** Close-up photo of a fracture surface on a representative piece of windscreen. This piece had cracks that progressed in opposite directions, as indicated by the black arrows. Mist regions (red brackets) and rib markings (yellow dotted lines) were visible on the fracture surface.

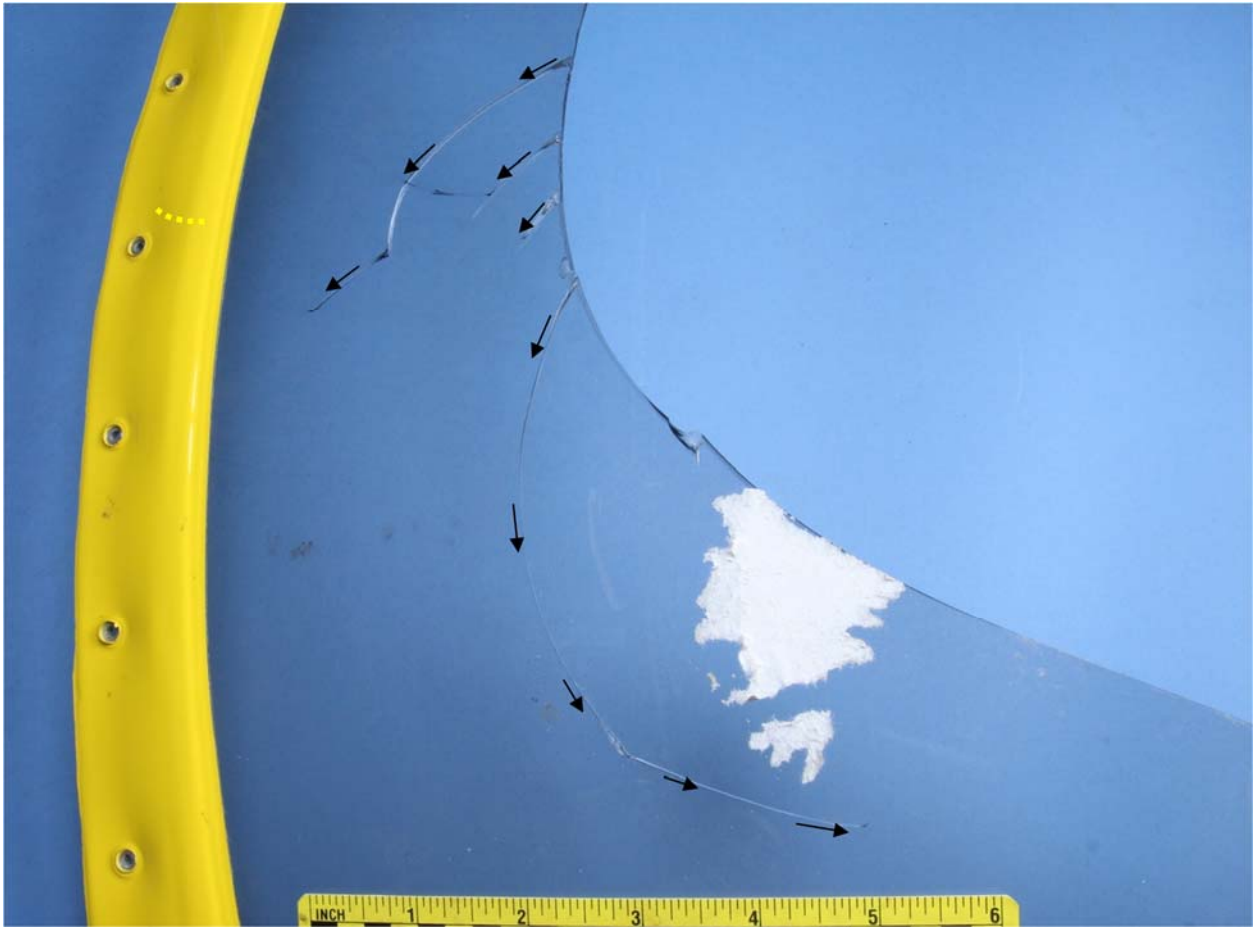
**Figure 5:** Close-up photo of cracks that had not progressed all the way through the thickness of the windscreen.
