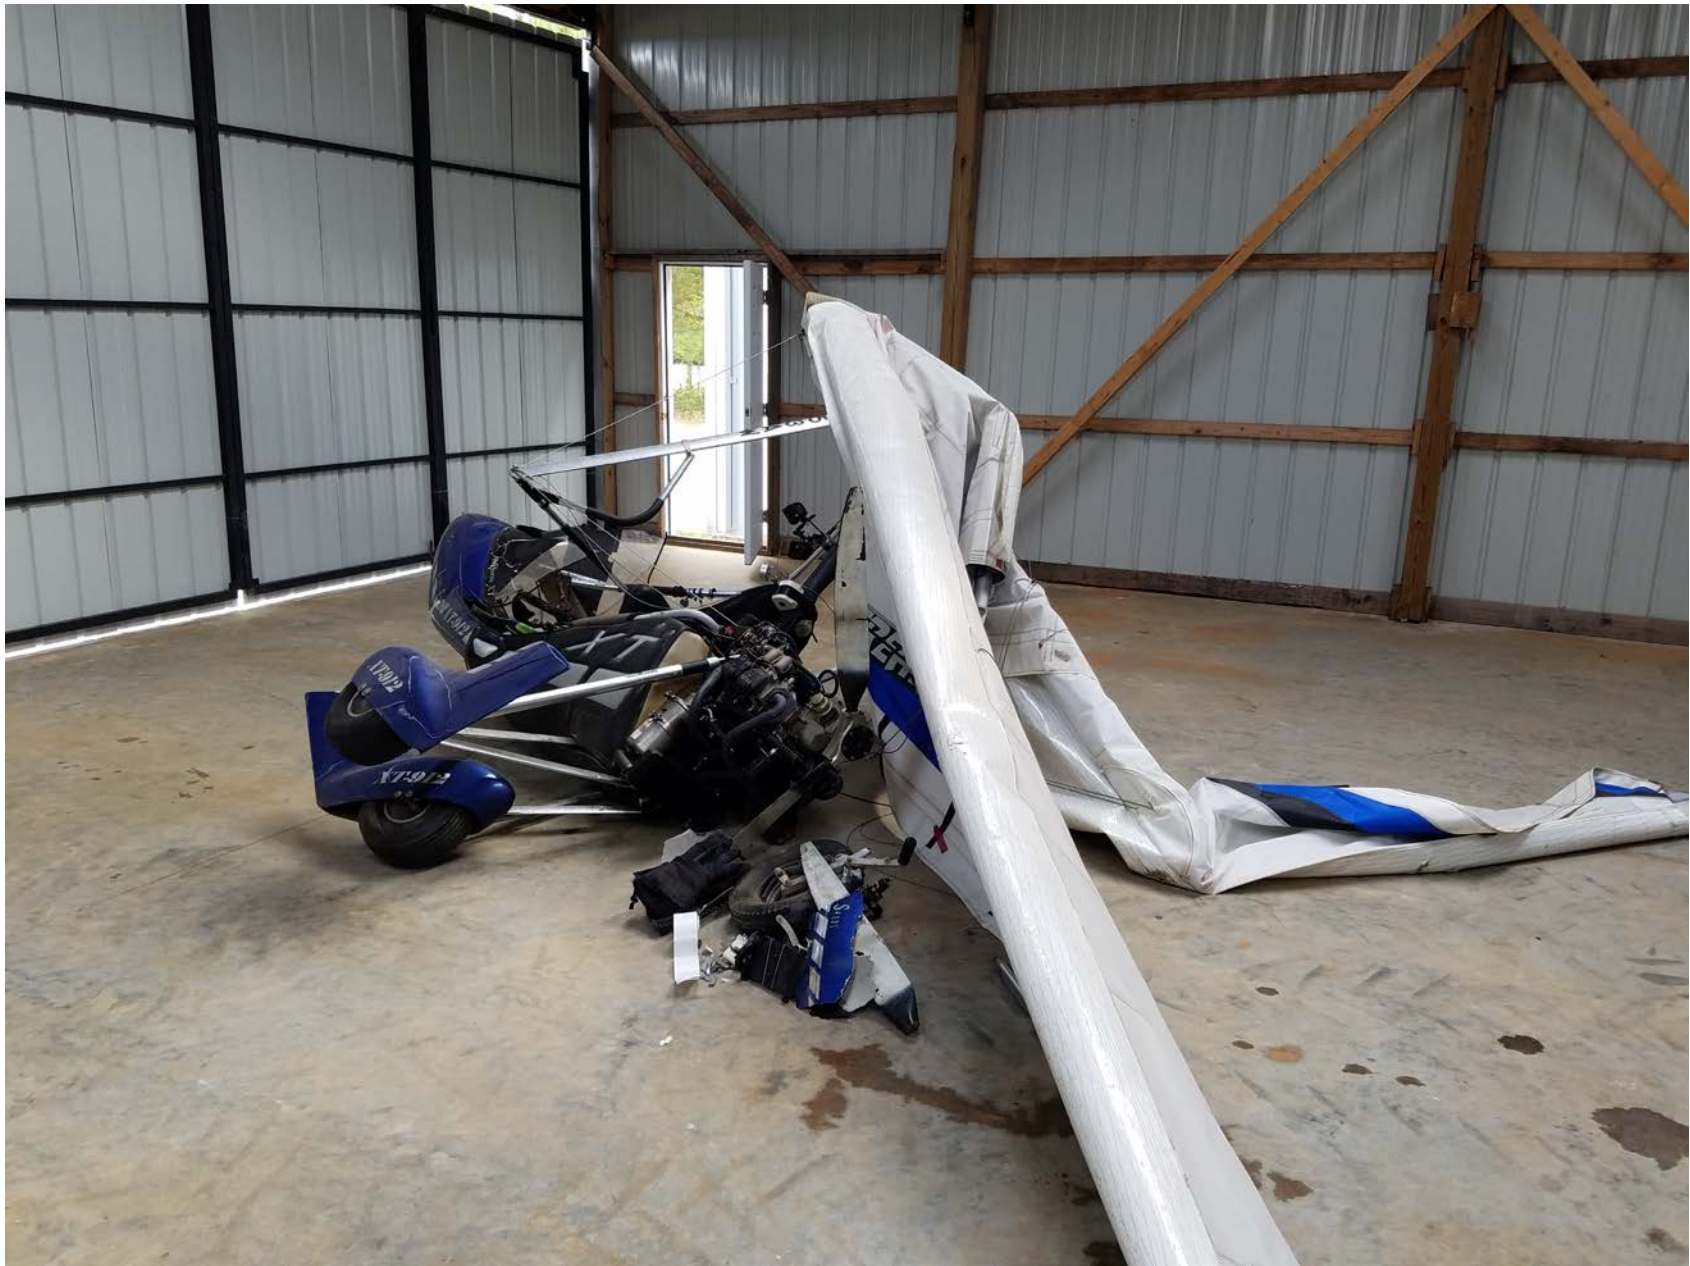
**Photo 1 – View of damage to leading edge tube (Courtesy of FAA)**

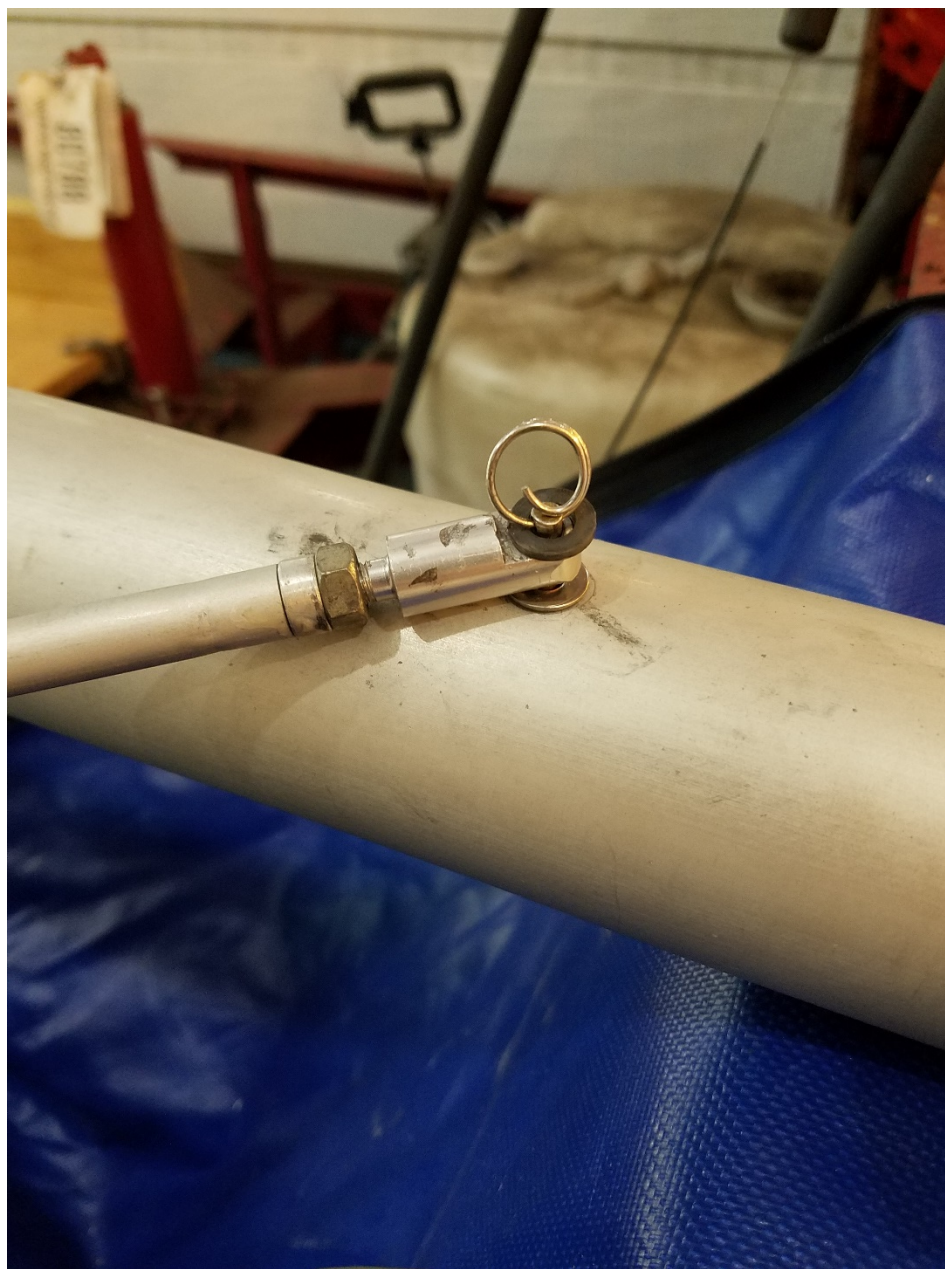
**Photo 2 - View of left/good side washout strut and split ring (Courtesy of FAA)**
