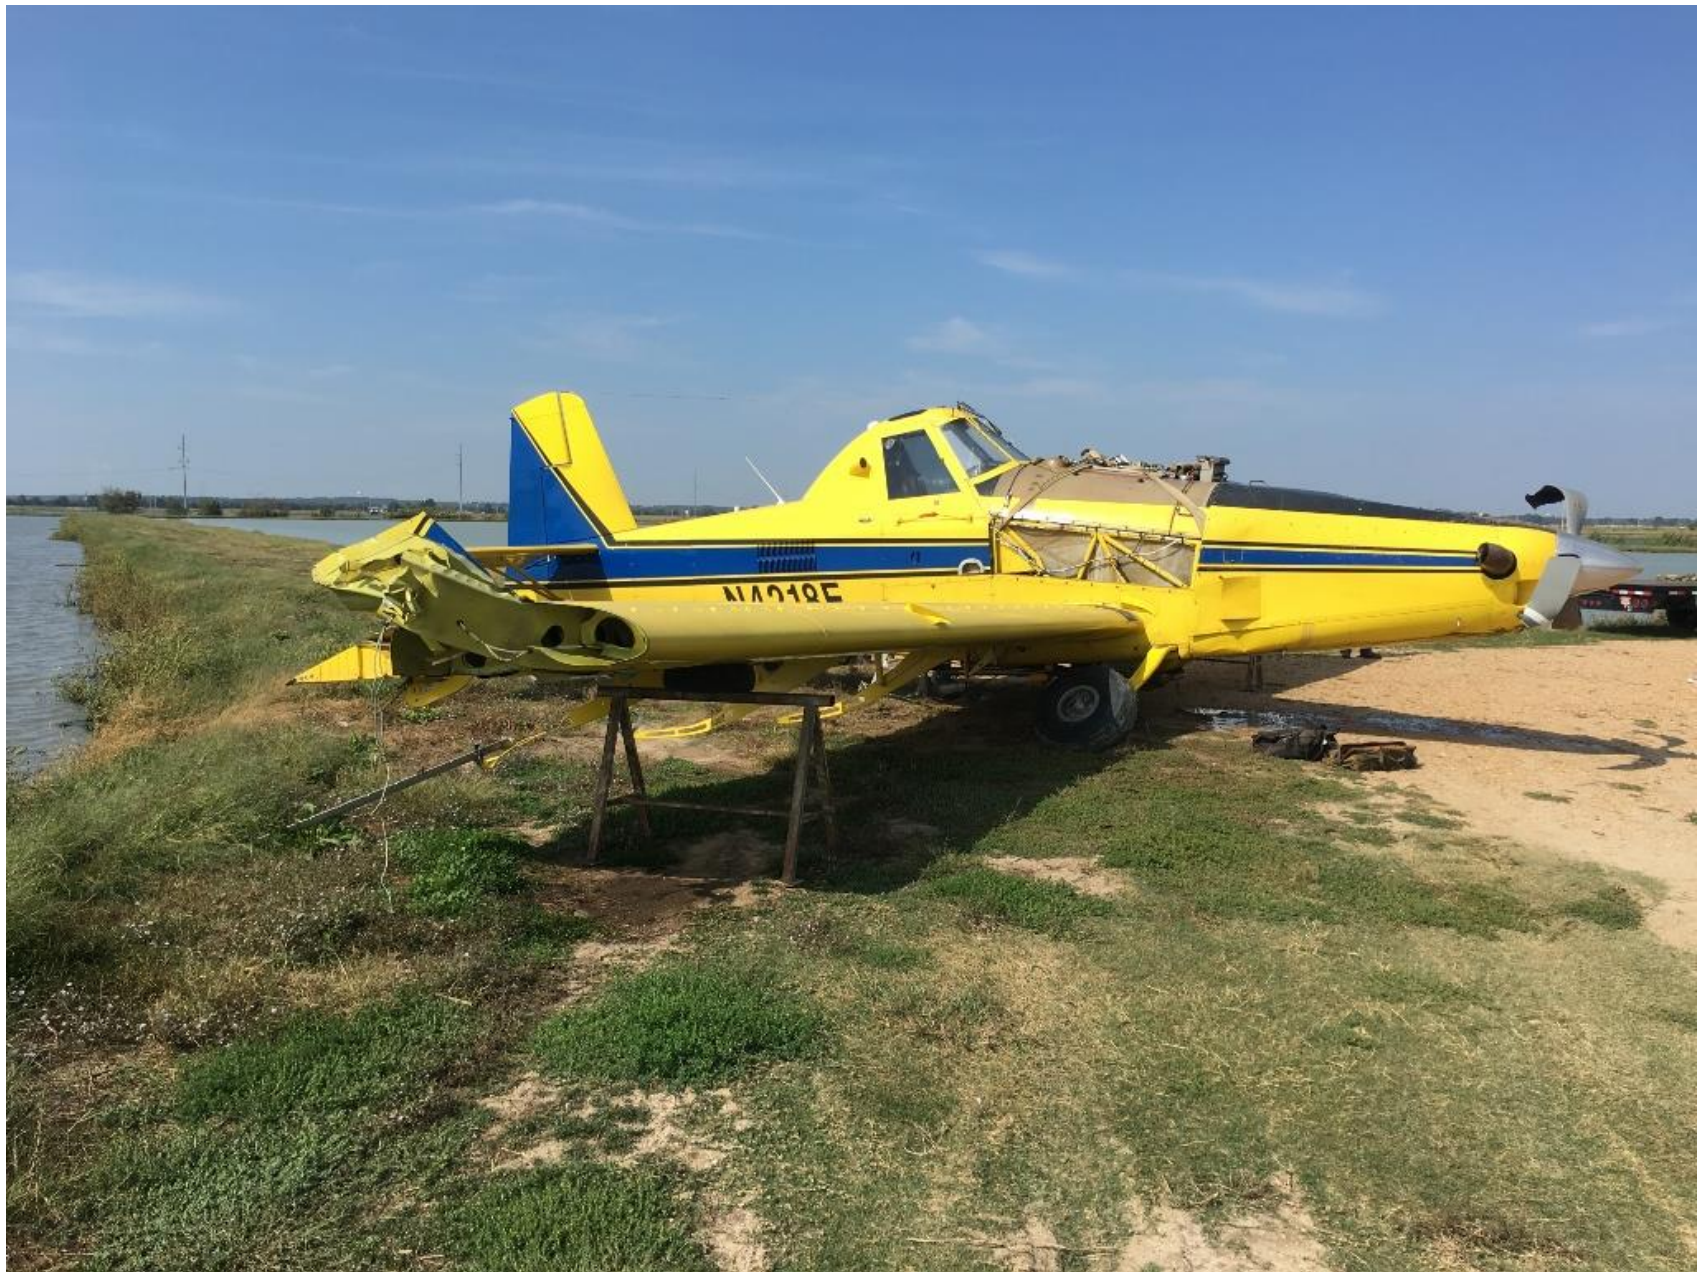
**Photo 1 – View of damaged right wing (photo courtesy of recovery company)**

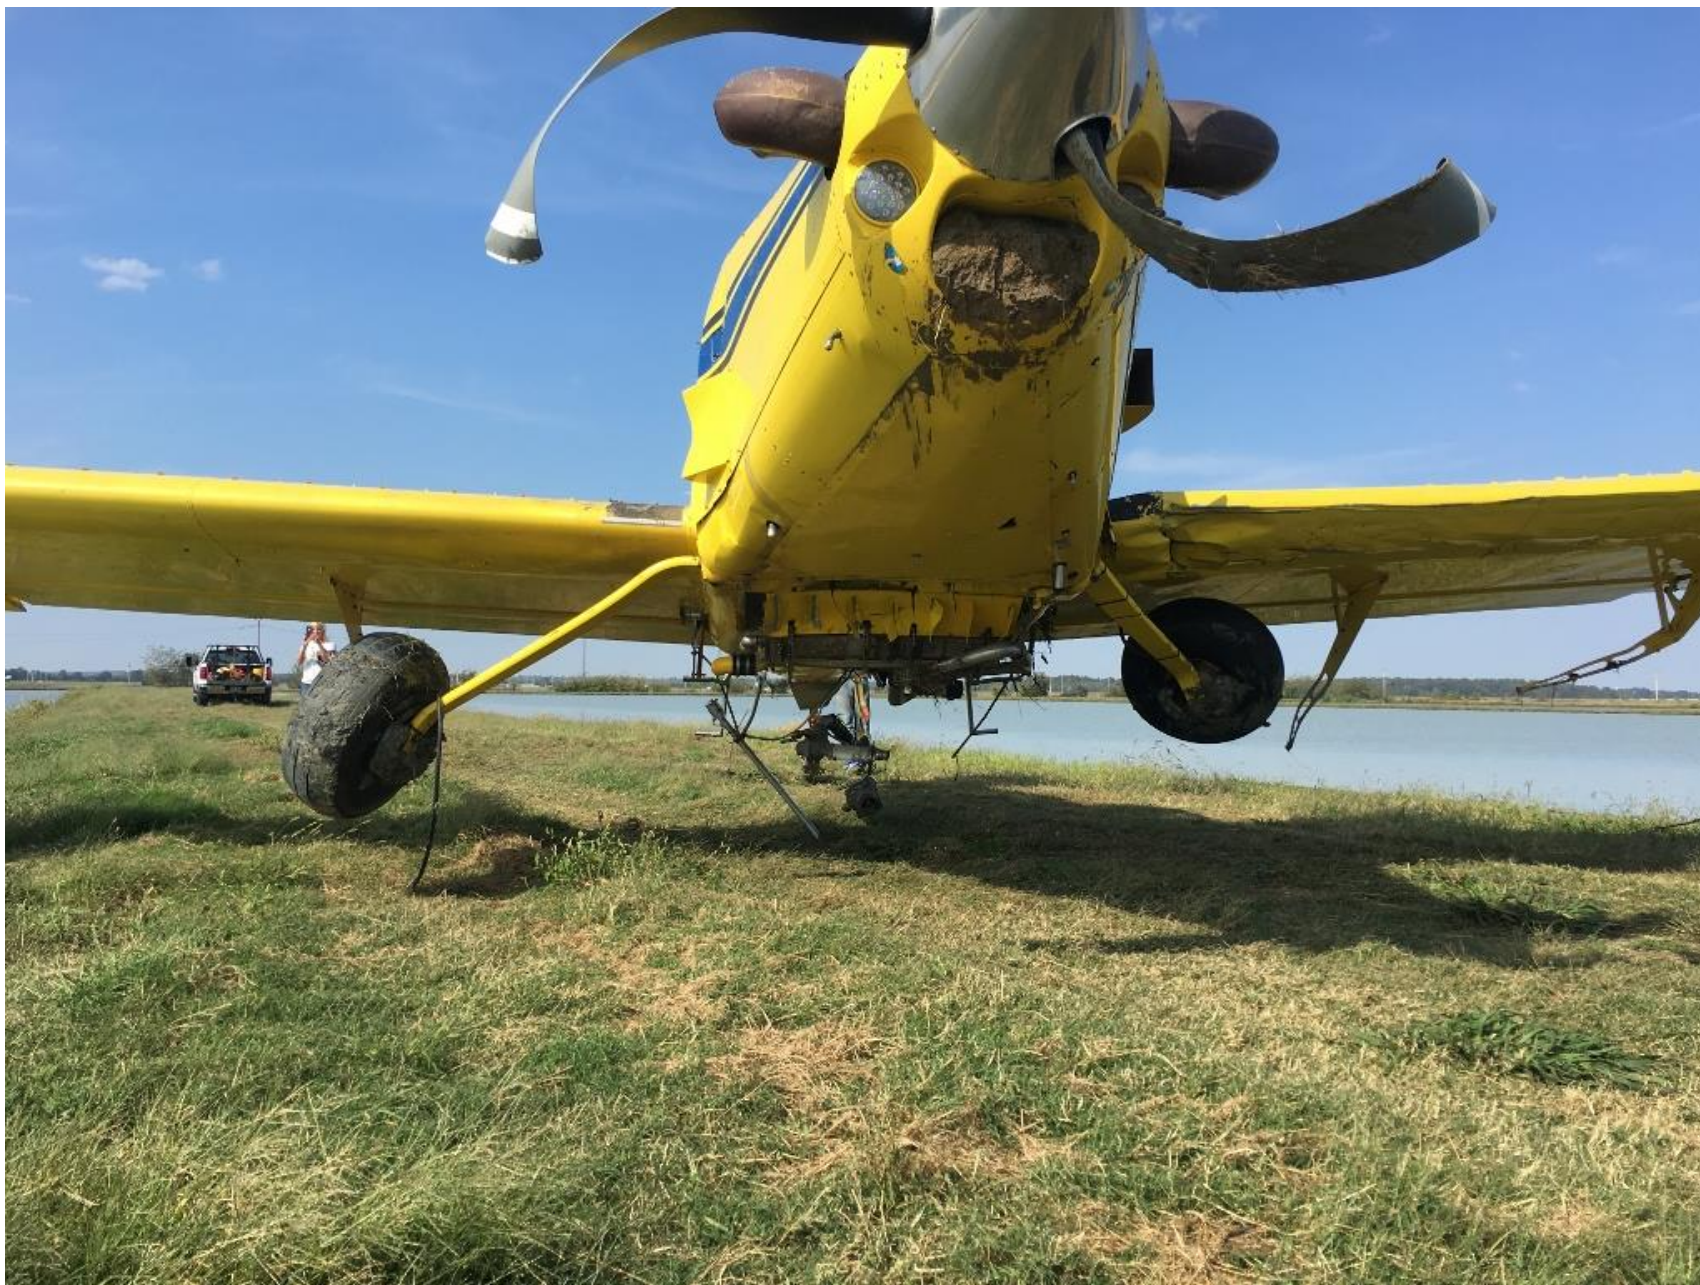
**Photo 2 – View of damaged left wing (photo courtesy of recovery company)**
