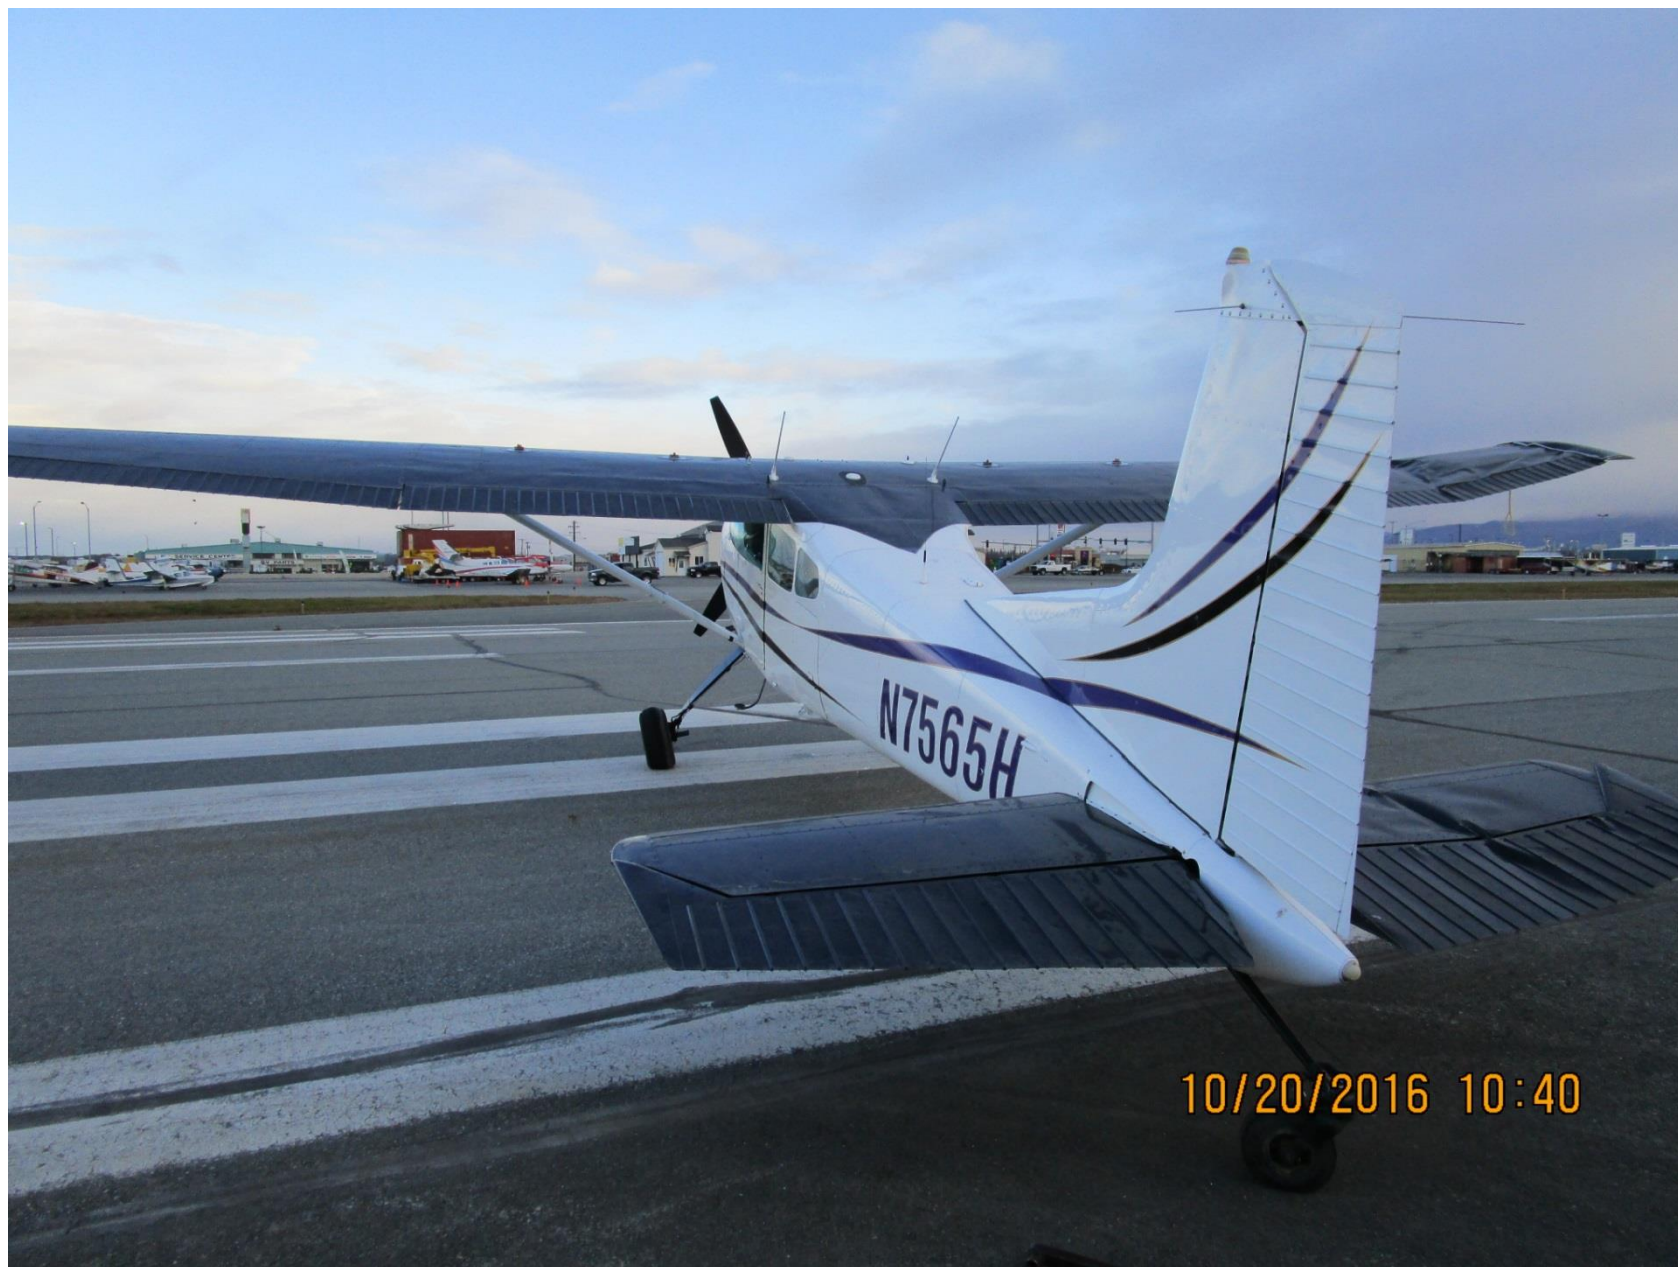
**Photo 1 – View of damaged empennage and right wing (Photo courtesy of the FAA)**
