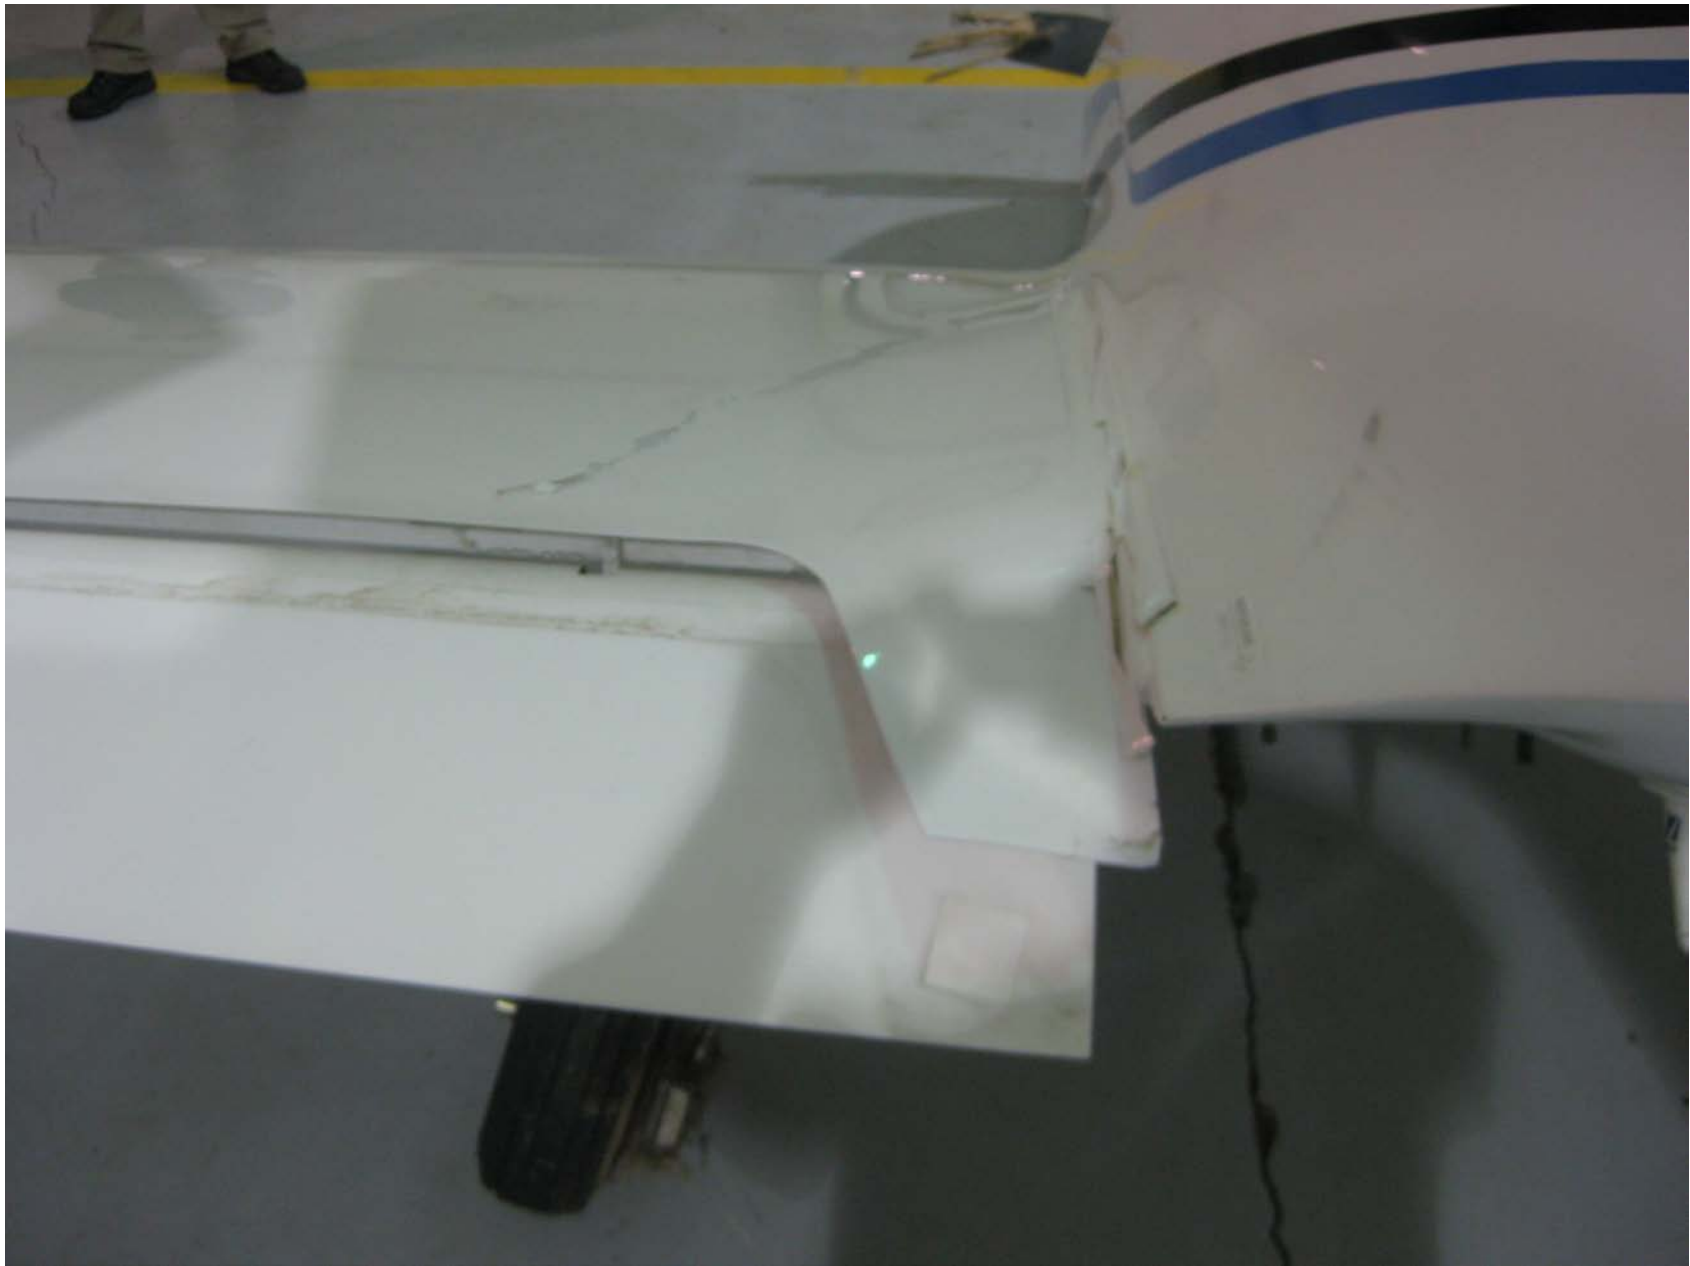
**Photo 1 – View of damage to the left wing root (Courtesy of FAA)**

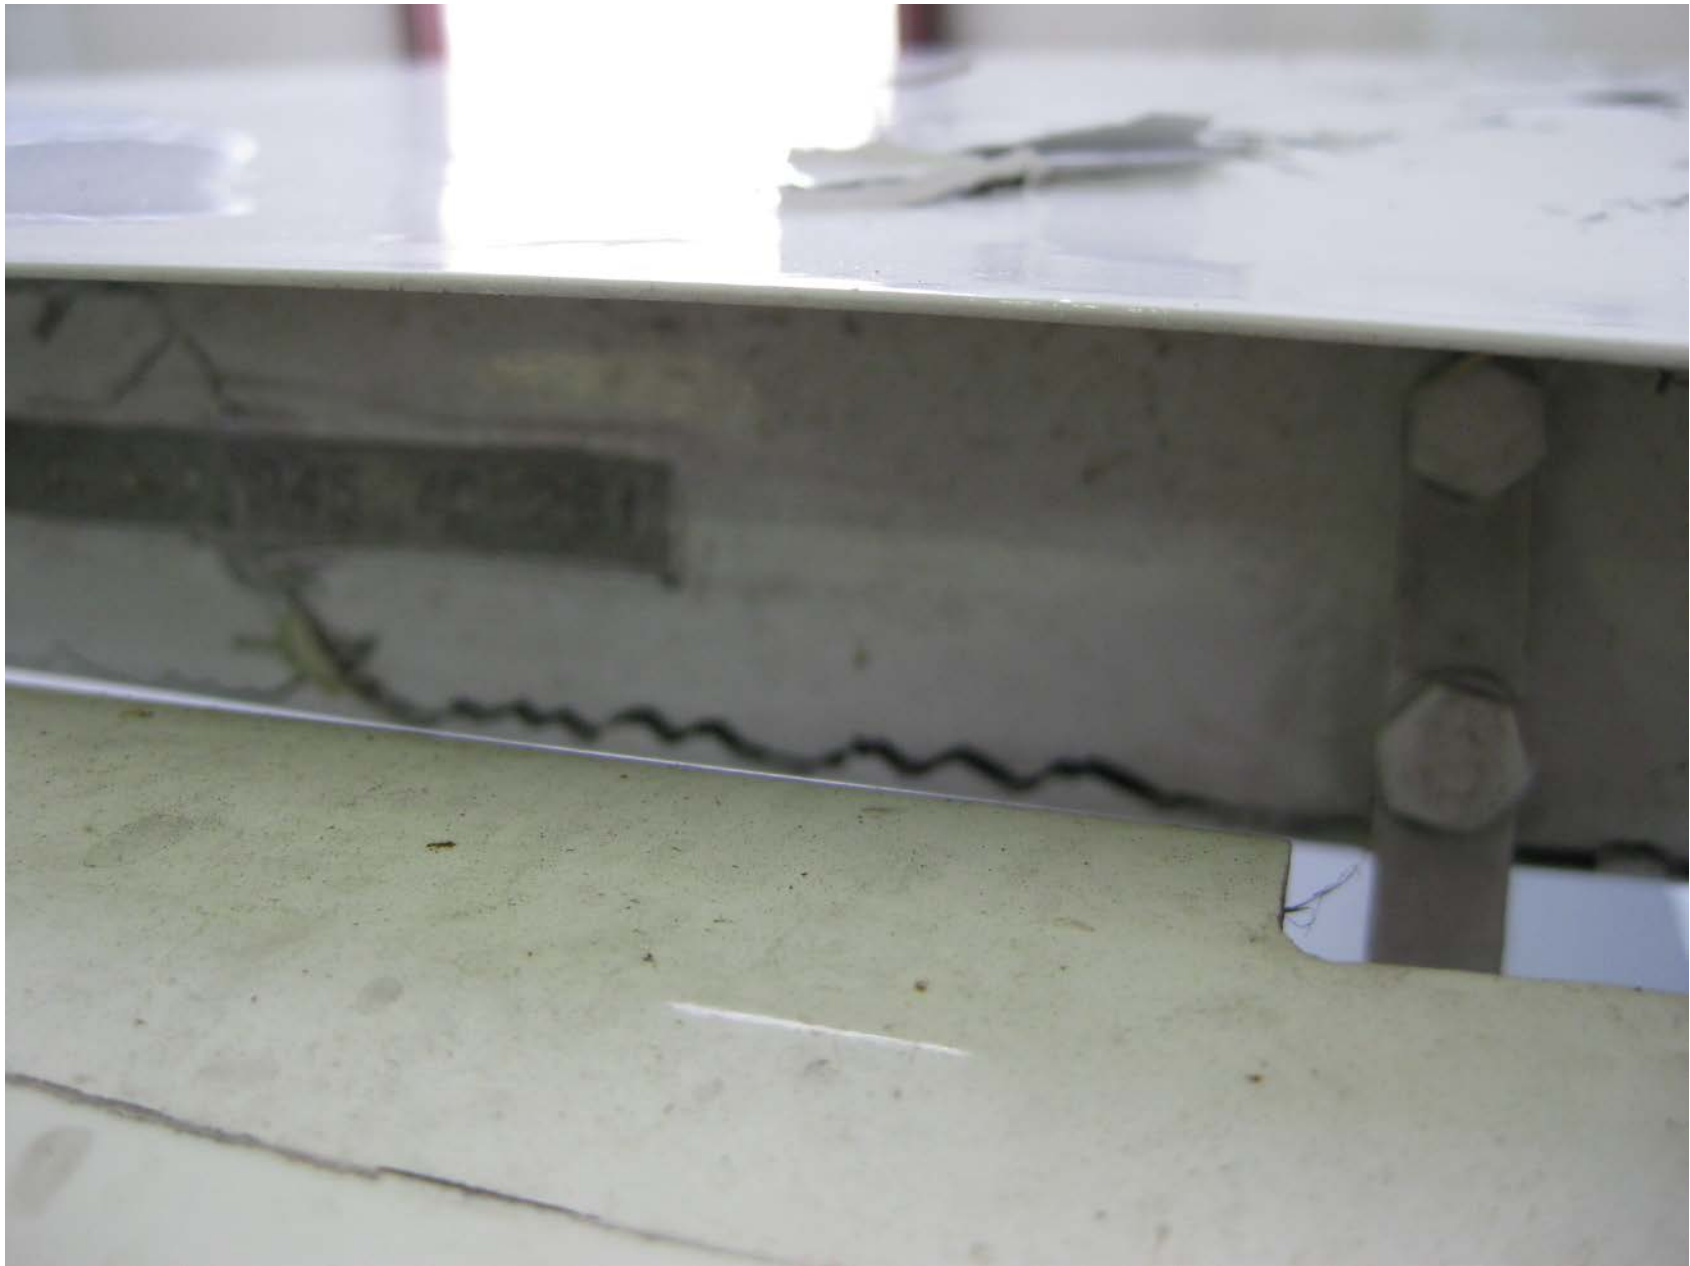
**Photo 2 – View of substantial damage to the composite left wing (Courtesy of FAA)**

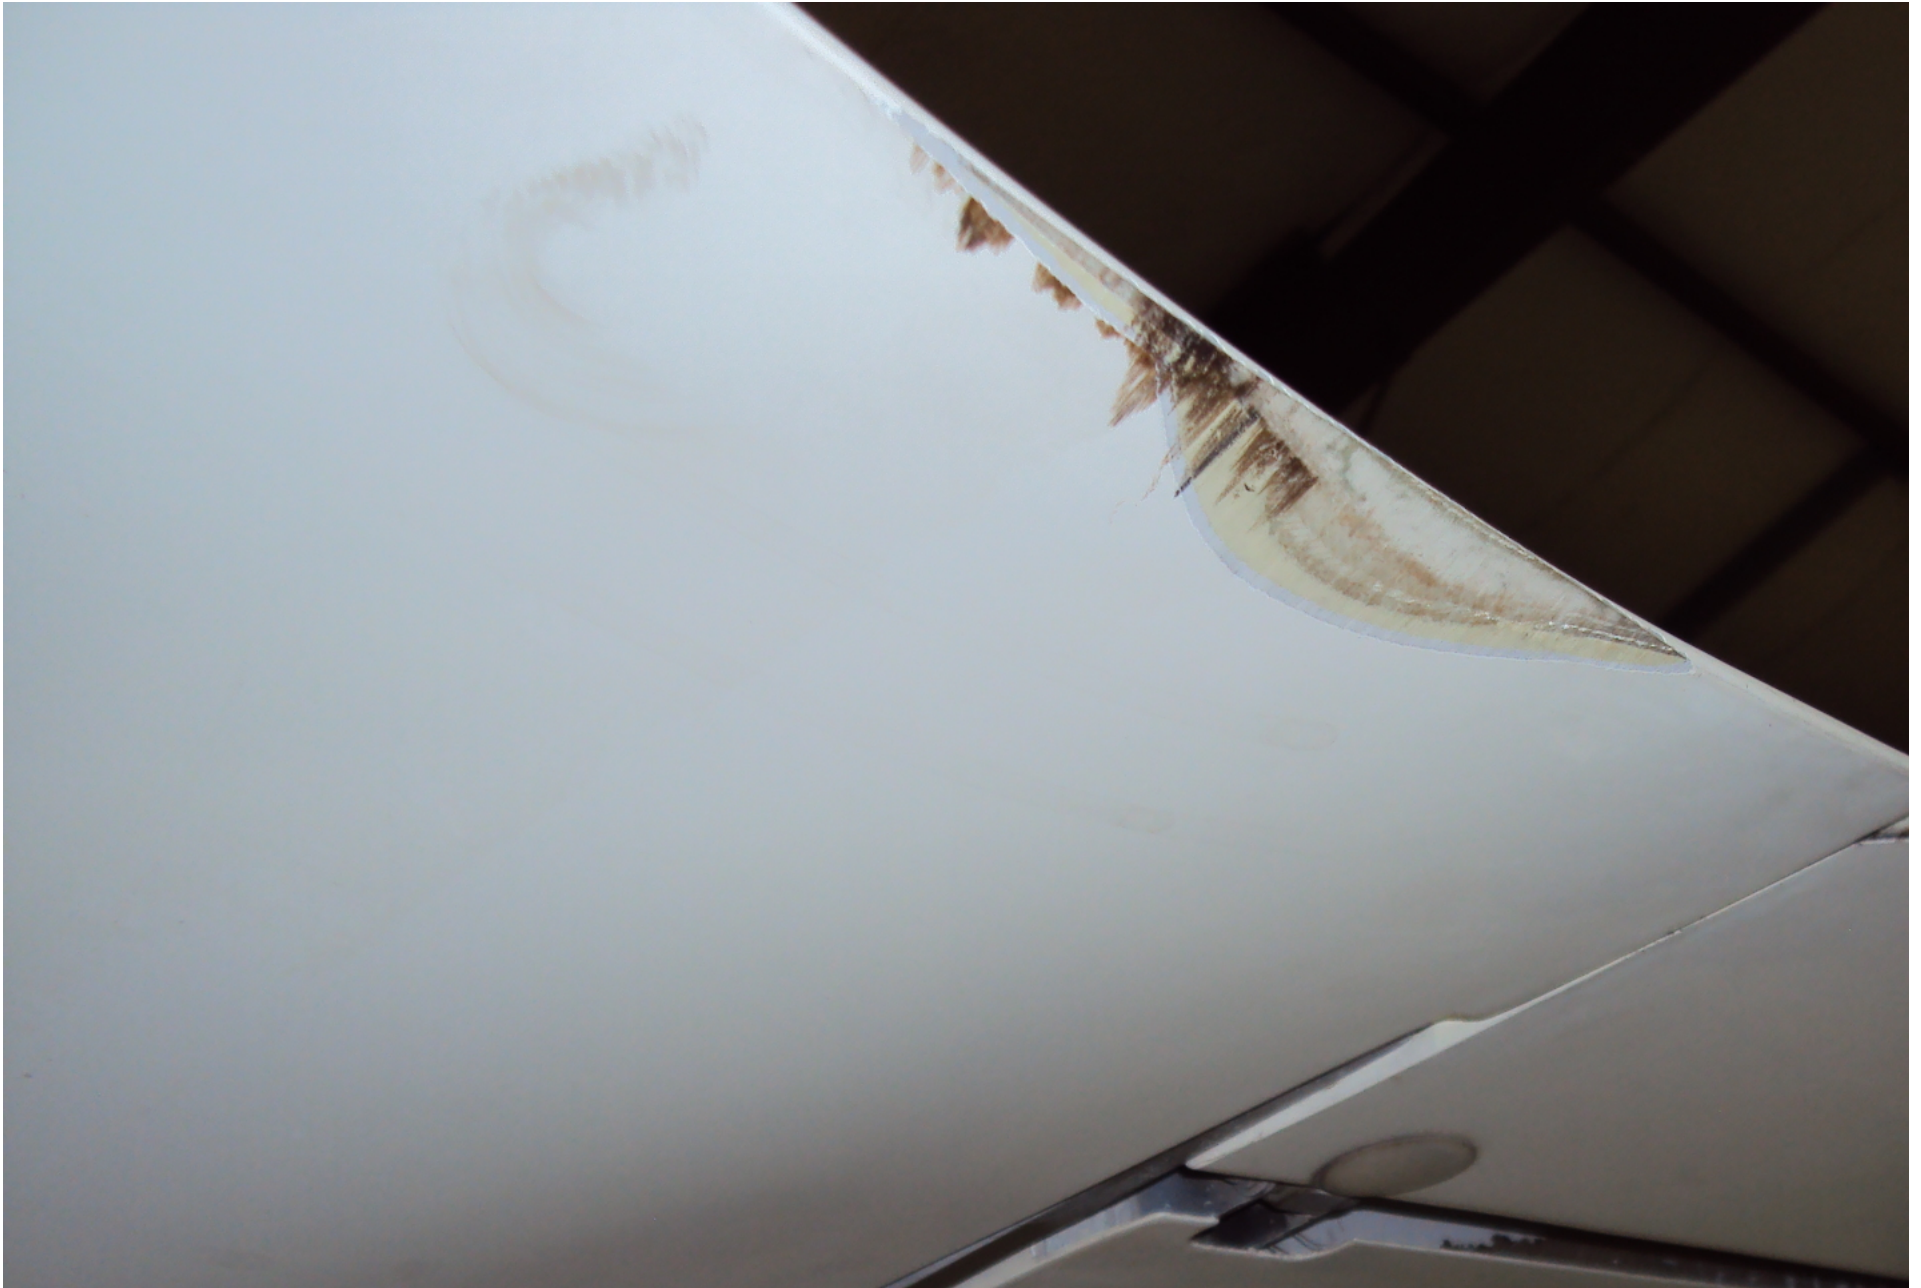
**Photo 3 – View of damage to the trailing edge of the outboard left wing (Courtesy of FAA)**

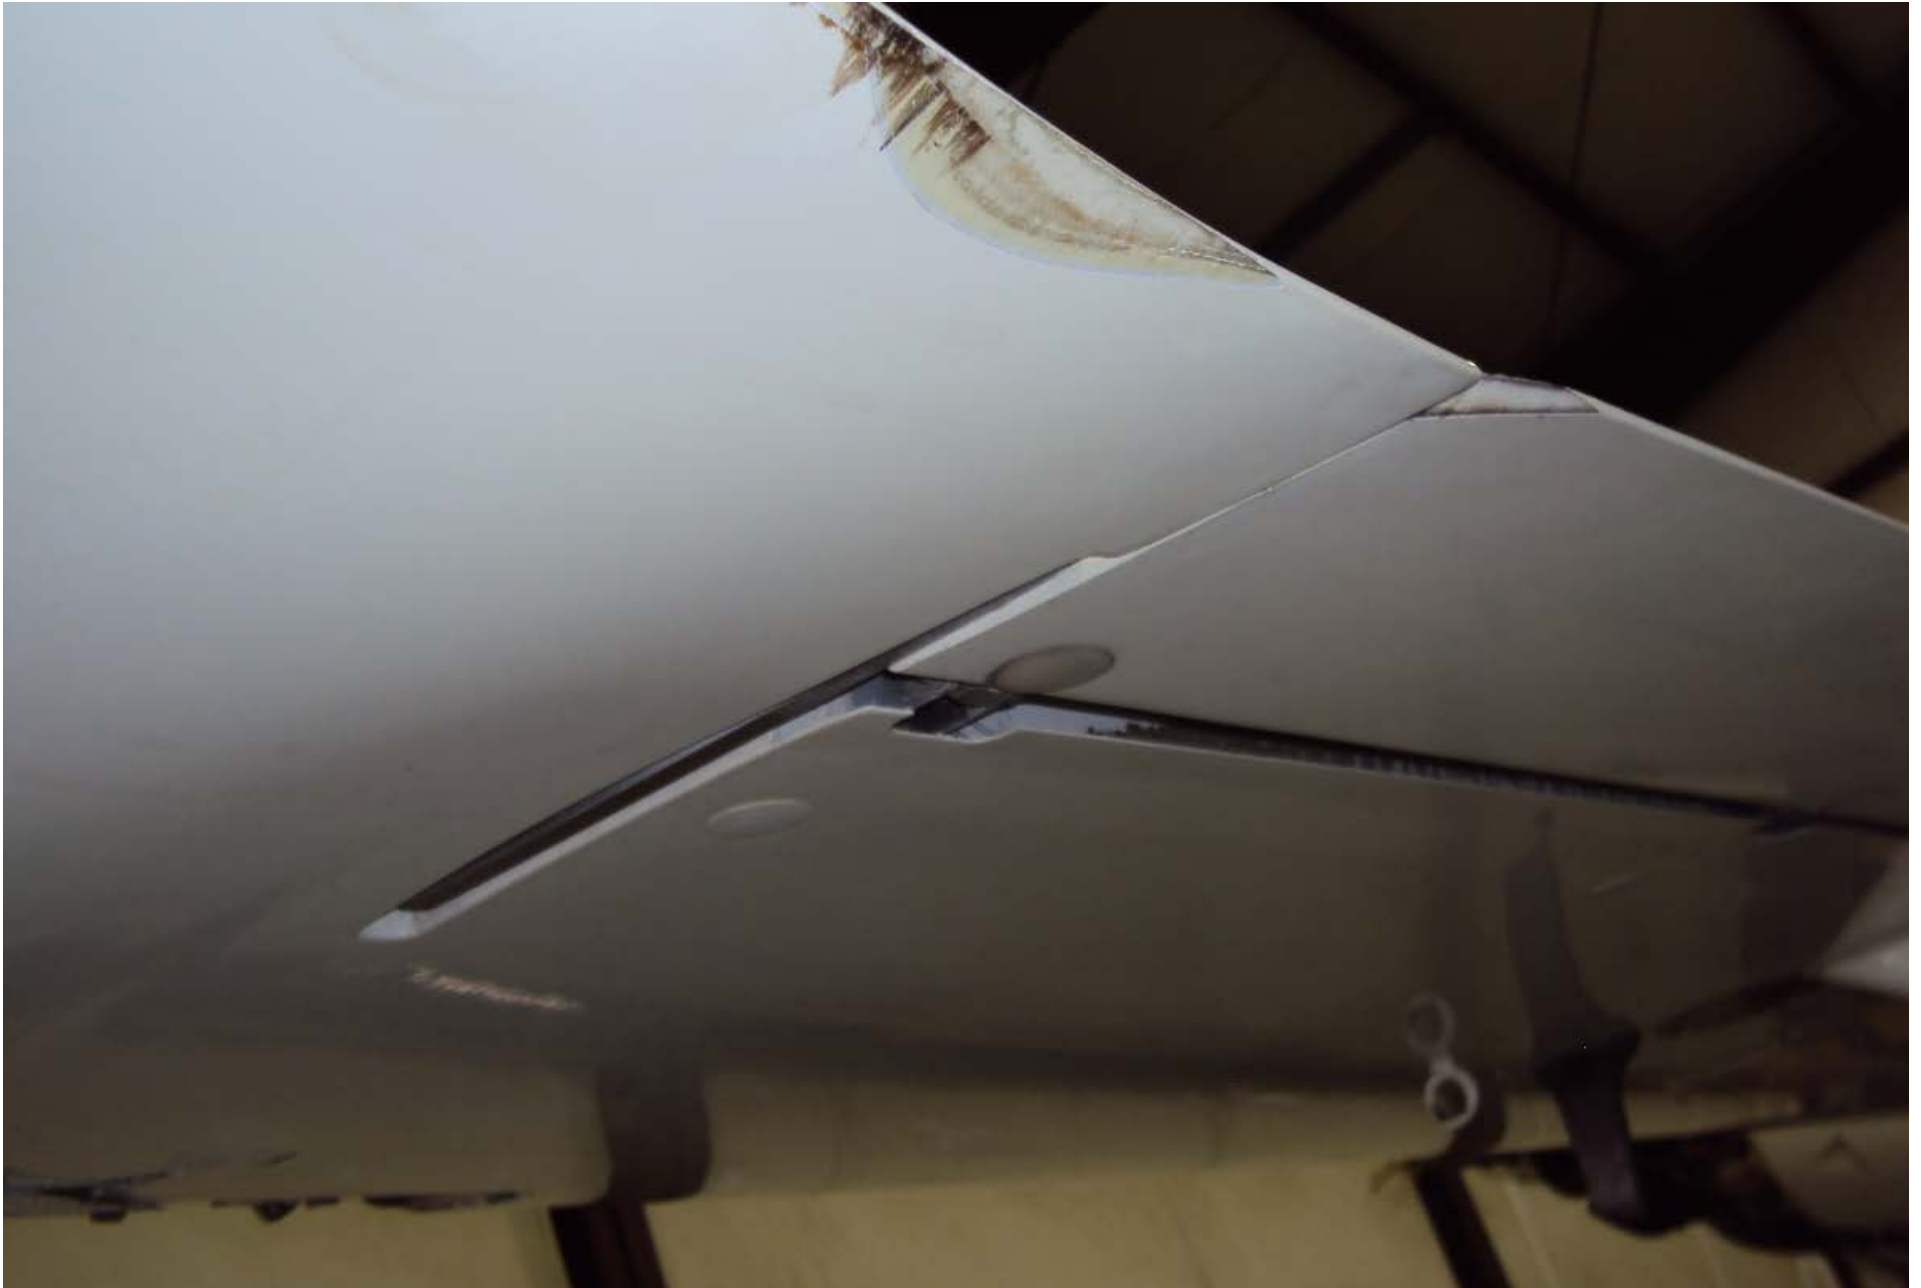
**Photo 4 – View of damage to left aileron (Courtesy of FAA)**

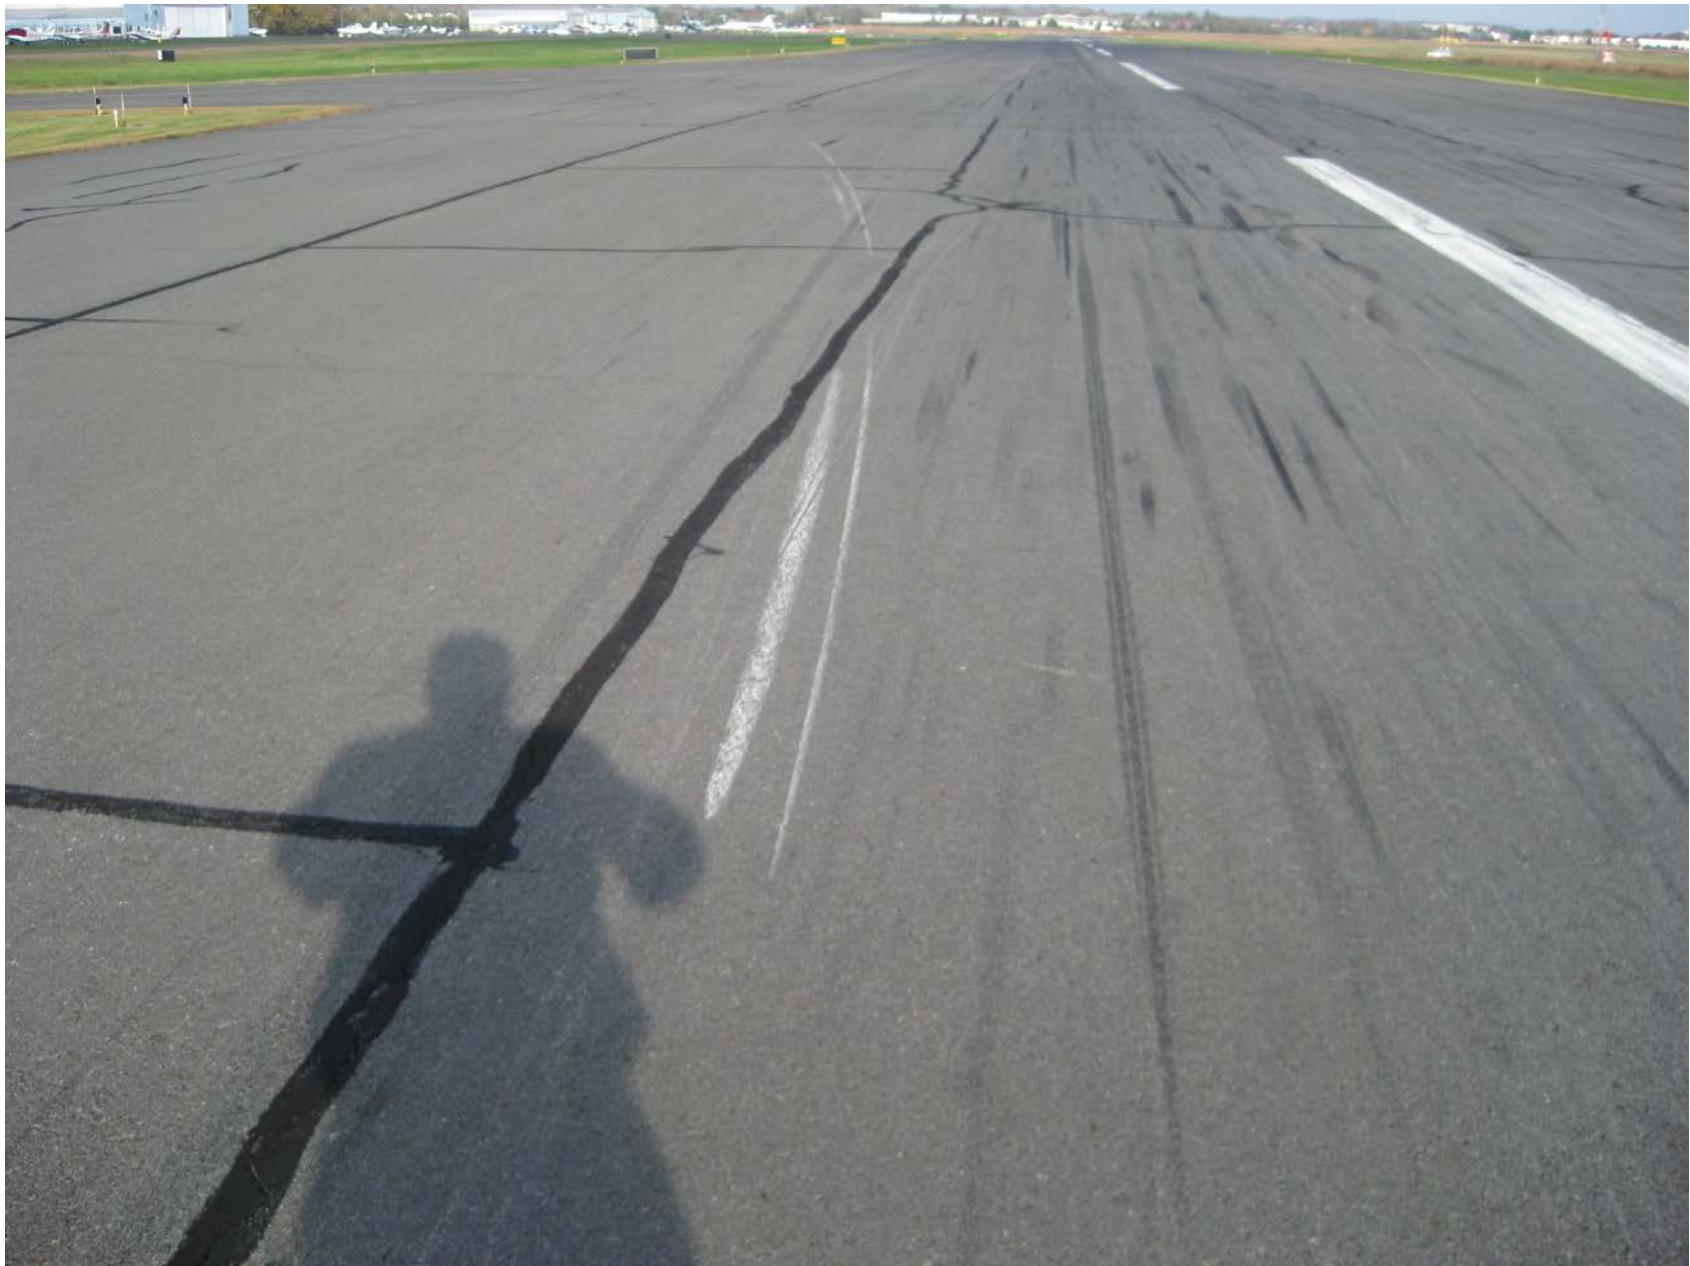
**Photo 5 – View of white paint transfer on the asphalt of Runway 34 (Courtesy of FAA)**
