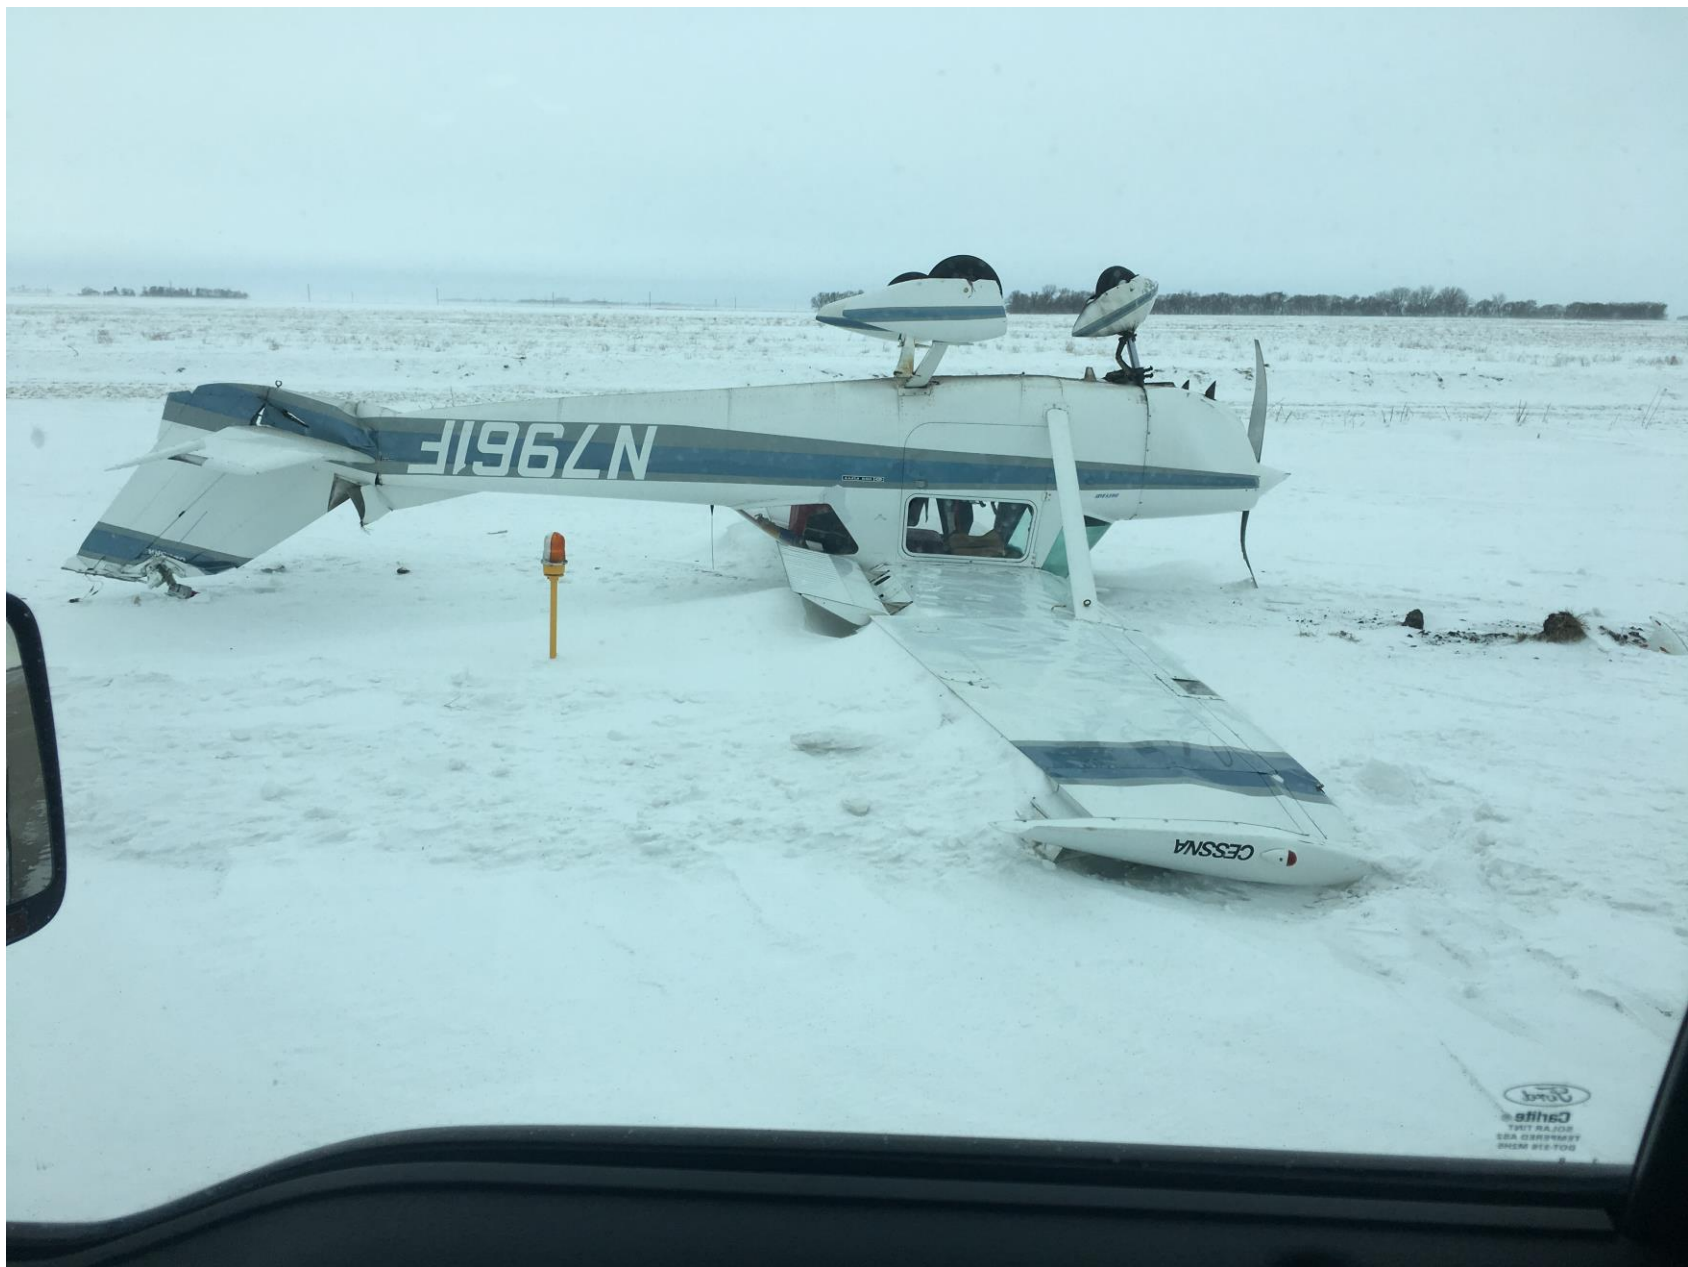
**Photo 1 – View of empennage damage (photo courtesy of the FAA).**
