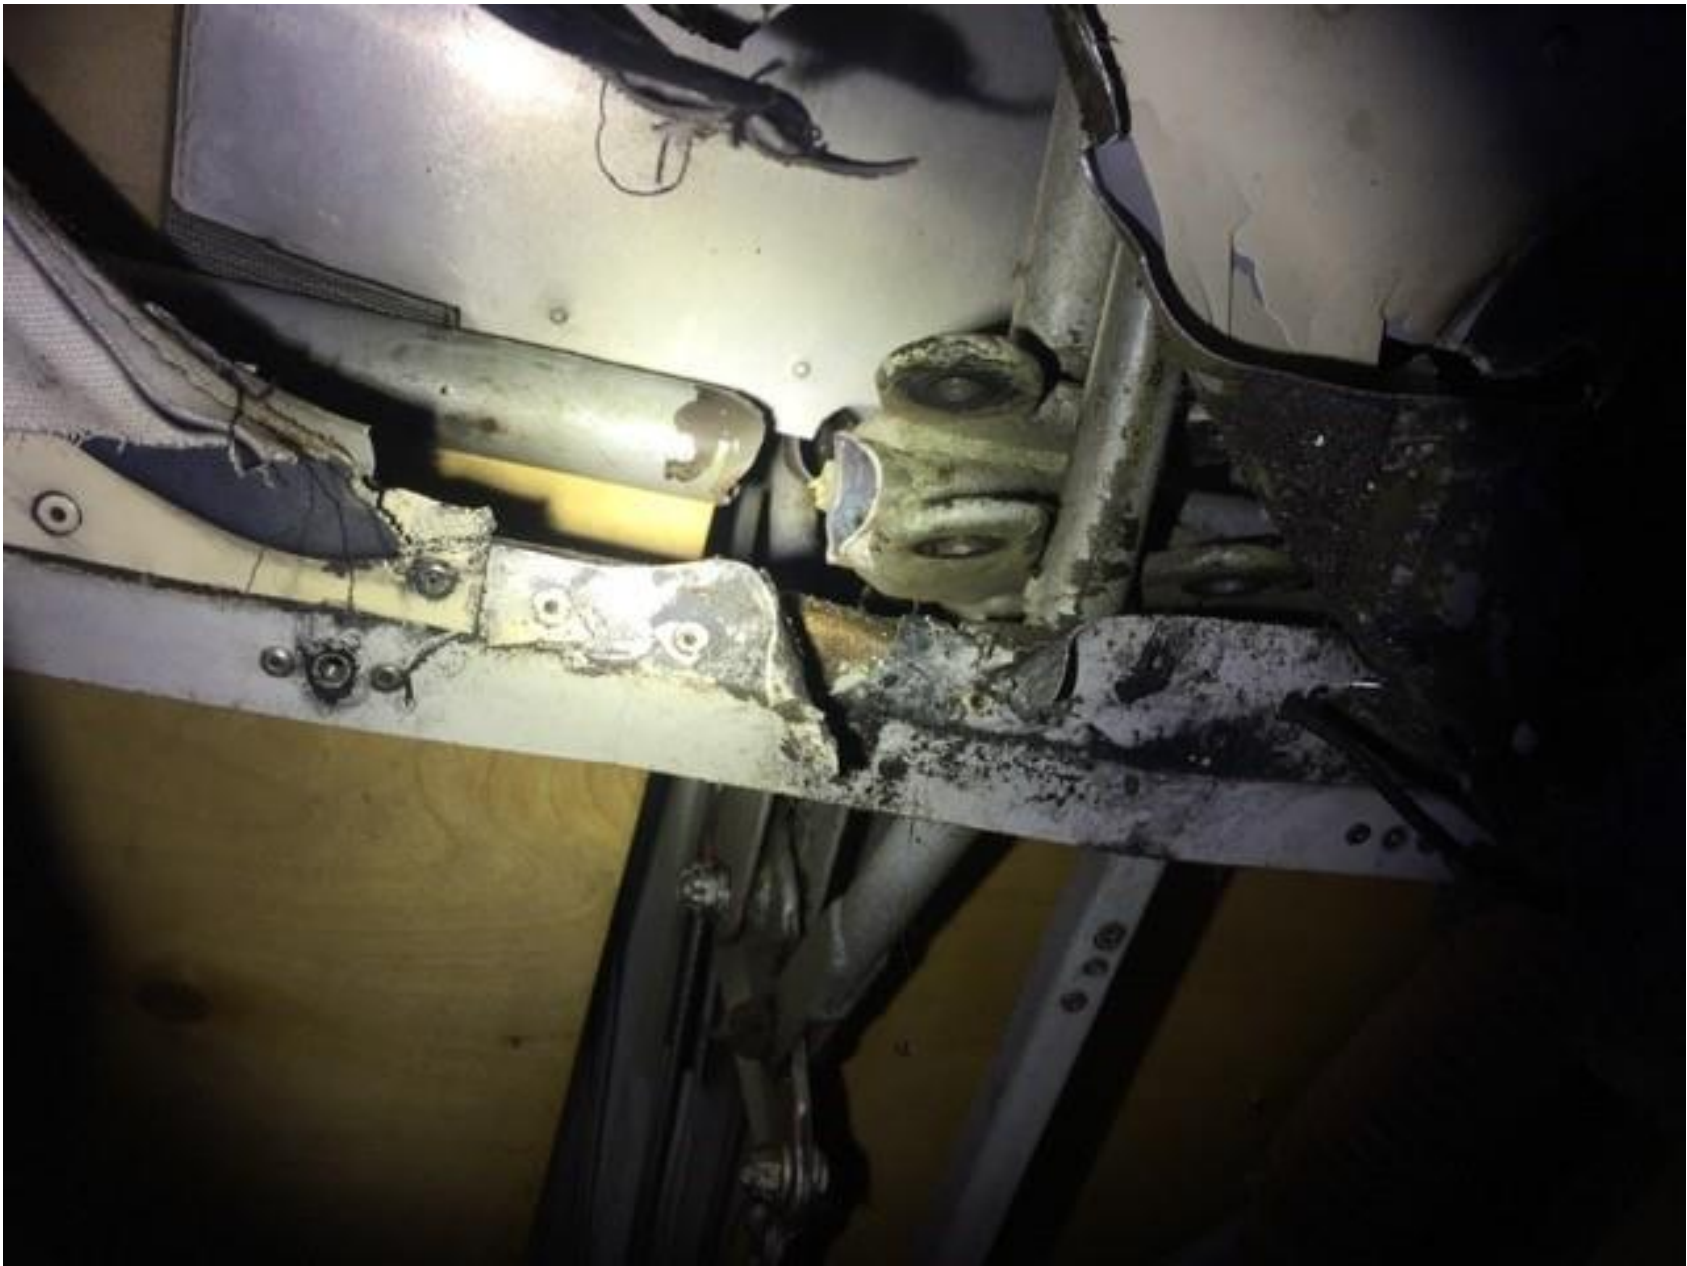
**Photo 1 – View of broken tubing near landing gear (photo courtesy of the FAA).**
