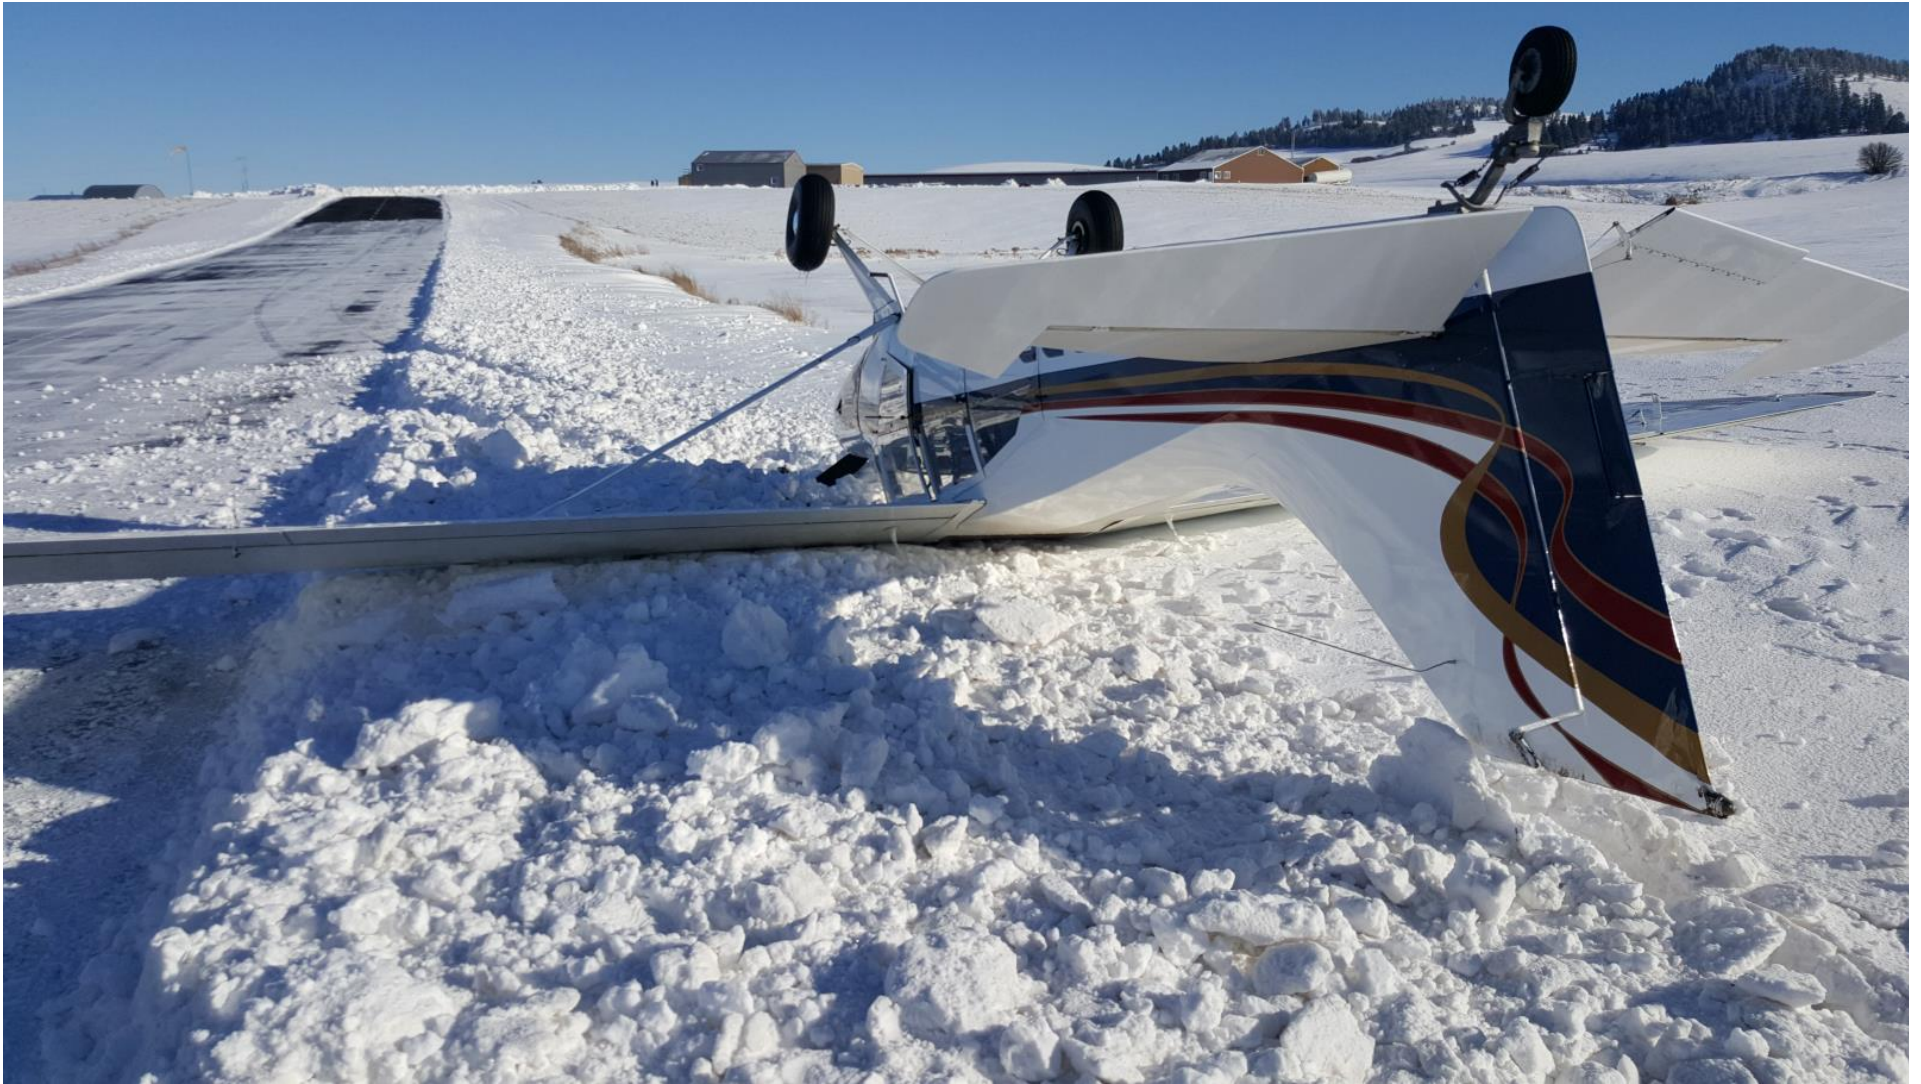
**Photo 1 – View of inverted airplane (photo courtesy of the pilot)**

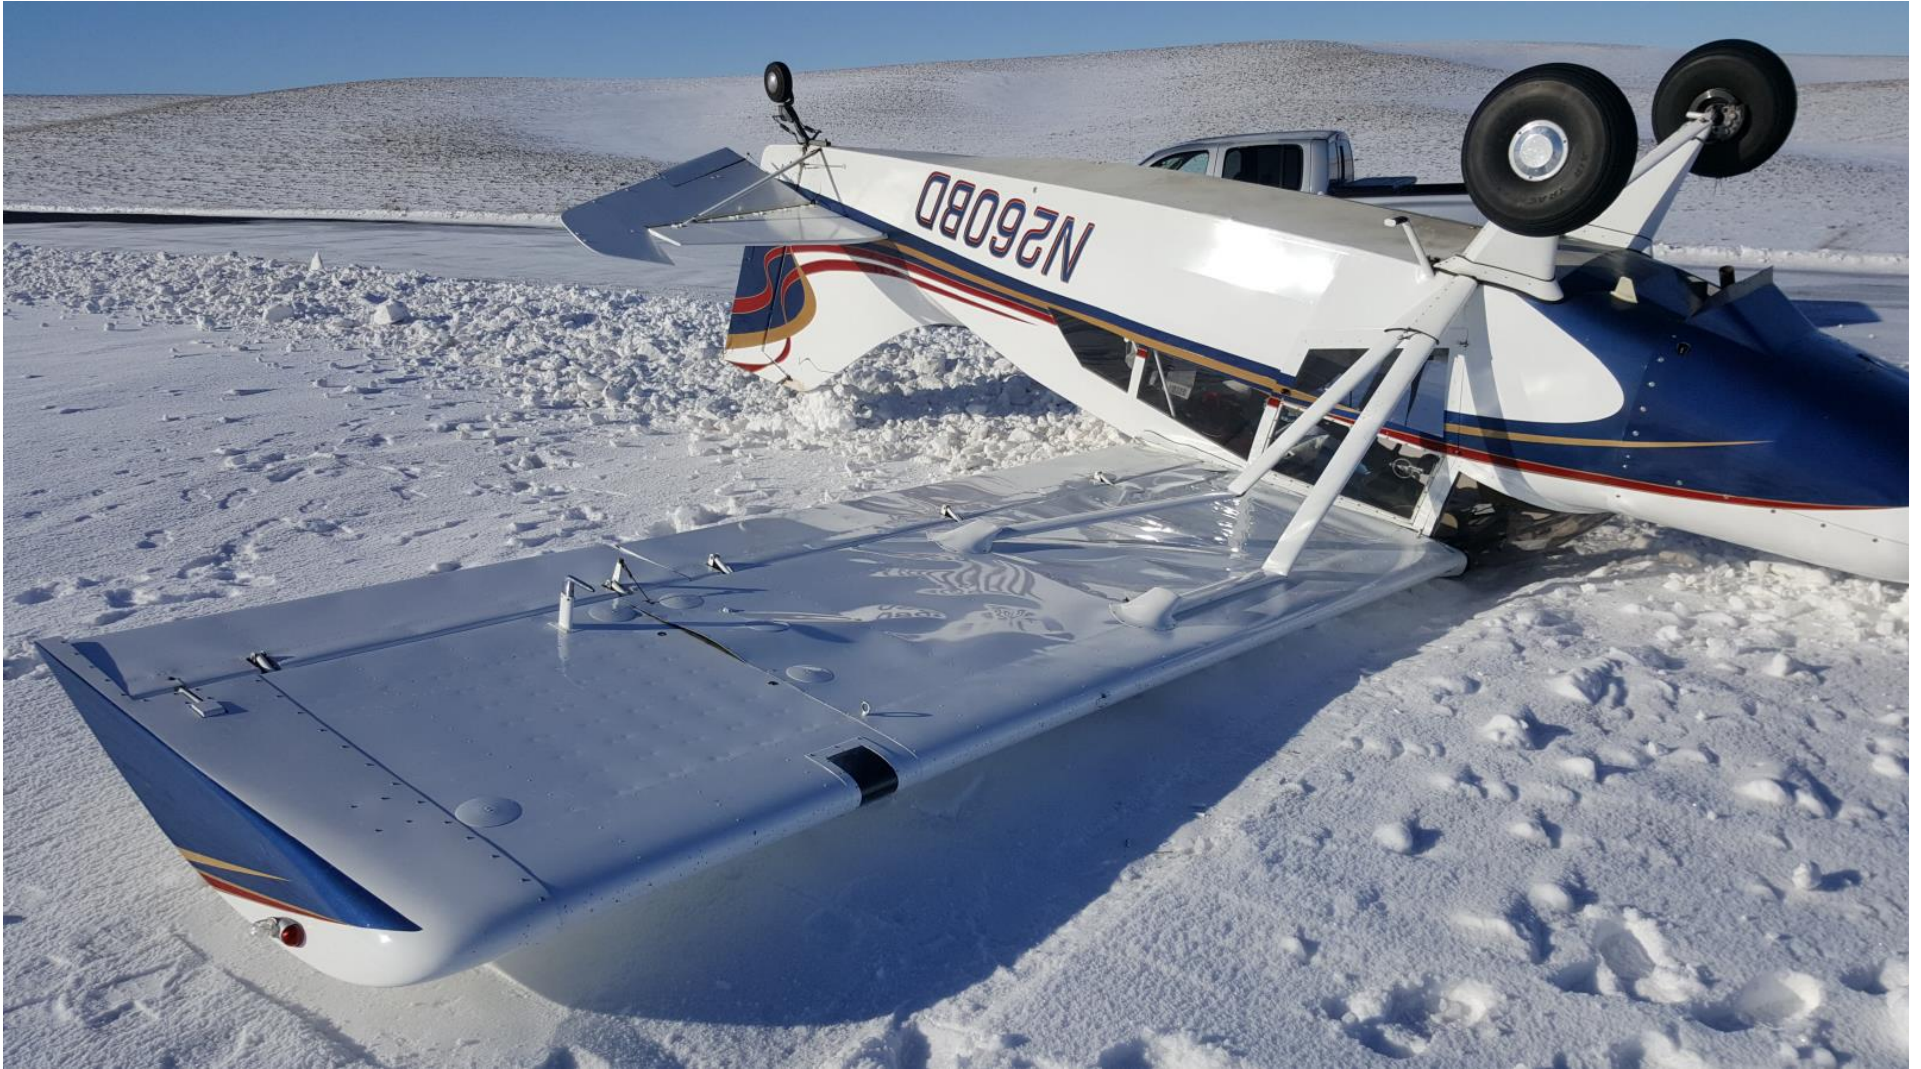
**Photo 2 – View of damaged left wing lift struts (photo courtesy of the pilot)**
