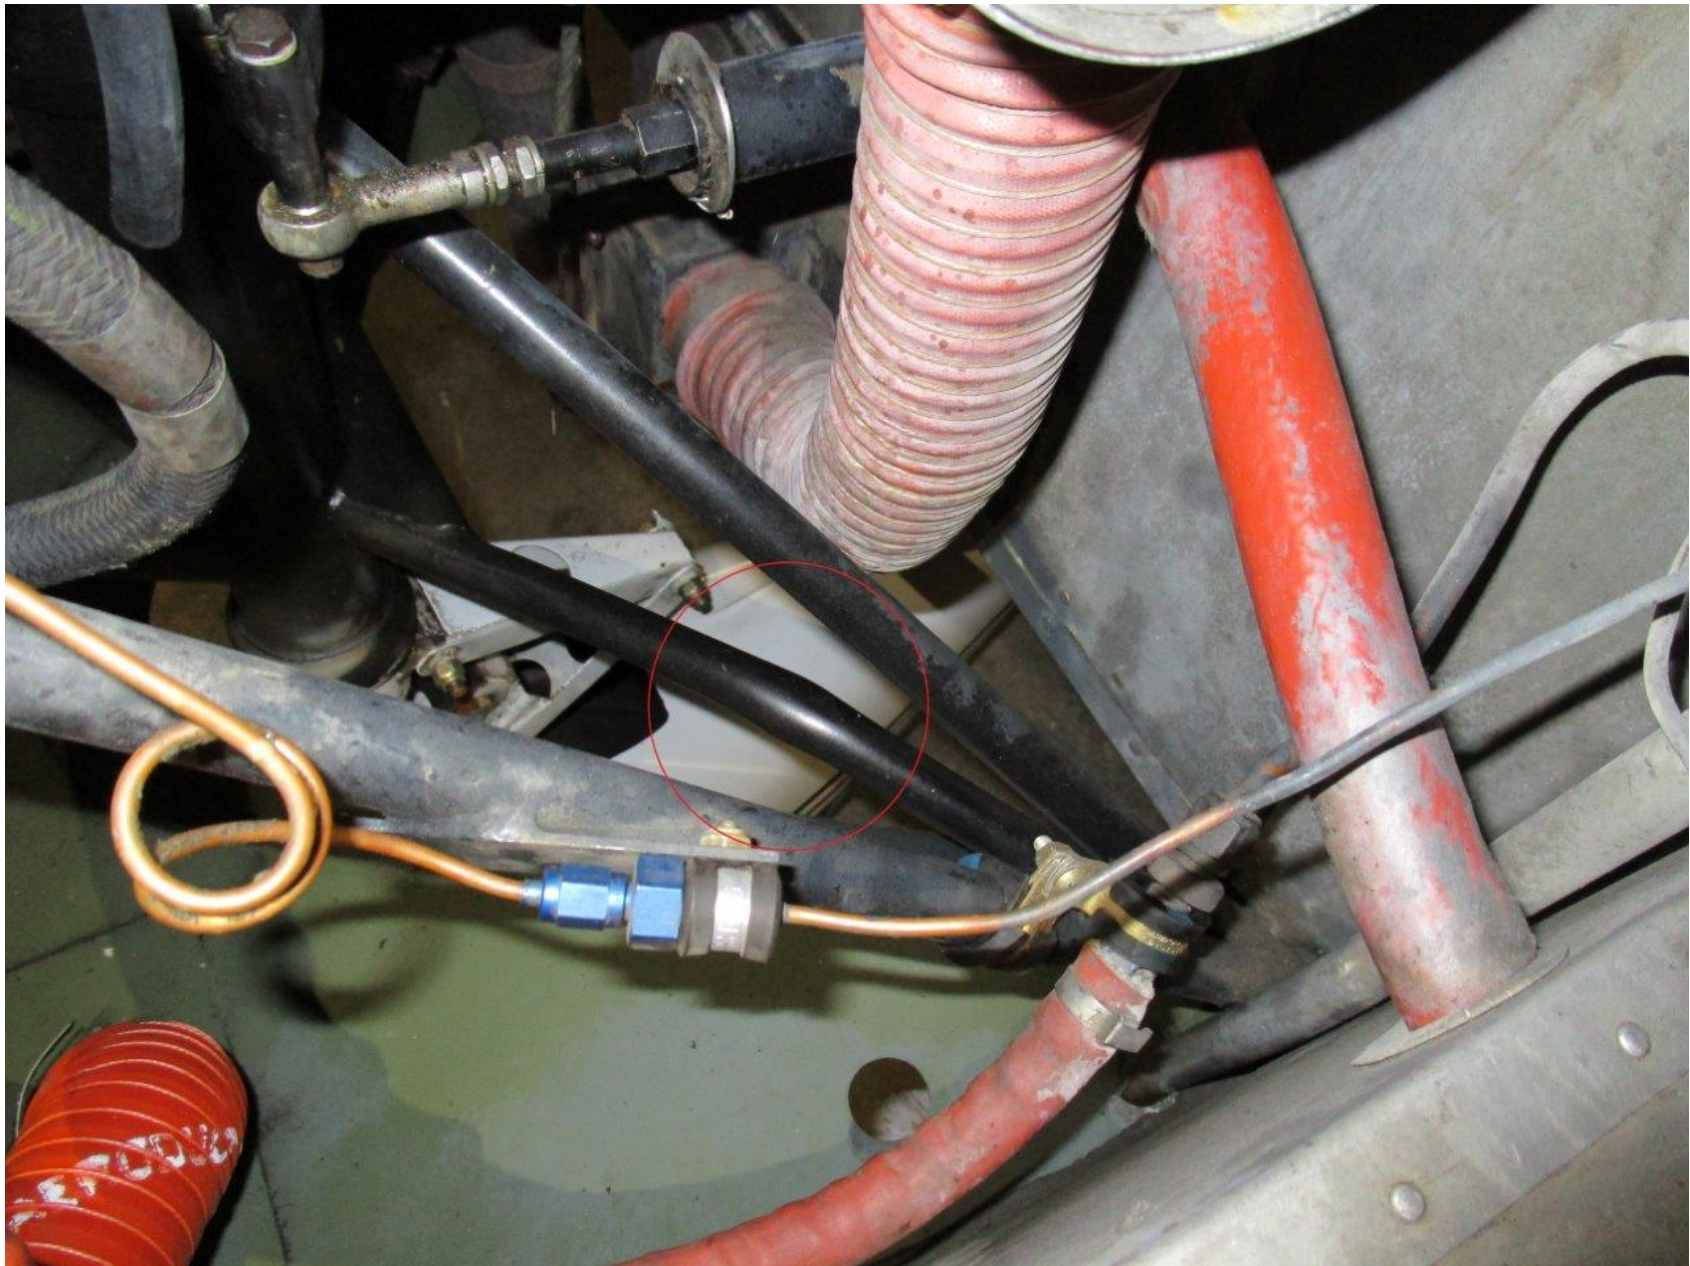
**Photo 1 – Damaged Engine Mounts (Photo Courtesy of FAA)**

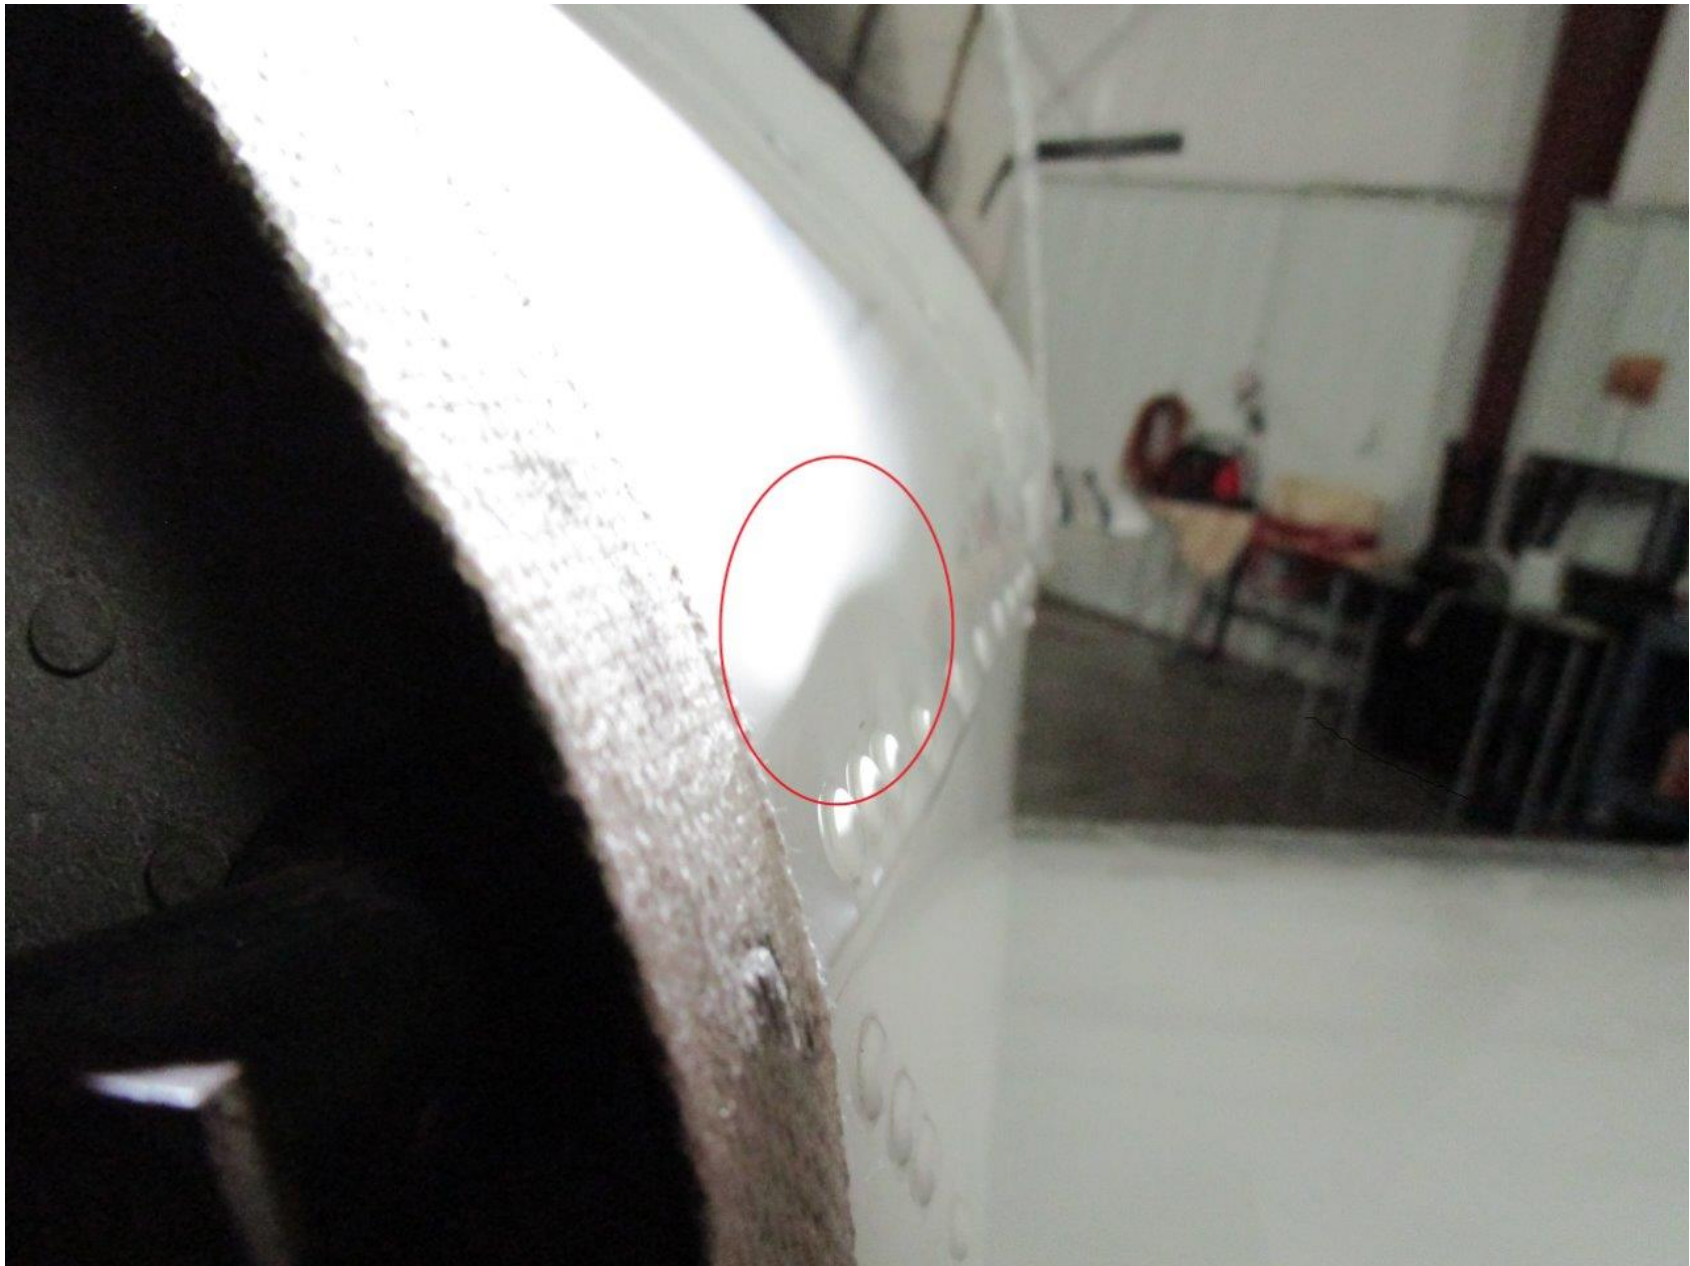
**Photo 2 – Buckled Skin Along Fuselage (Photo Courtesy of FAA)**
