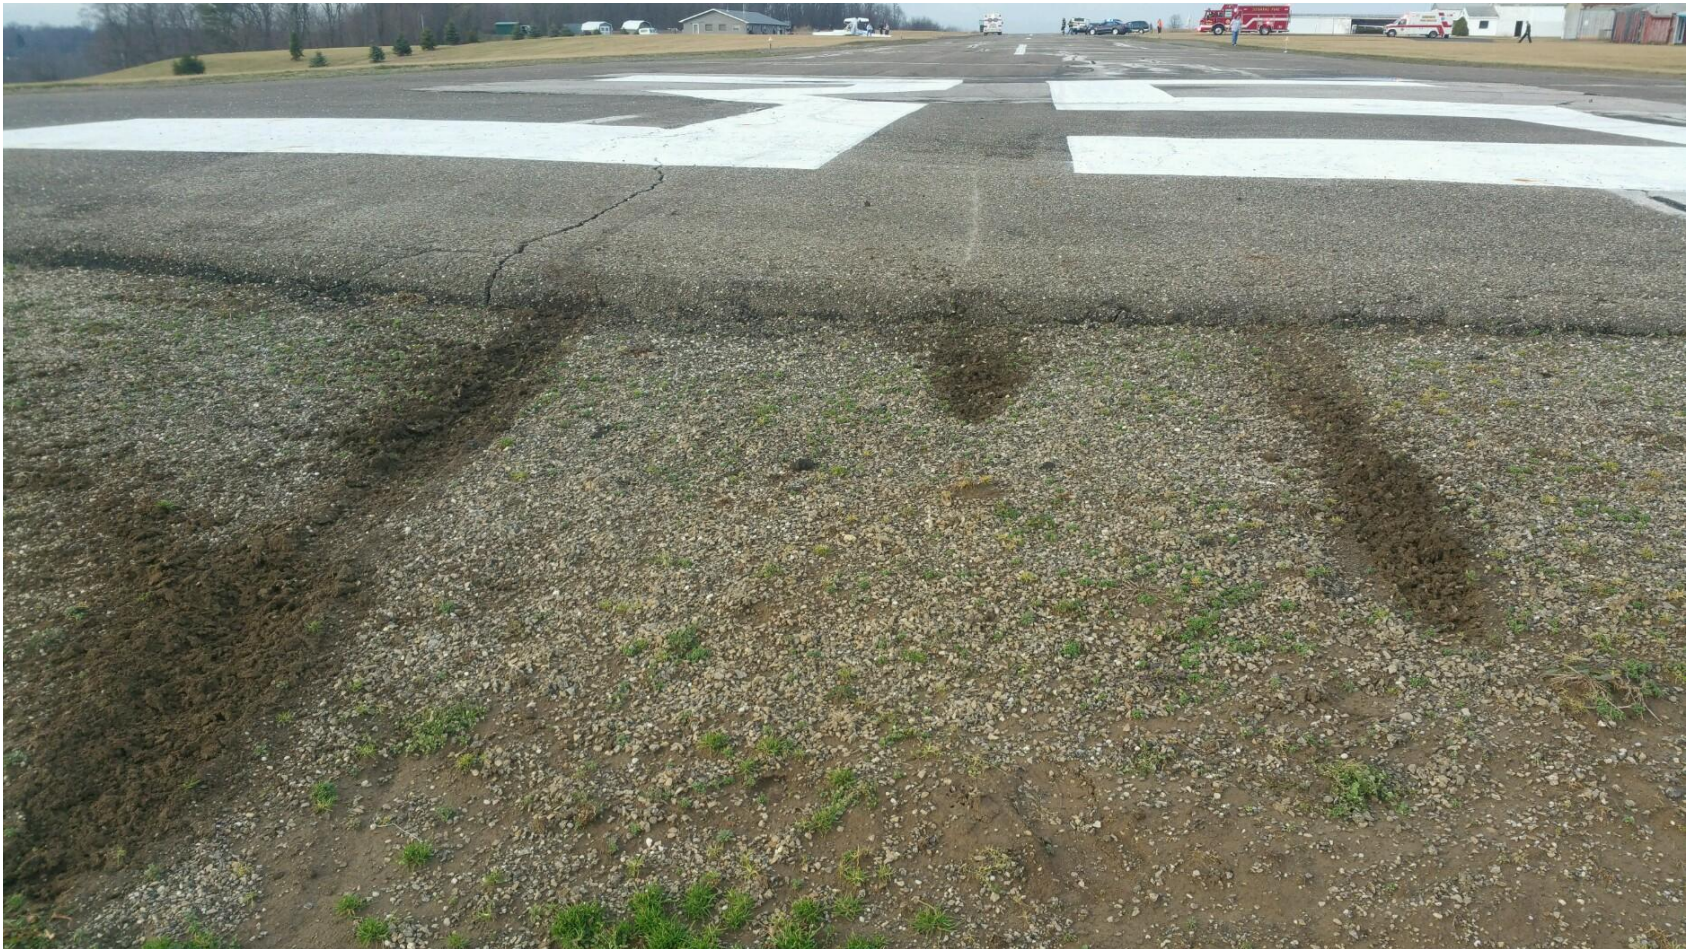
**Photo 1 – View of the first touch down point and asphalt perimeter (Courtesy of FAA)**

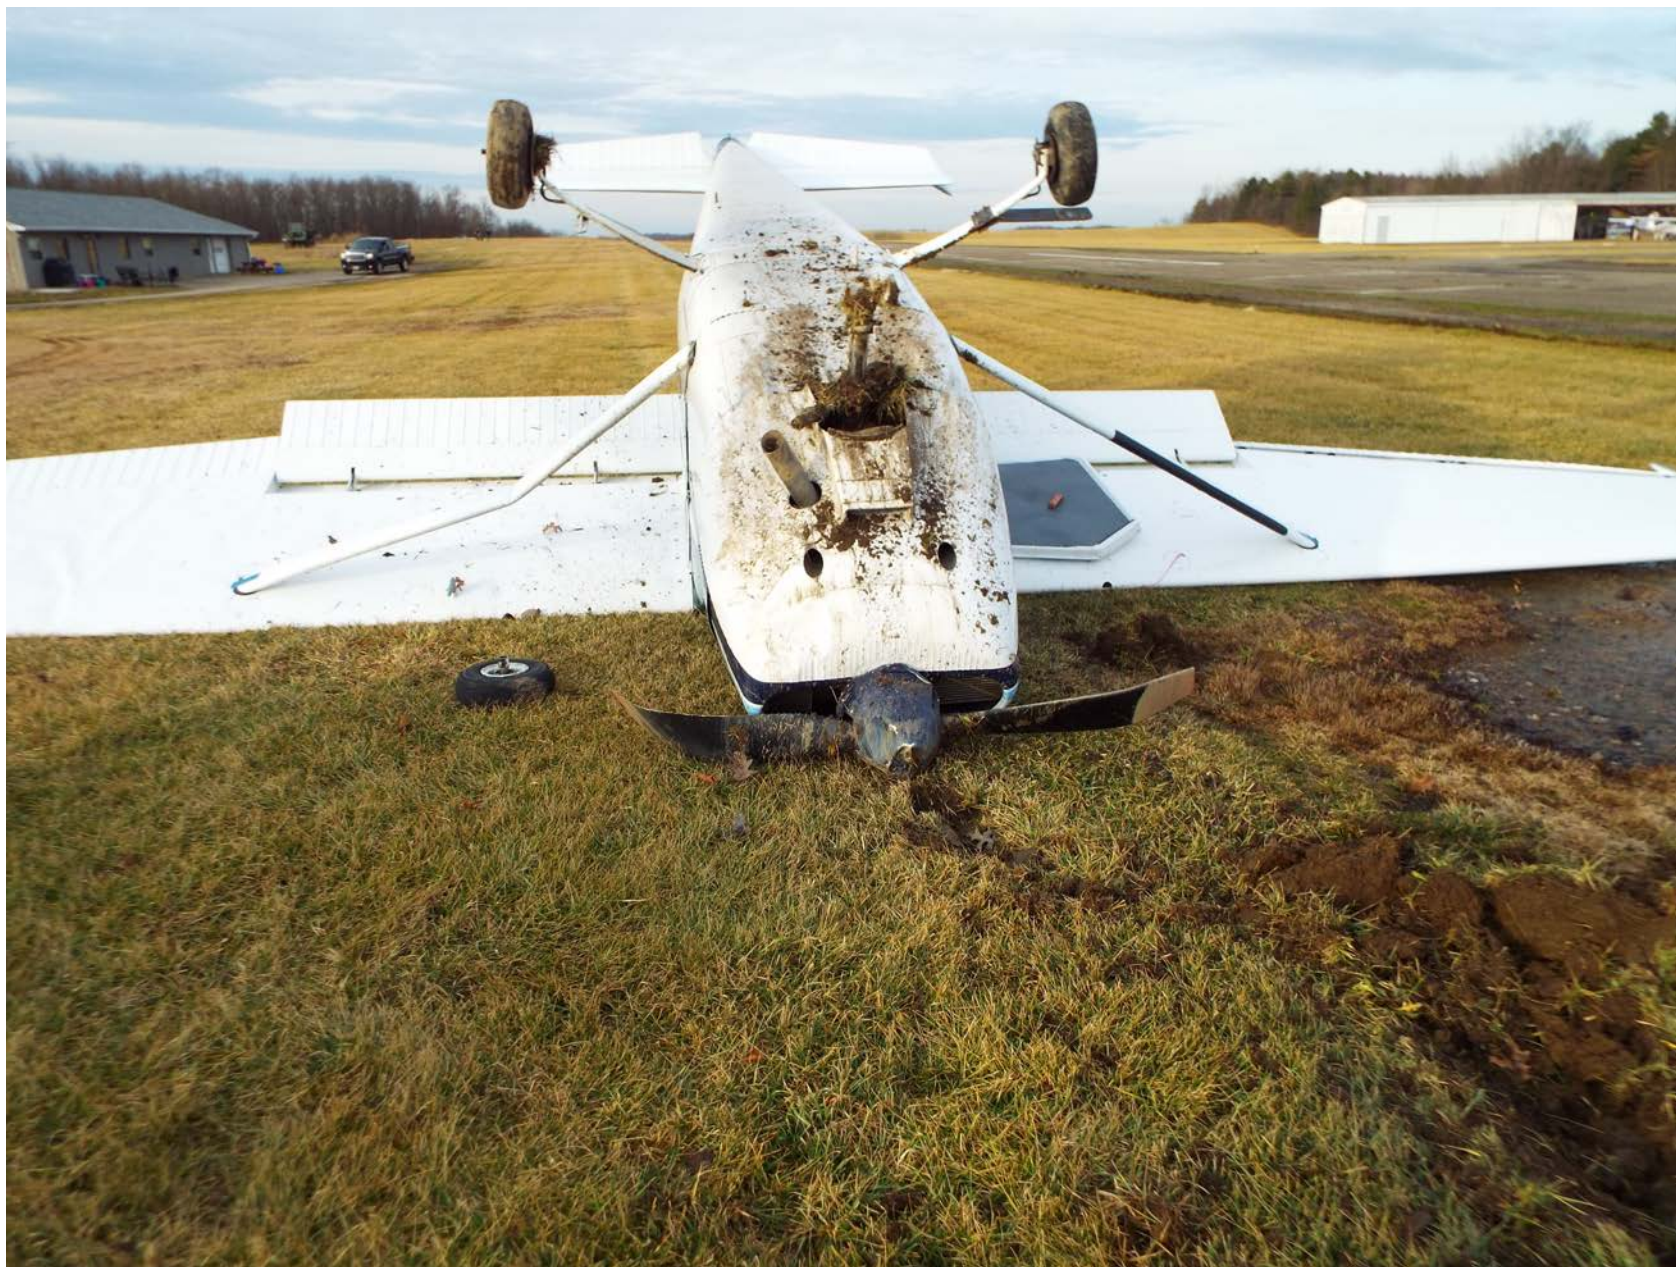
**Photo 2 – View of damage to the left wing strut (Courtesy of FAA)**
