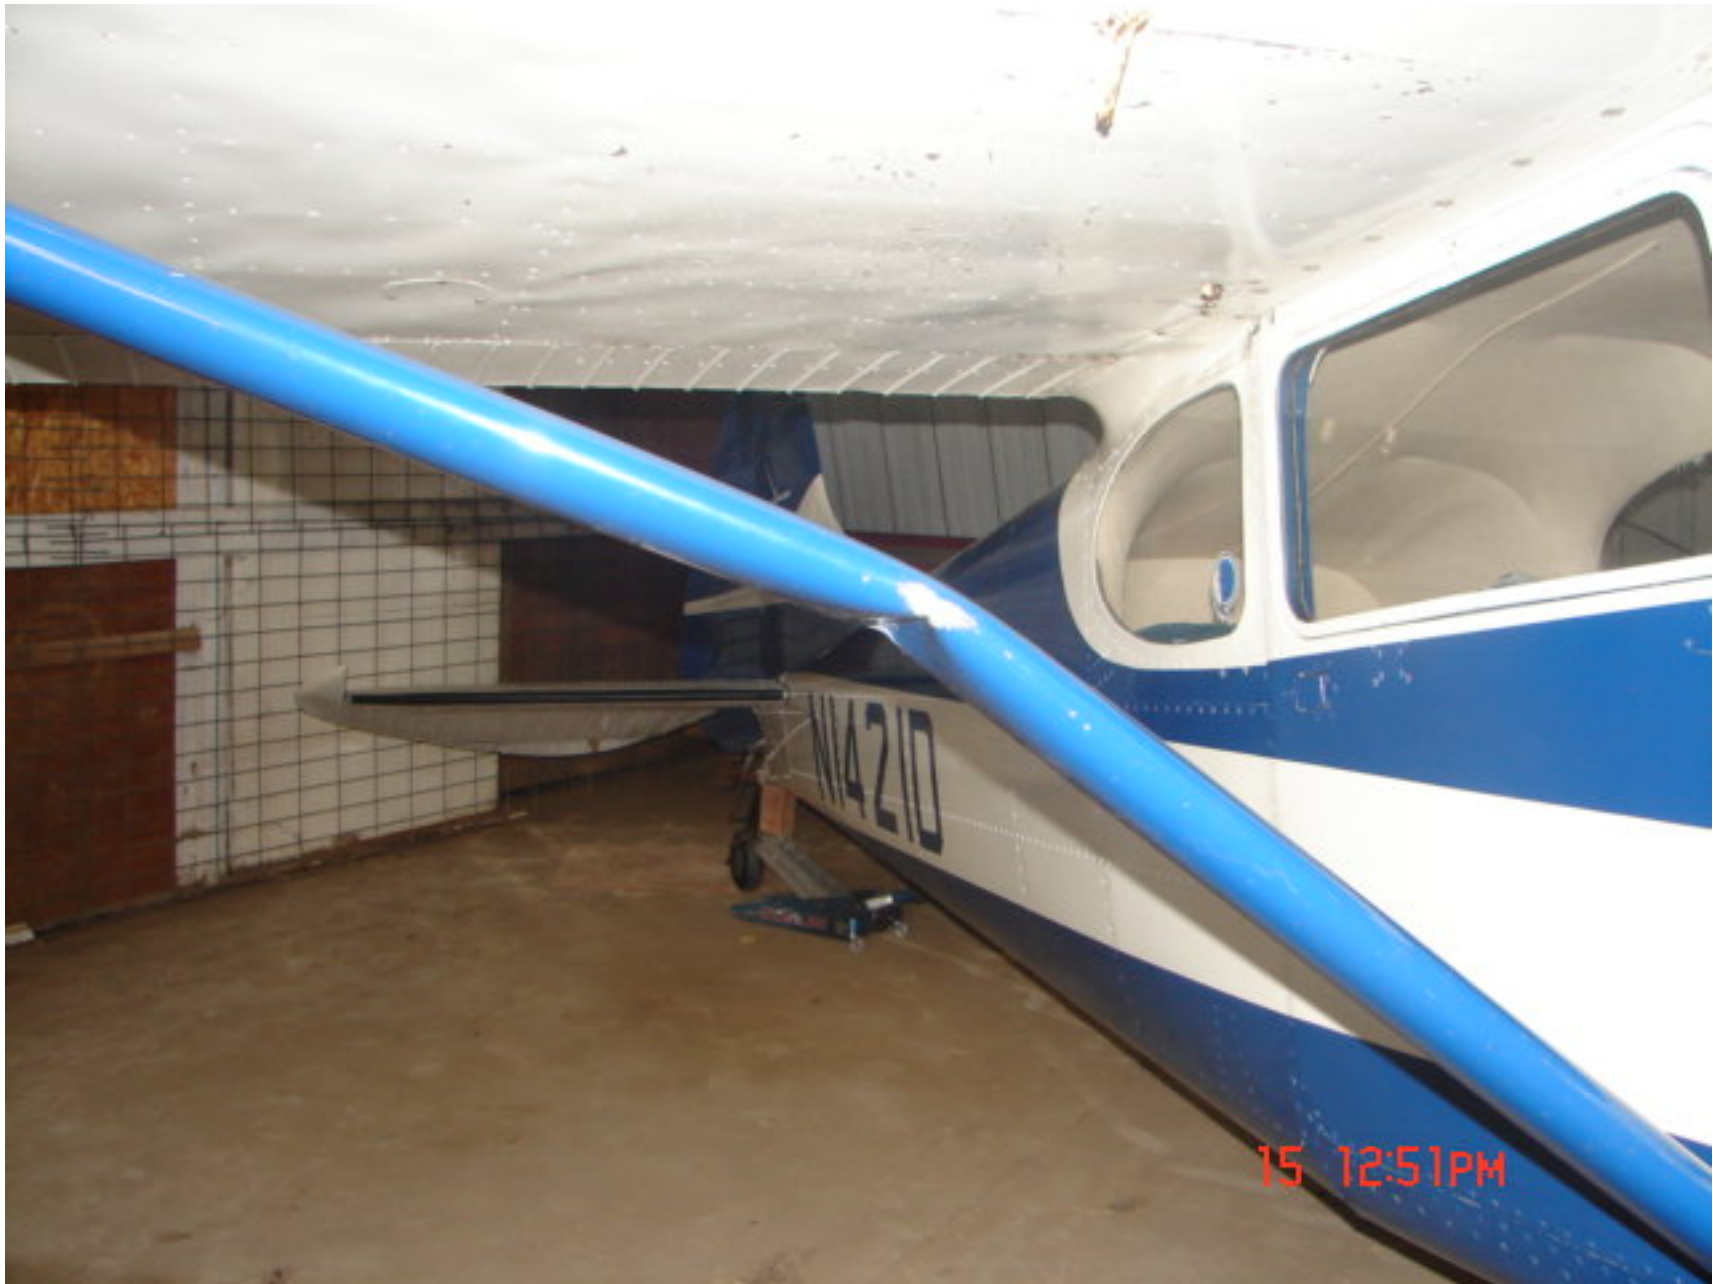
**Photo 1 – View of damaged right wing lift strut (photo courtesy unknown)**

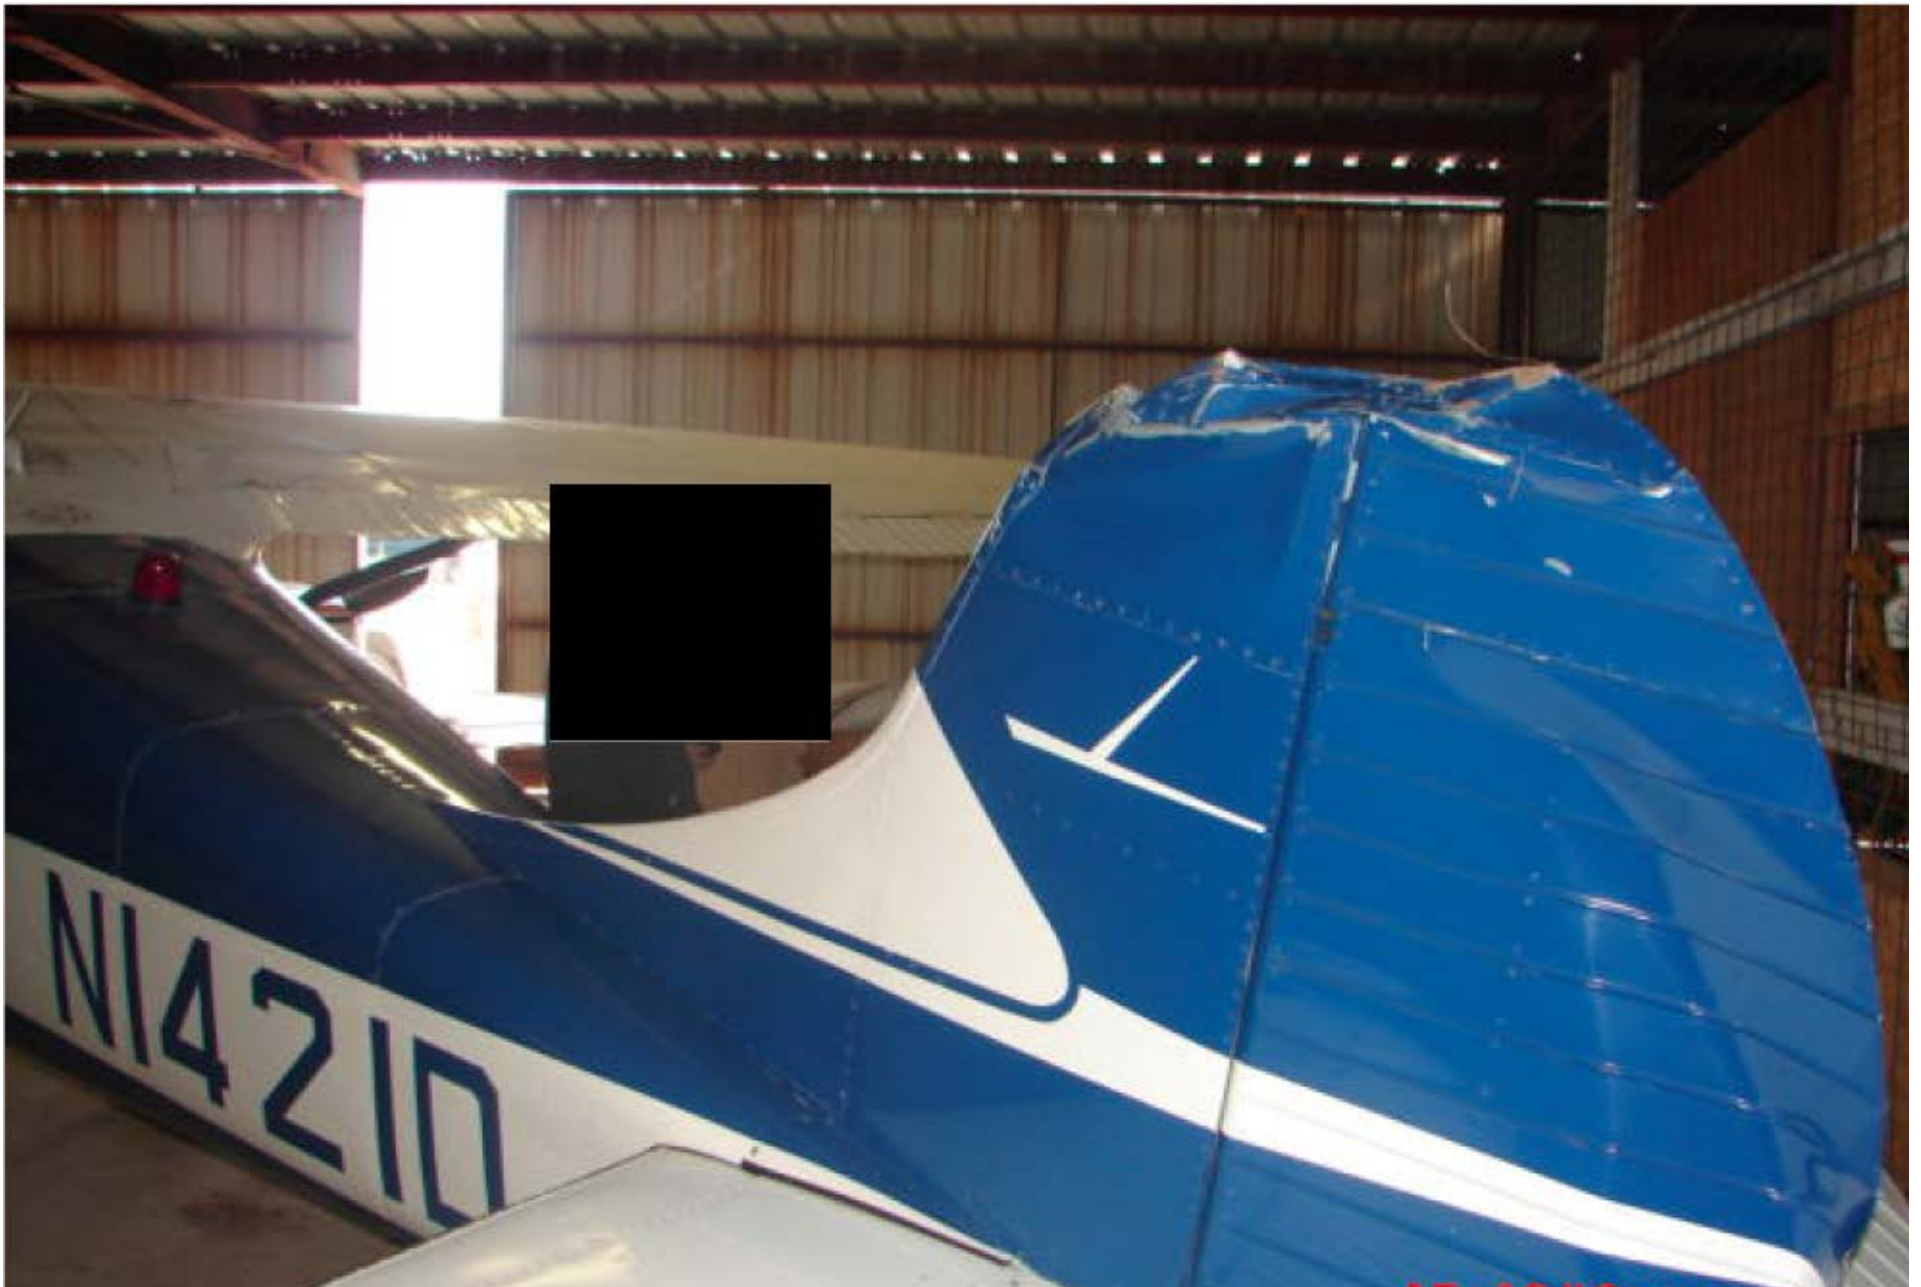
**Photo 2 – View of damaged vertical stabilizer and rudder (photo courtesy unknown)**
