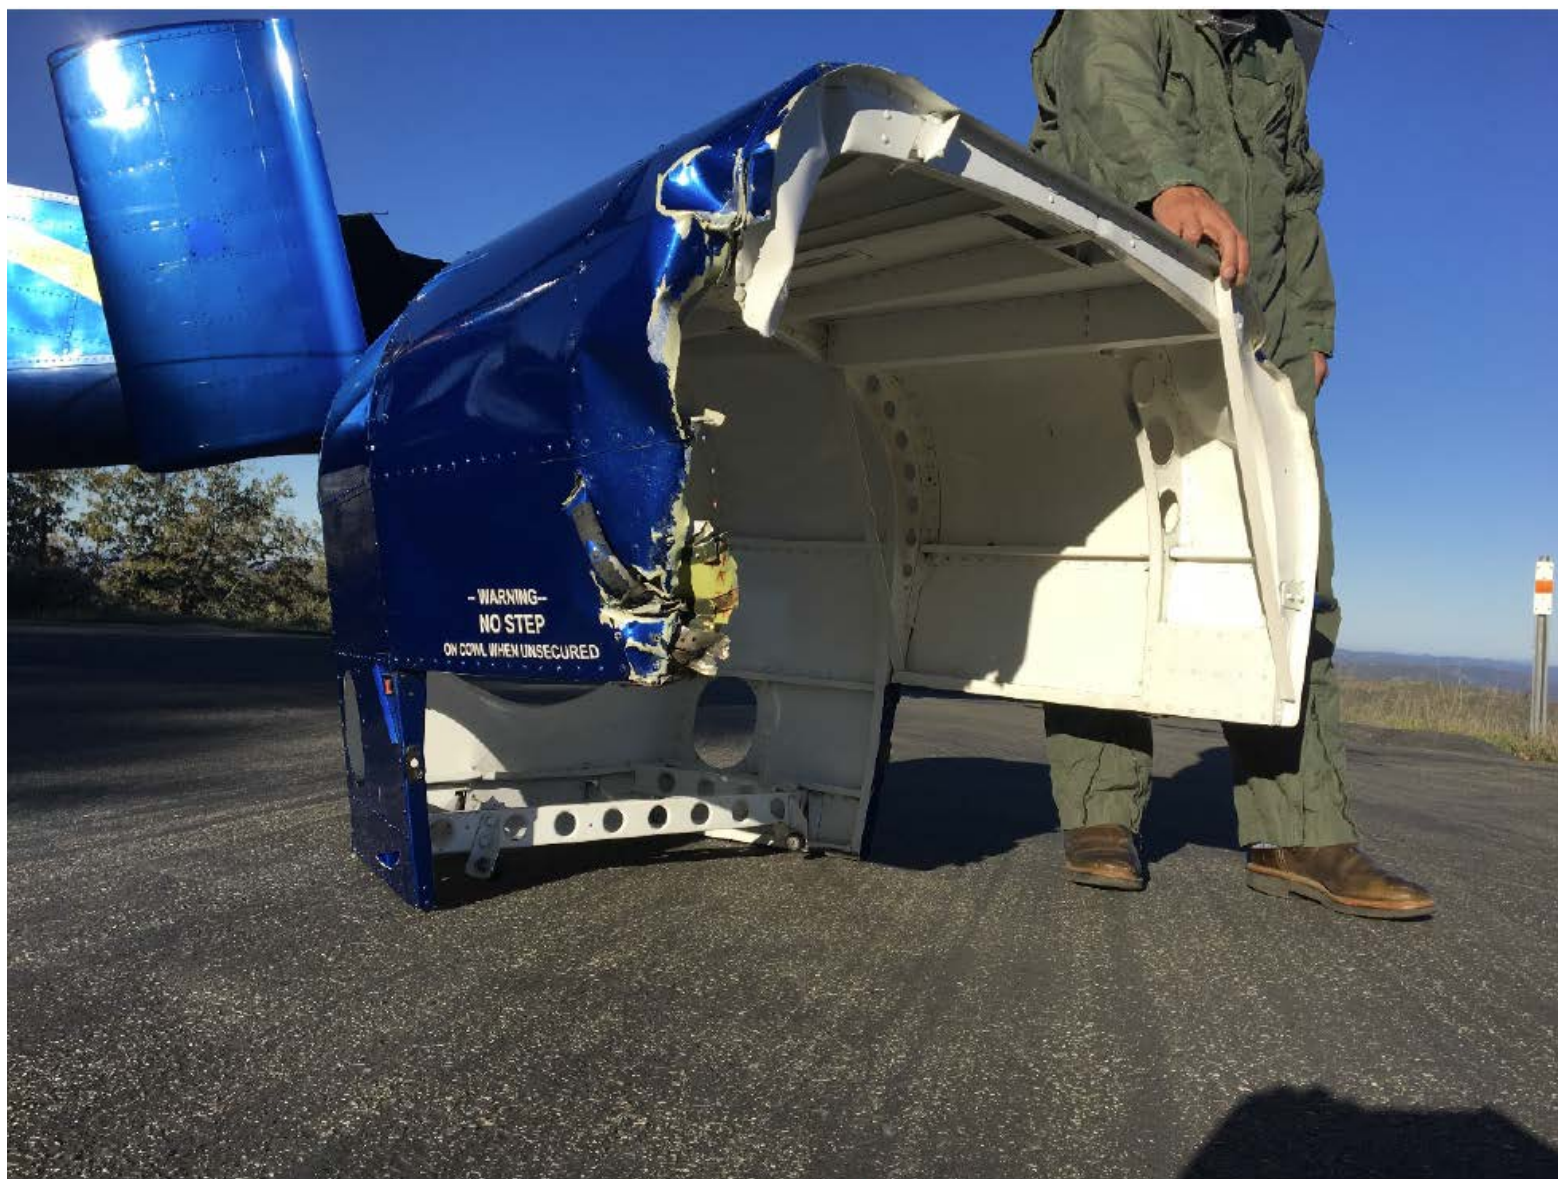
Engine Cowling

**Photo 1 – View of the damage to the engine cowling (Courtesy of Operator)**

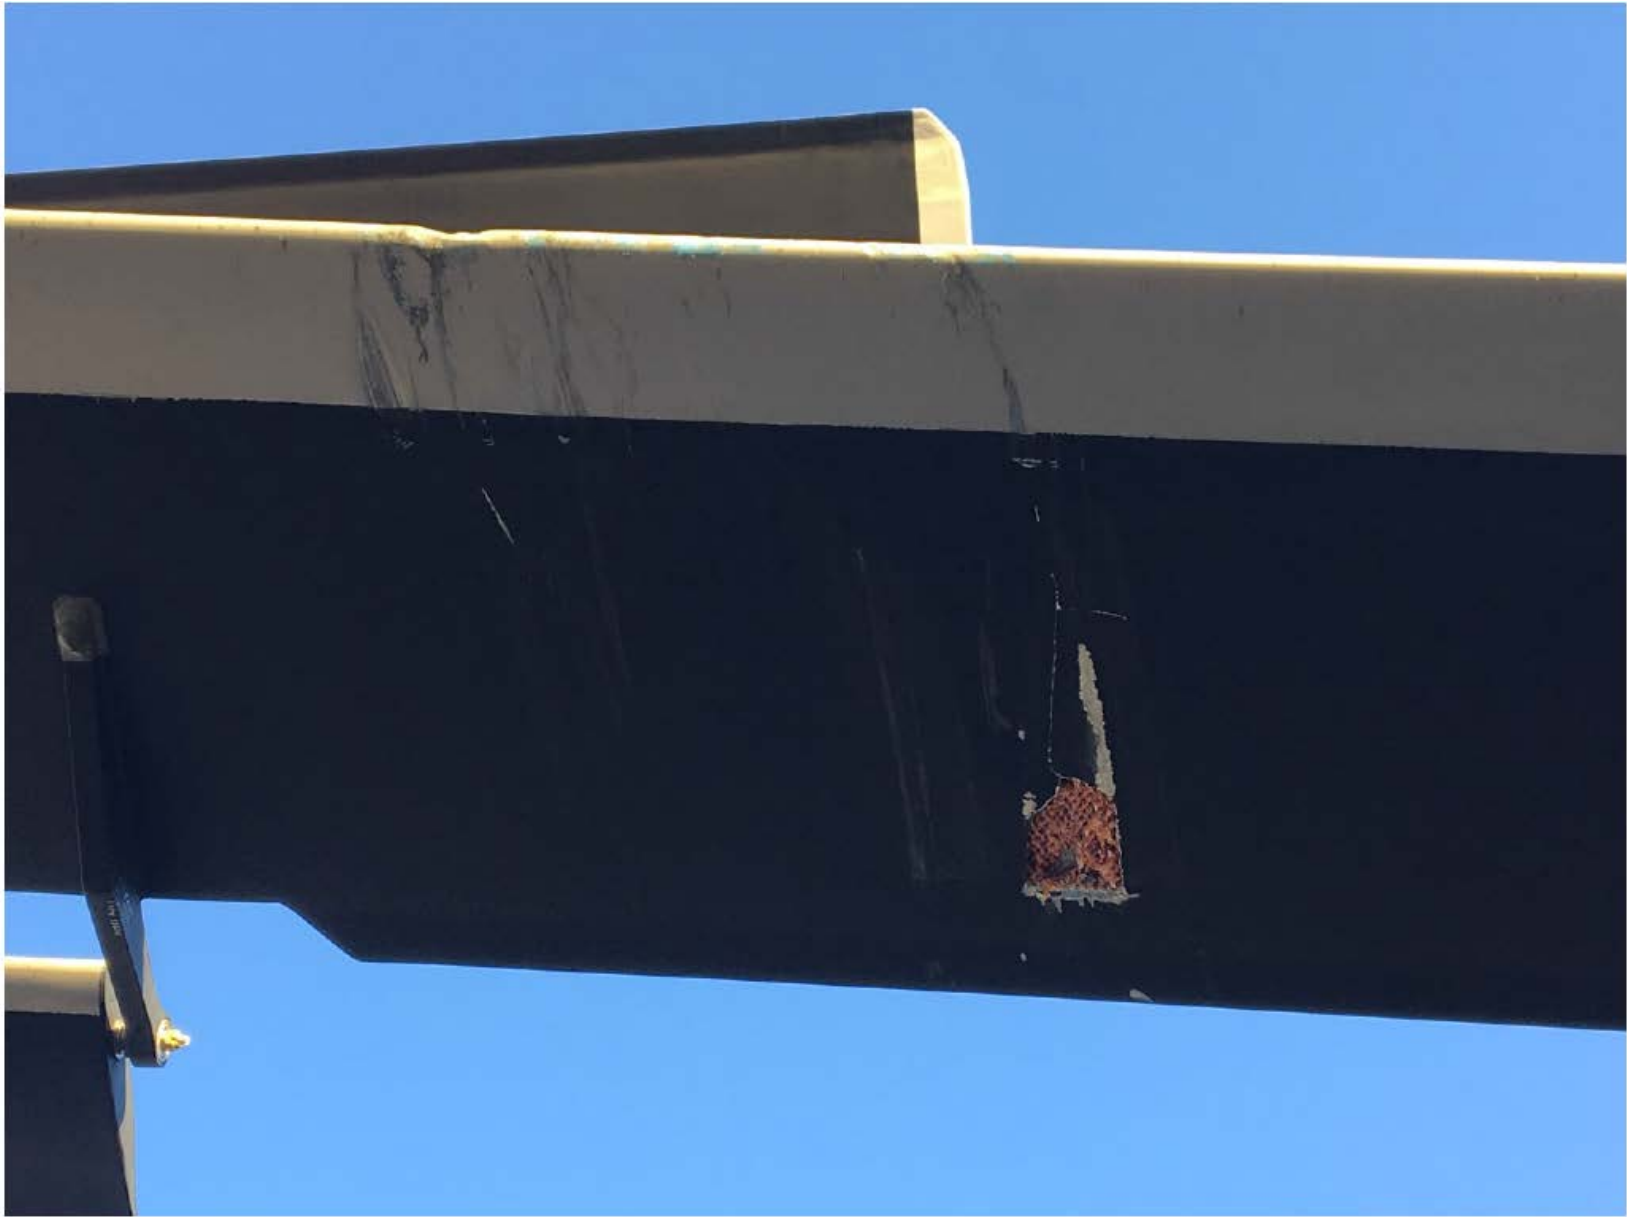
RH White Blade

**Photo 2 – View of damage to the white blade (Courtesy of Operator)**

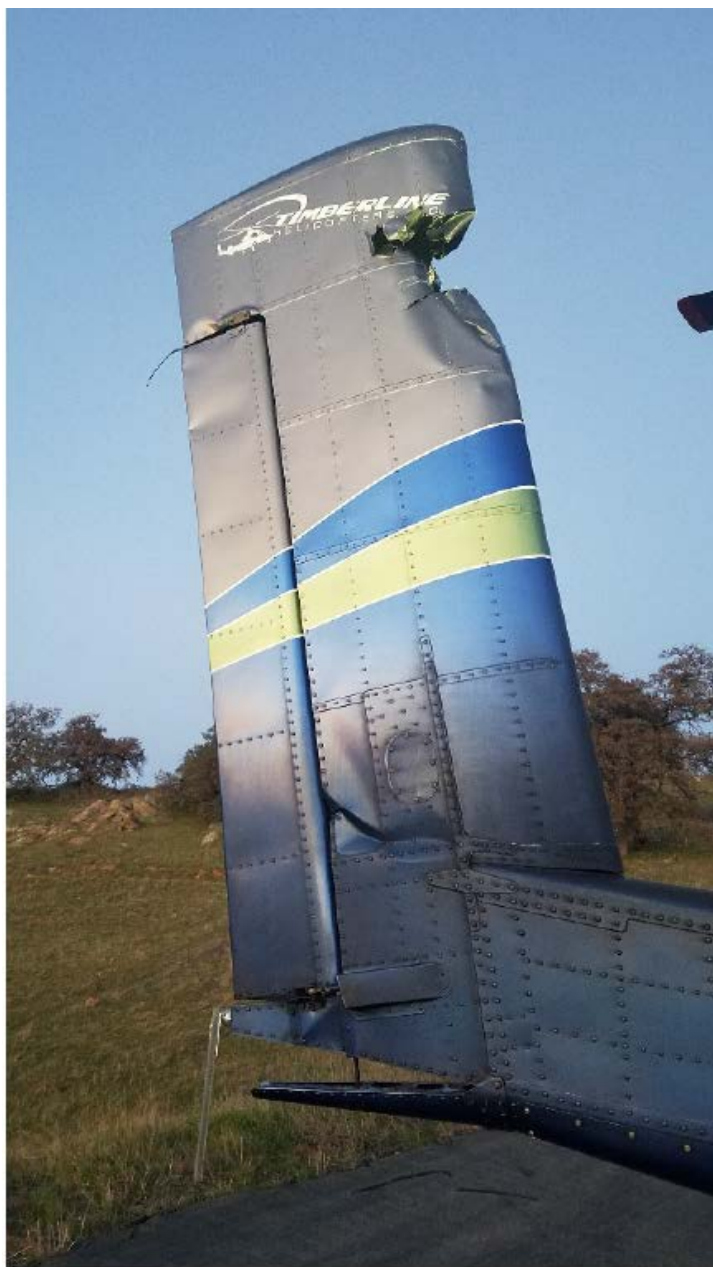
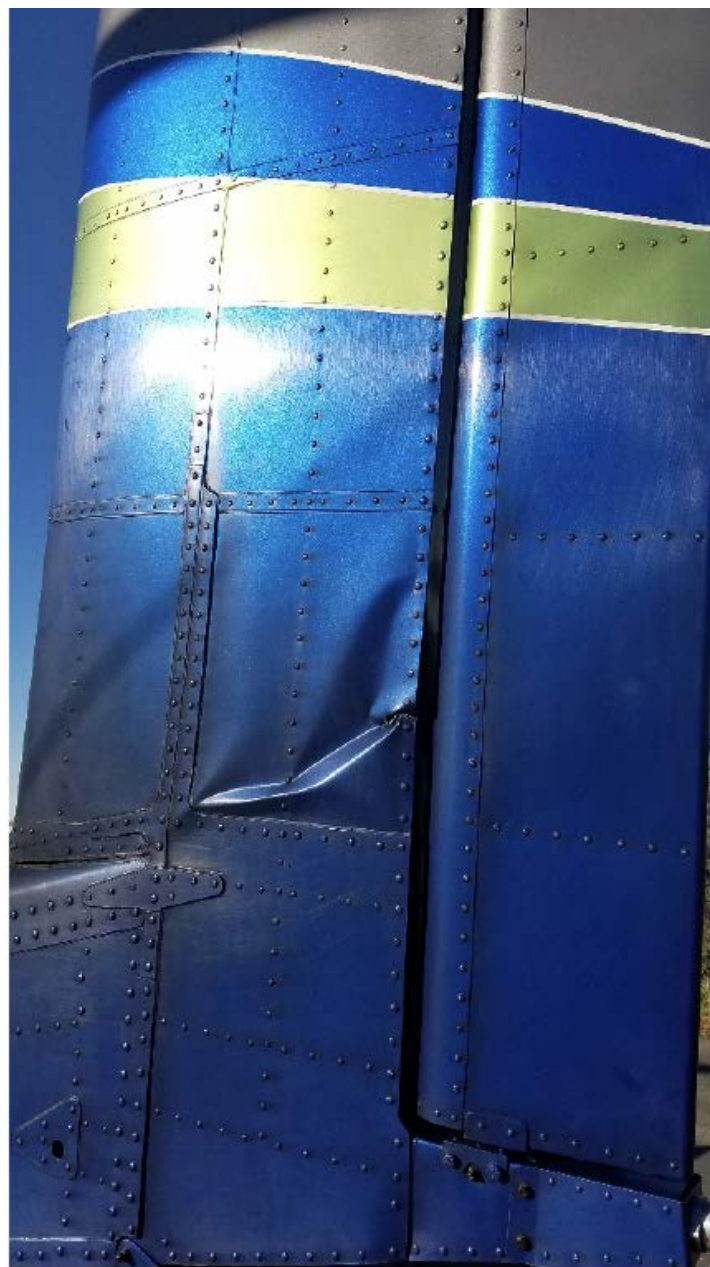
**Photo 3 – View of damage to the vertical stabilizer (Courtesy of Operator)**
