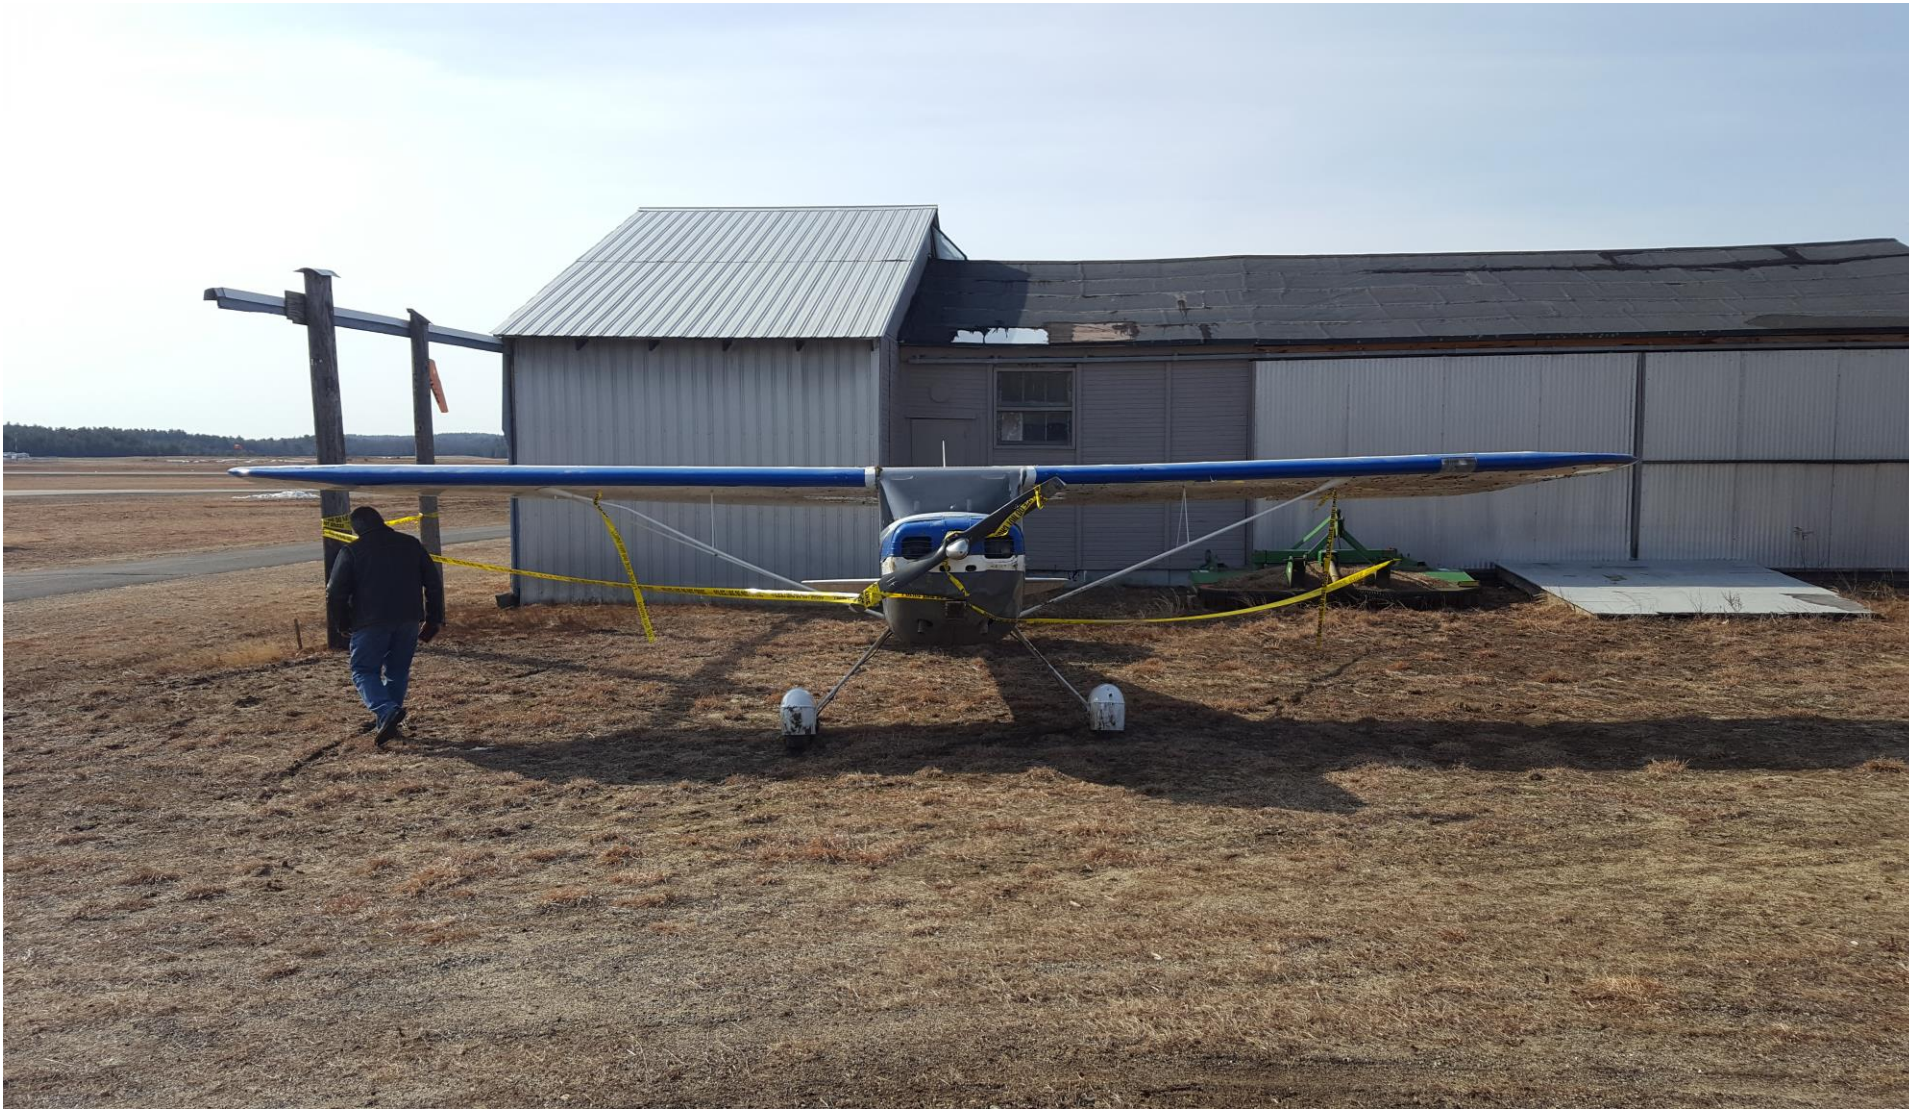
**Photo 1 – Front view of damaged lift strut (Photo courtesy of the FAA)**
