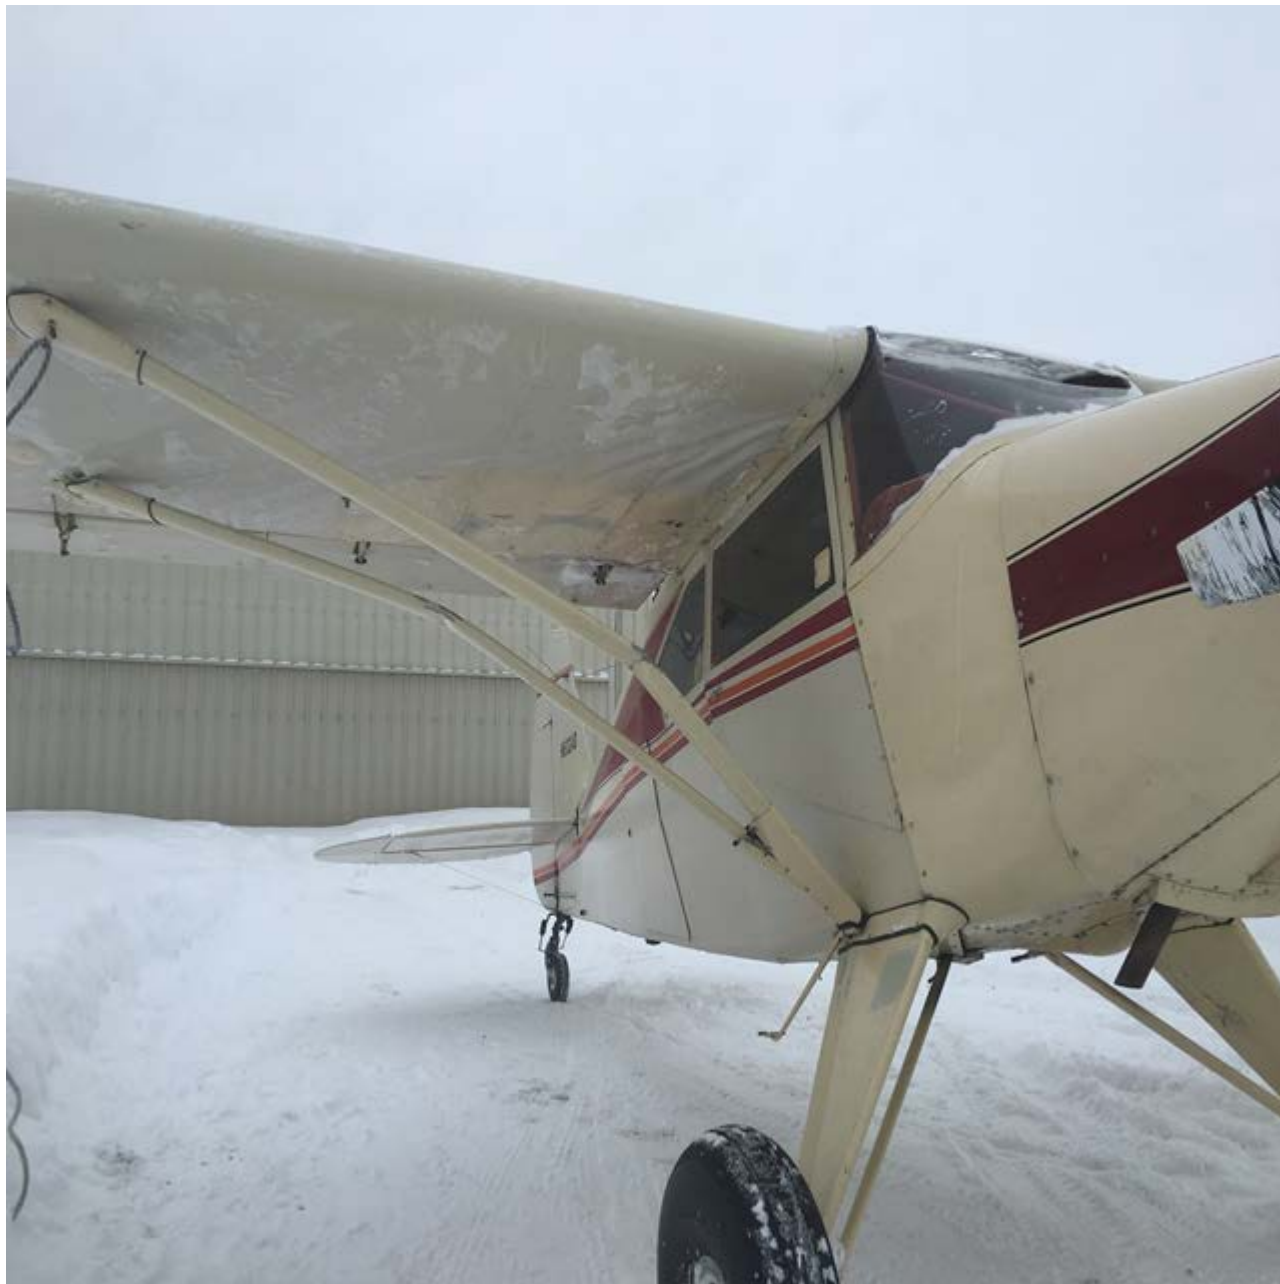
**Photo 1 – View of damaged right wing lift strut (photo courtesy of pilot)**
