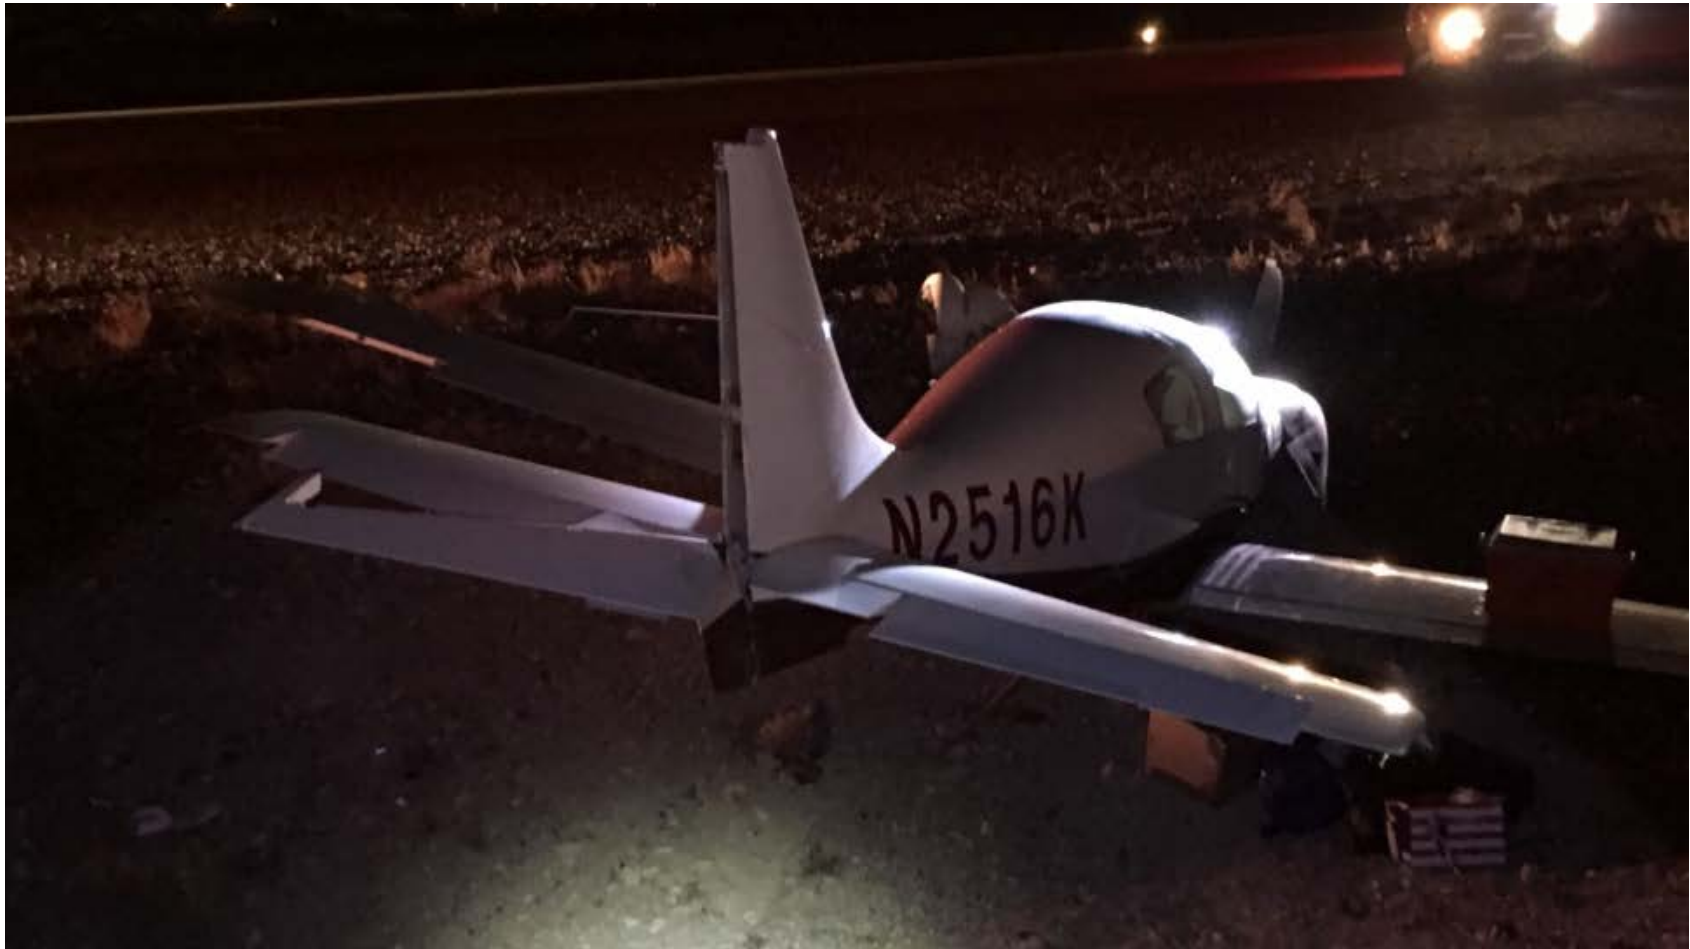
**Photo 1 – View of damage to rudder (Courtesy of FAA)**

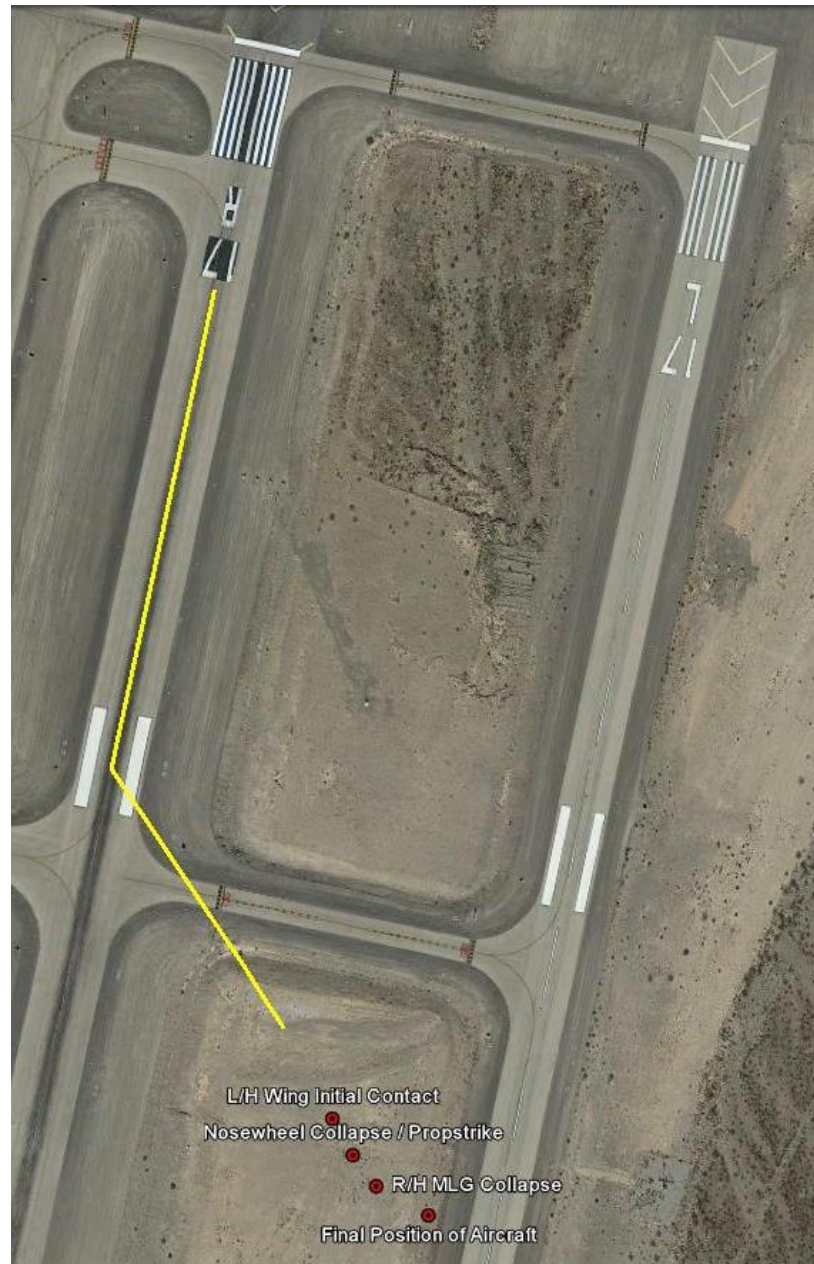
**Photo 2 – Wreckage path diagram (Courtesy of FAA)**
