NTSB Chairman  
NTSB Headquarters  
490 L'Enfant Plaza SW  
Washington, D.C. 20594

This is a Petition for Reconsideration filed under chapter 49 Code of Federal Regulations (C FR) section 845.32 in connection with NTSB Aviation Accident Factual/Final reports; G A A 17 C A 191, for which I was the Pilot In Command.

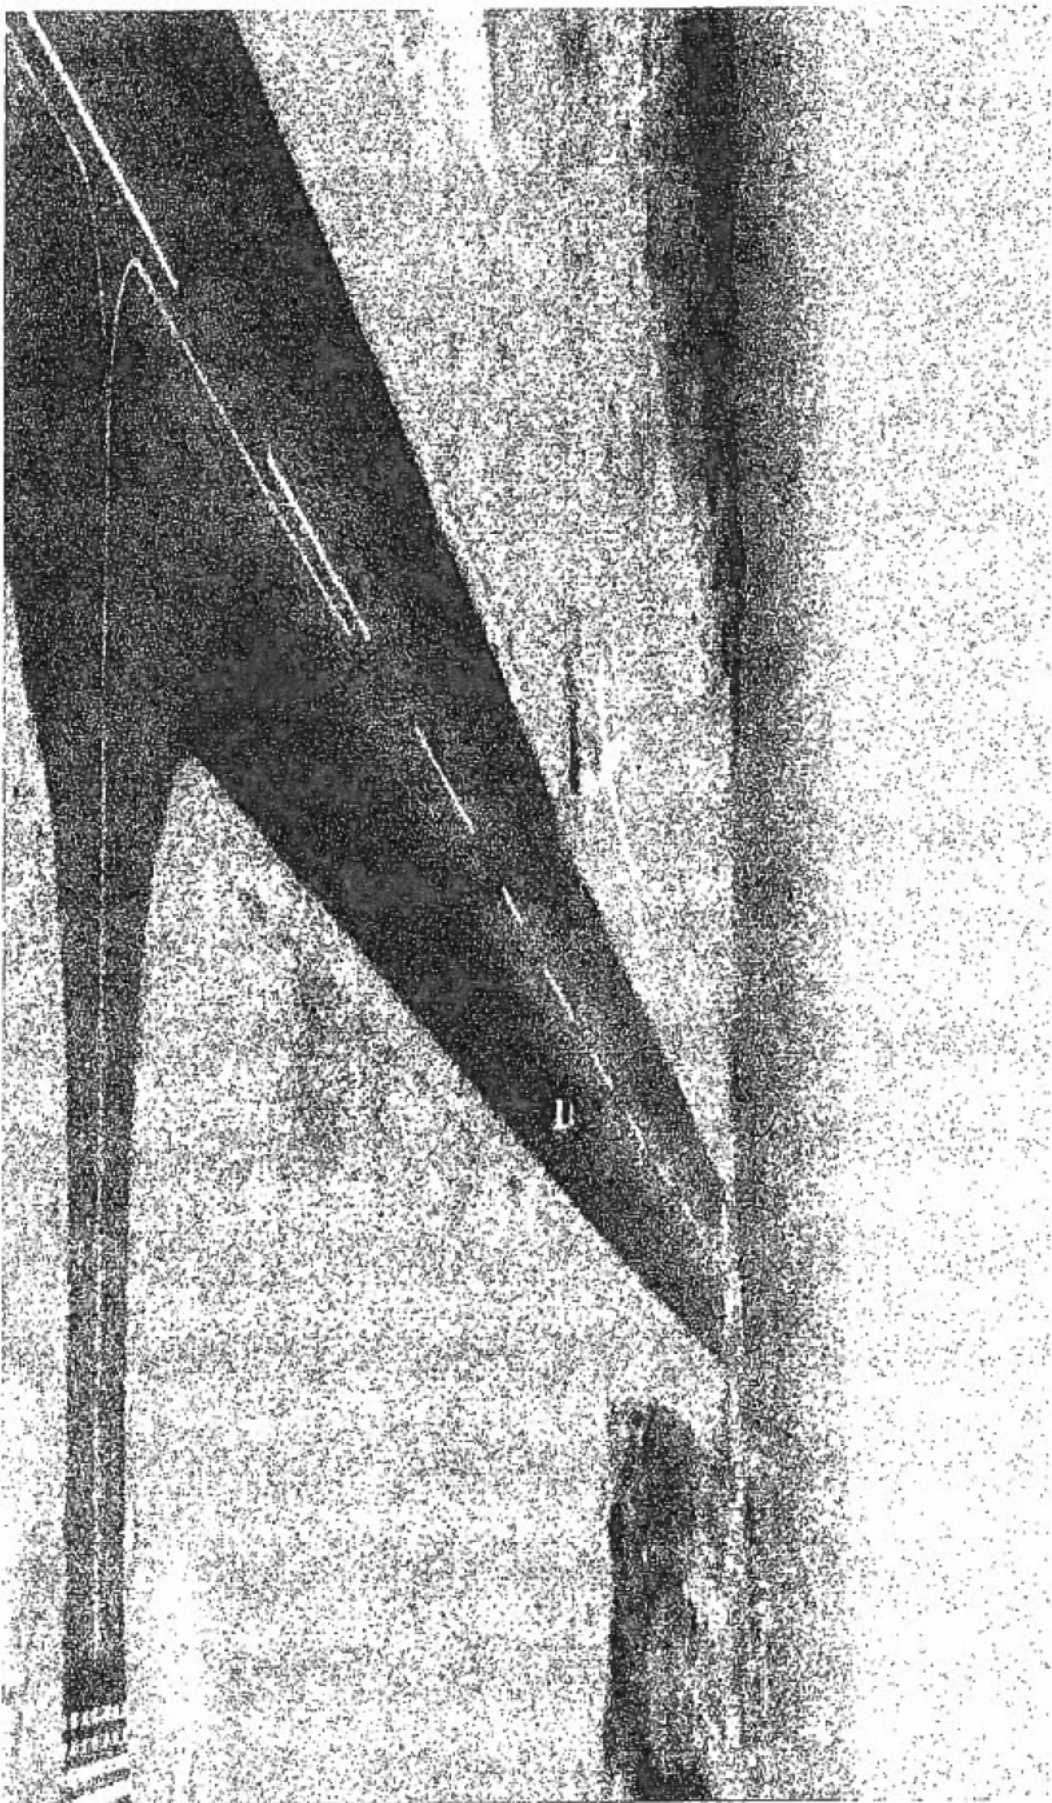
It should be noted that the FAA theory of events and accident investigation report states that the aircraft propeller initially struck the runway in a low pitch configuration. I believe that it is abundantly clear at first glance that the aircraft propeller was in a feathered position upon initial impact.

**Photo 1 – View of airplane after ground loop (Courtesy of FAA)**

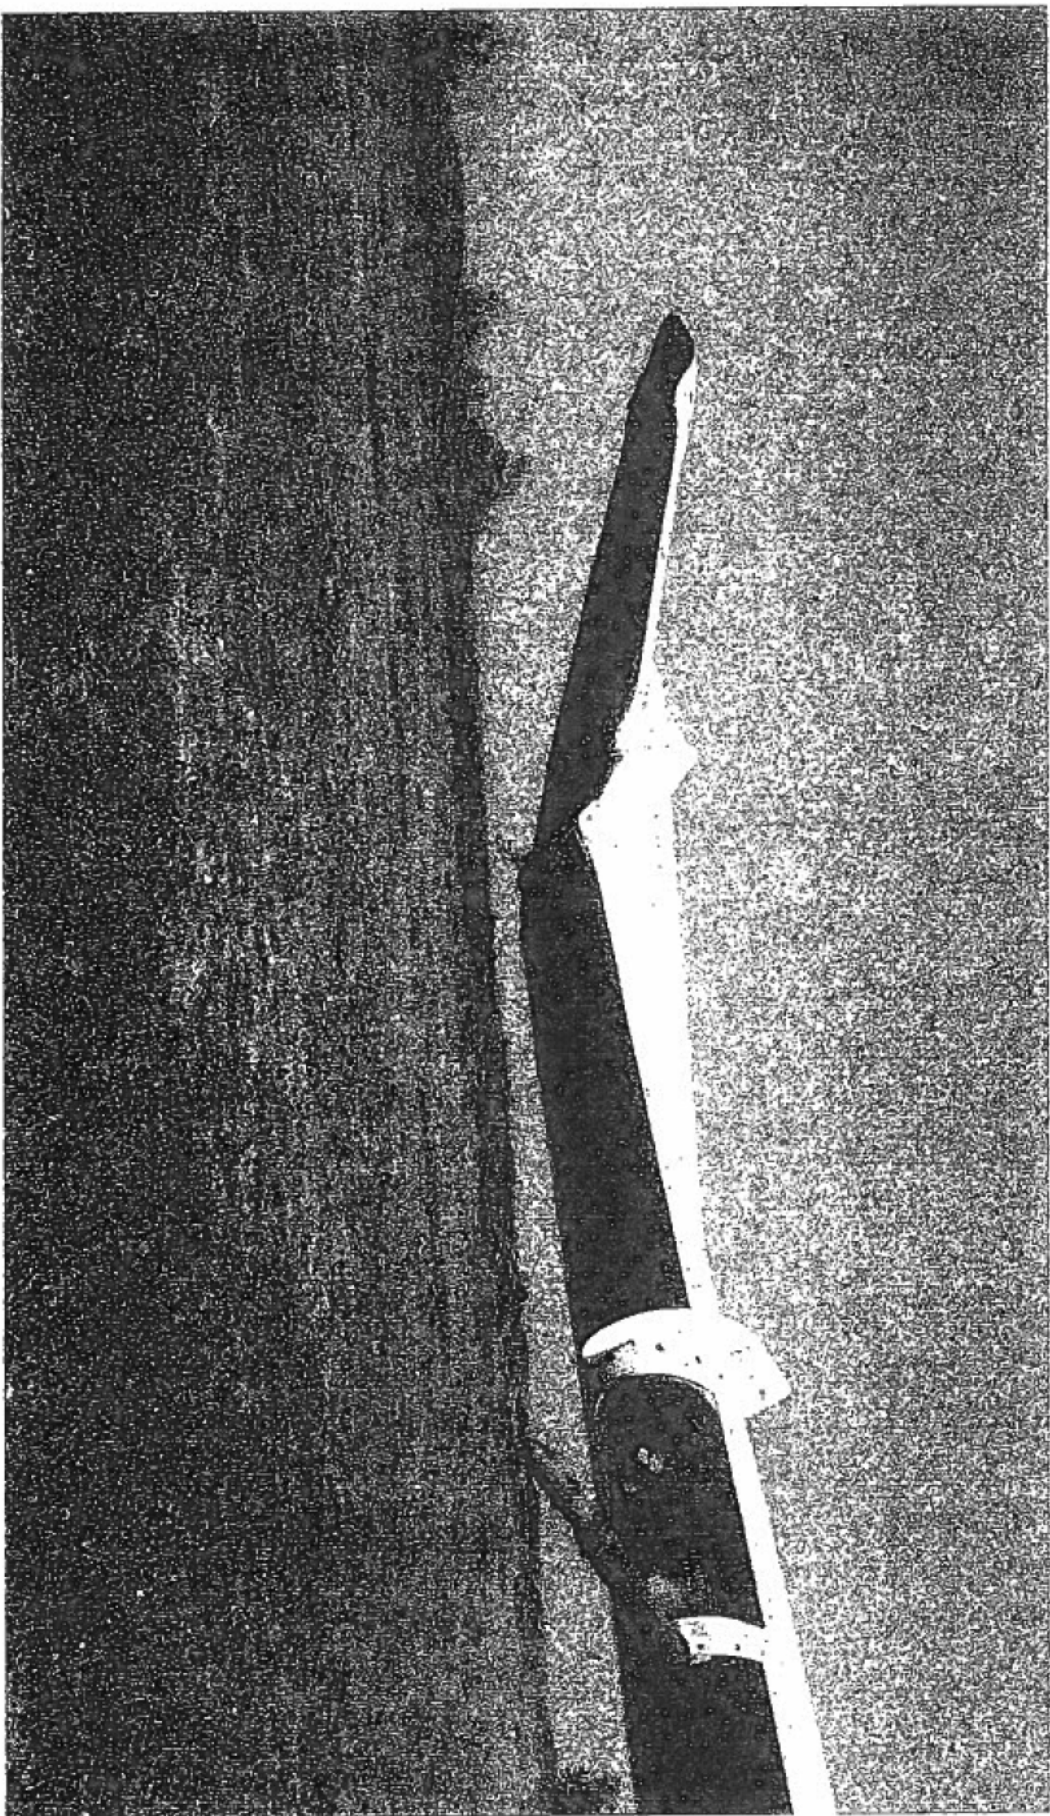
Photo 2 – View of damage to right wing (Courtesy of FAA)

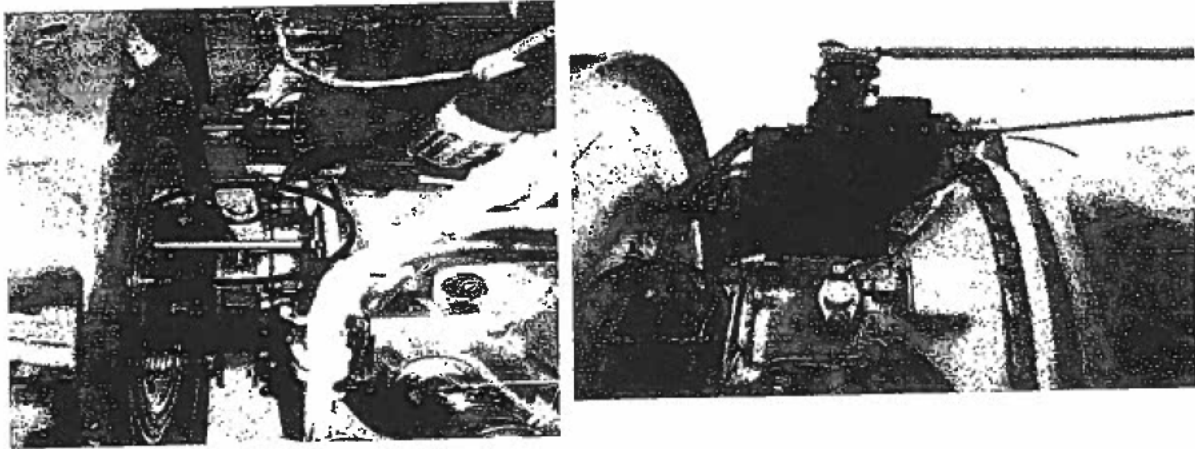
**Figure 1.** Photographs of exemplar engines showing correct (left) and incorrect orientation (right) of the beta arm

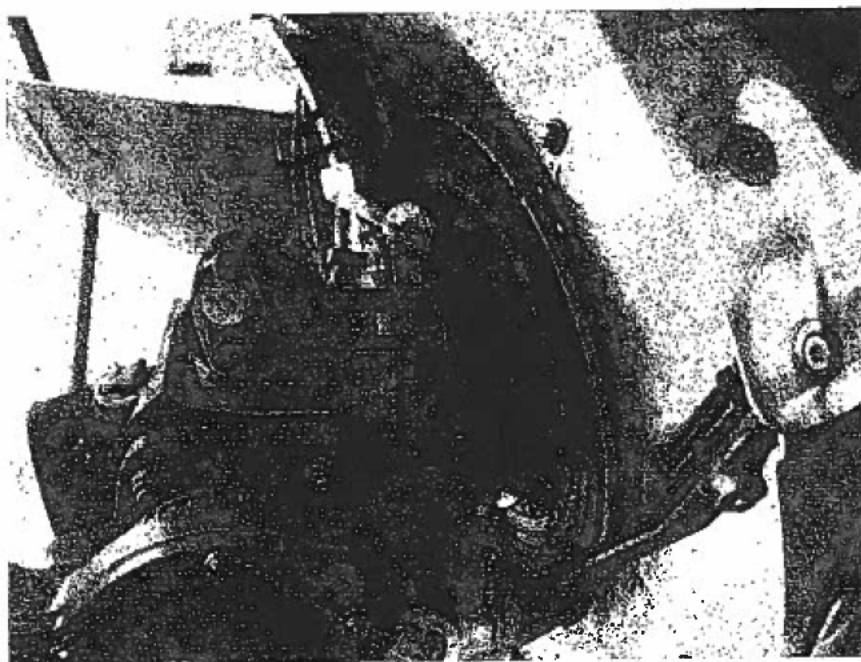
**Figure 2.** A photograph showing a beta arm guide pin installed incorrectly in the aft direction (the red arrow points forward, indicating the pin's correct orientation).
