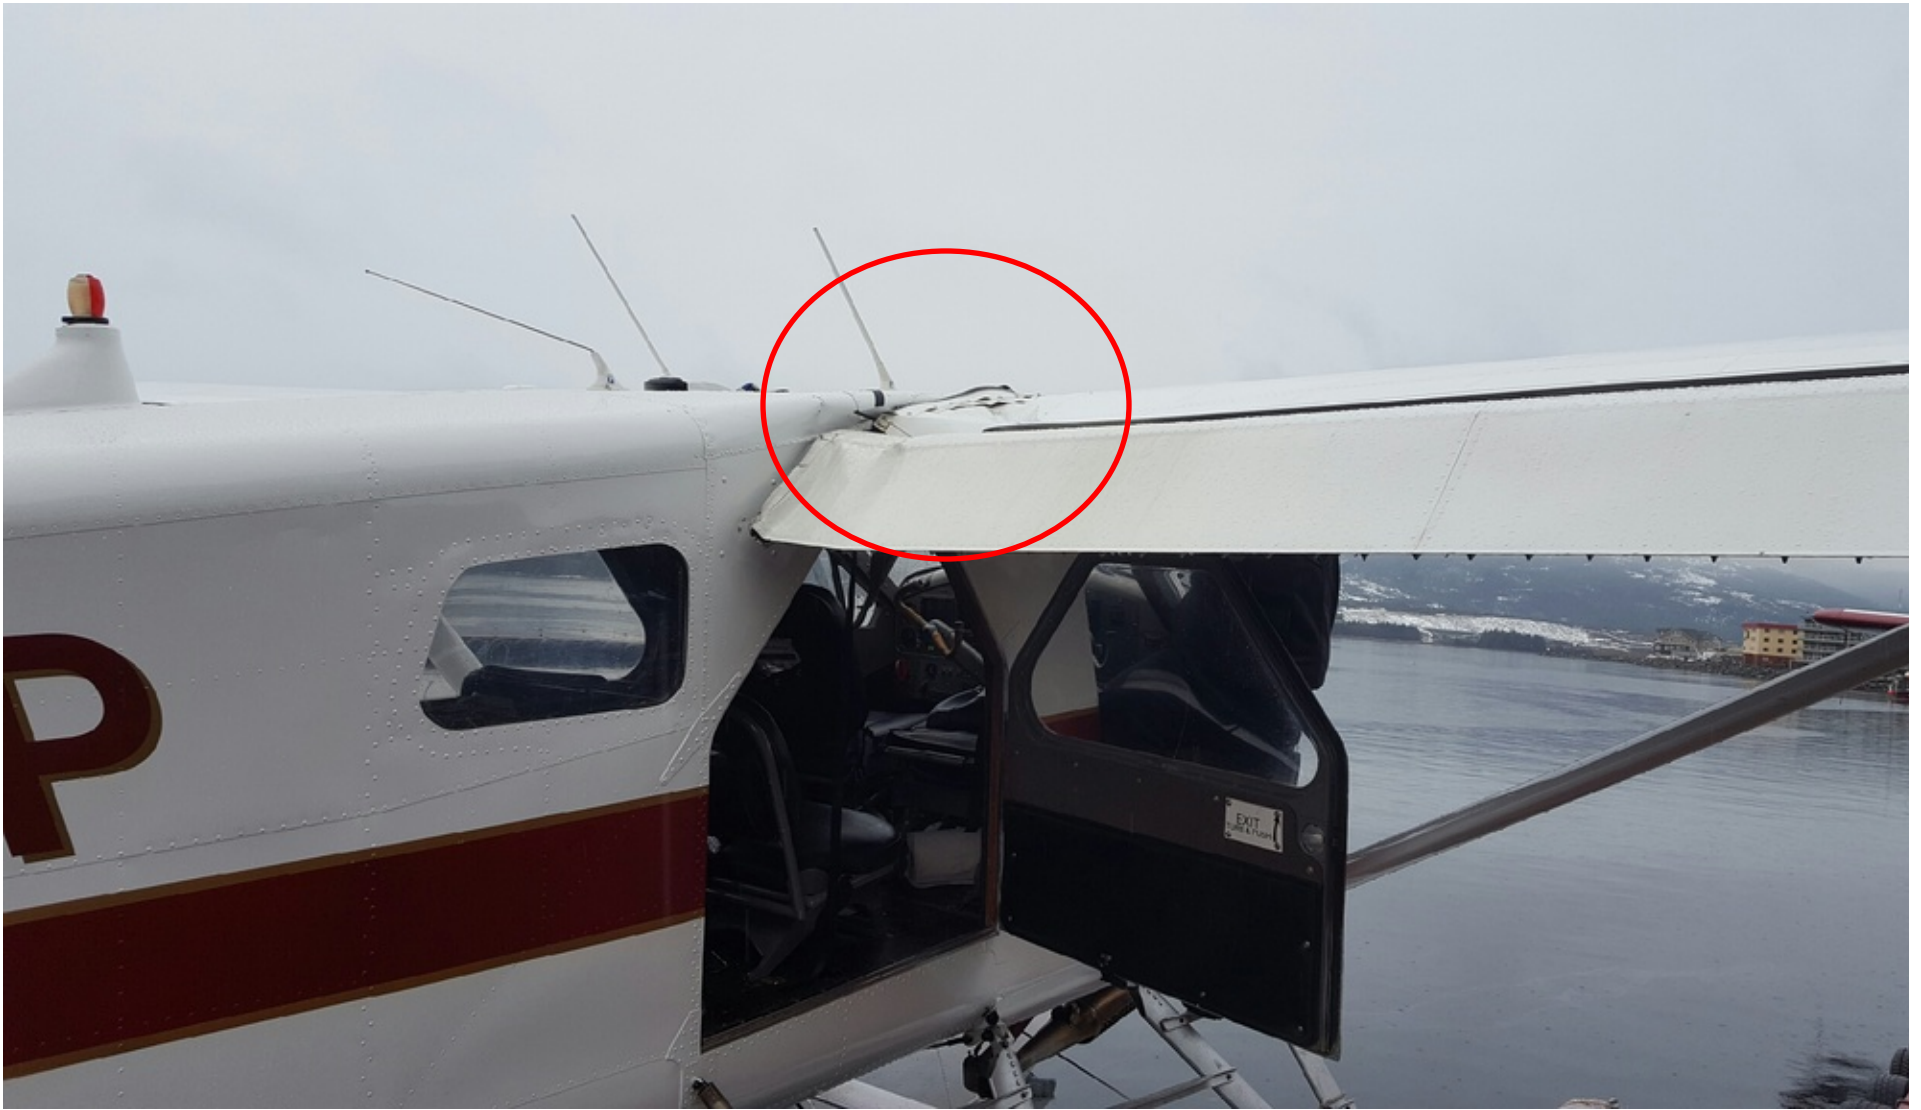
**Photo 1 –View of Right Wing Damage (Photo Courtesy of FAA)**

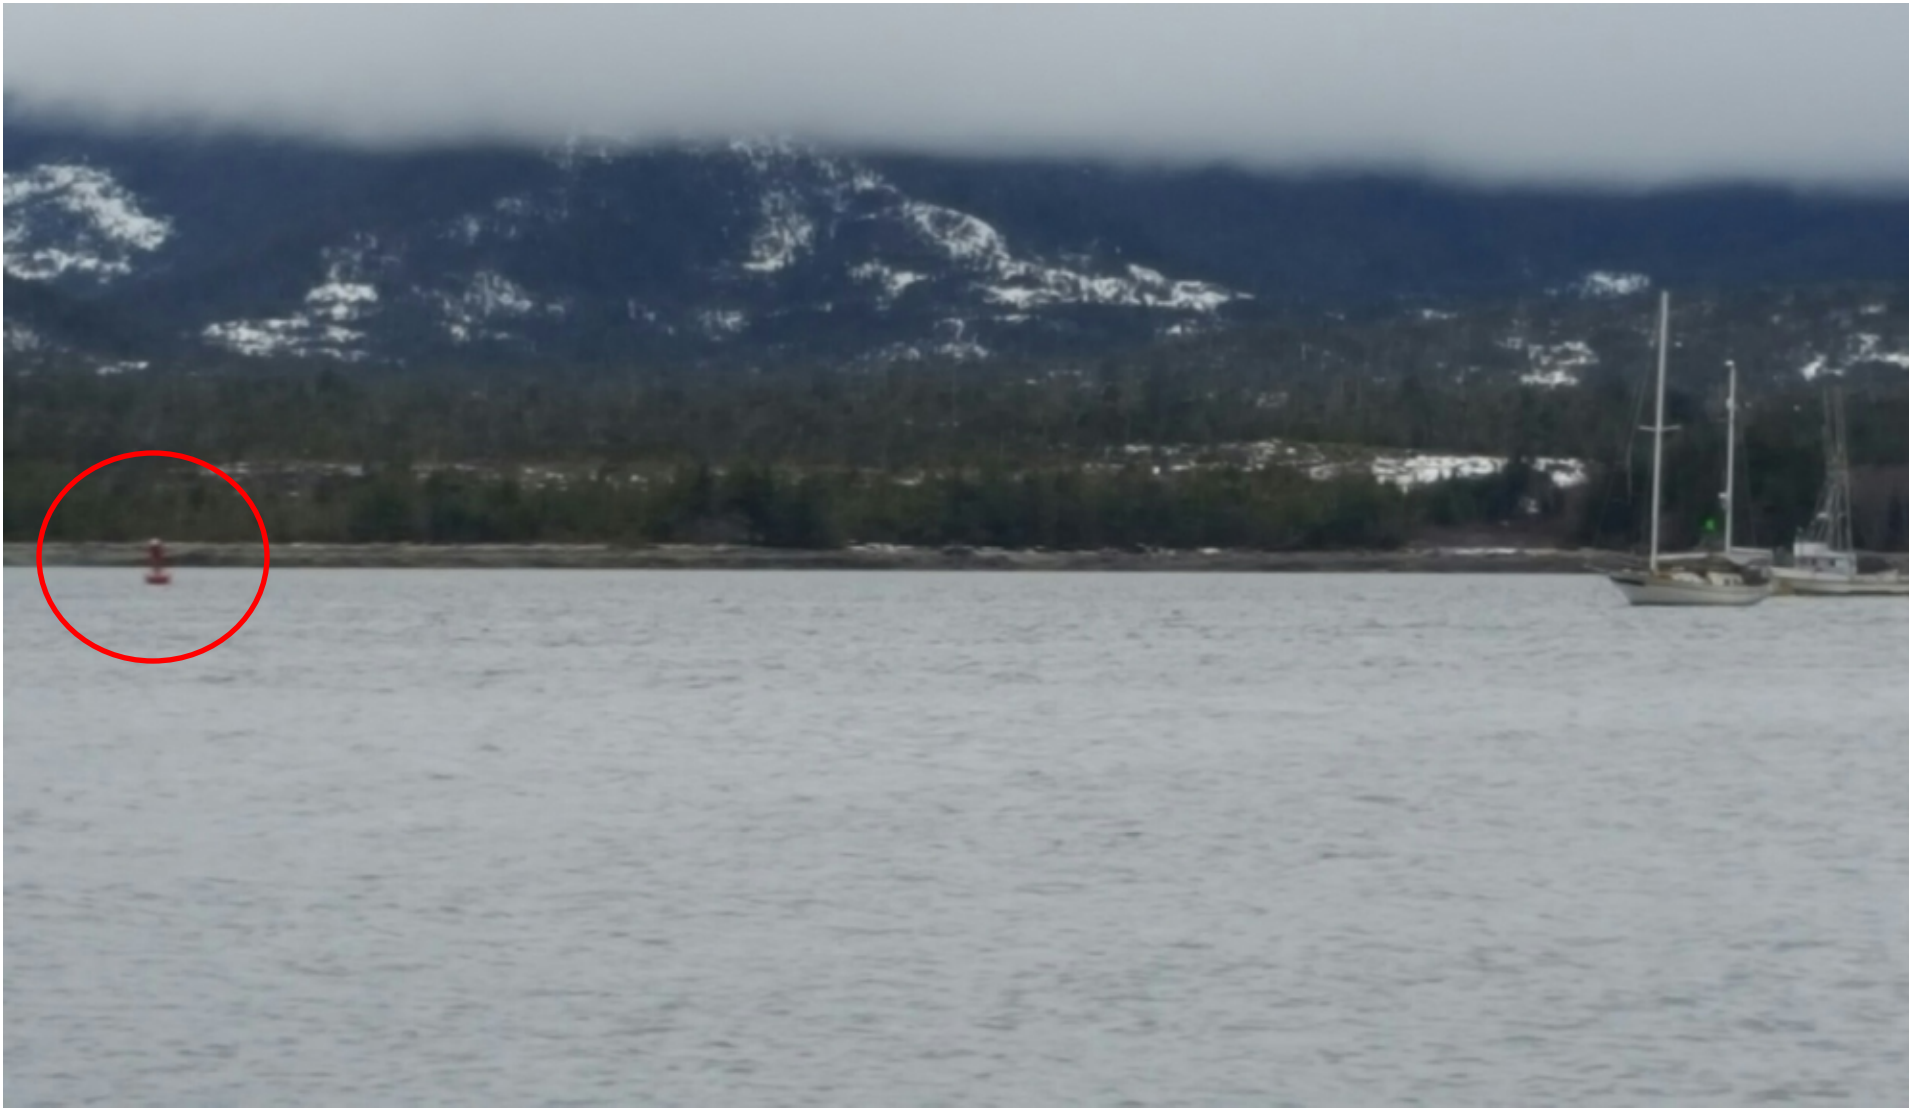
**Photo 2 – Marker Buoy in Harbor (Photo Courtesy of FAA)**
