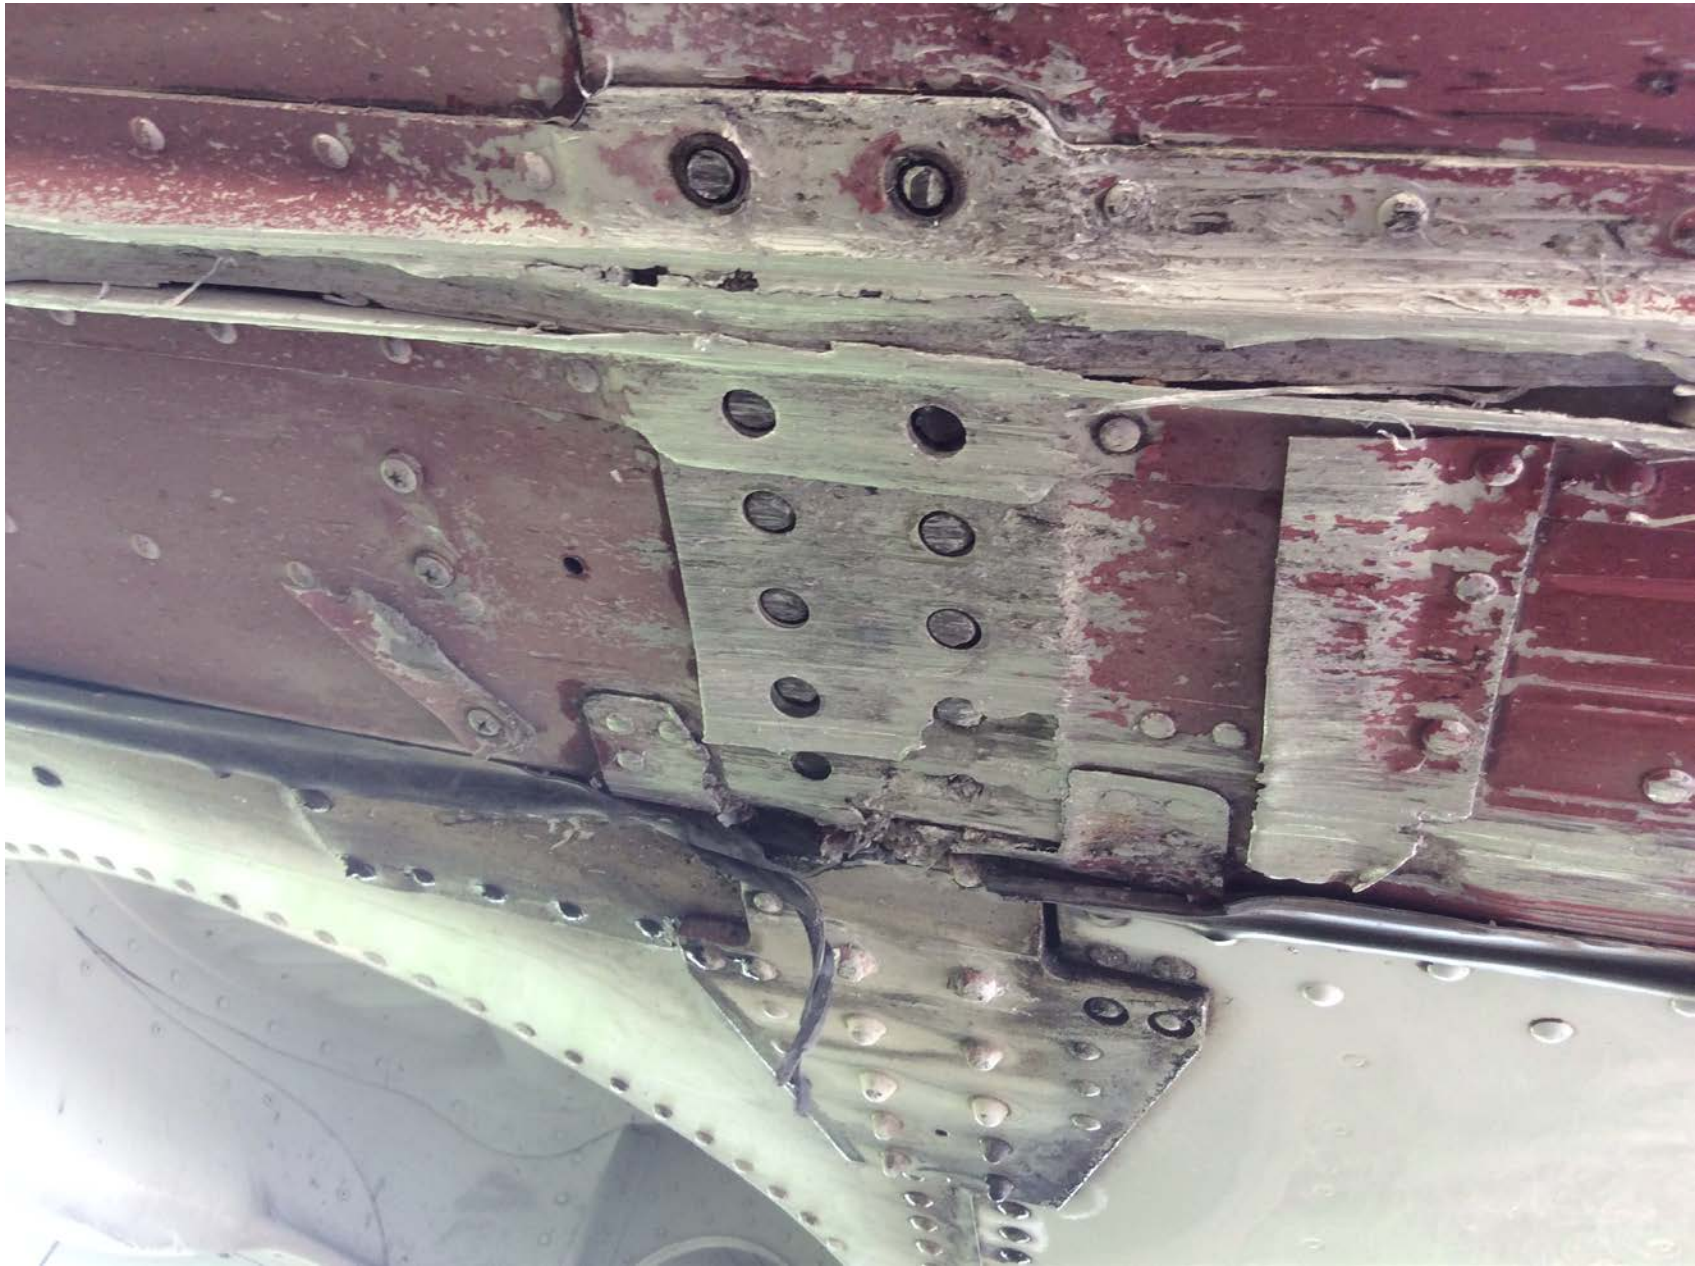
**Photo 1 – View of damage to longerons (Courtesy of FAA)**
