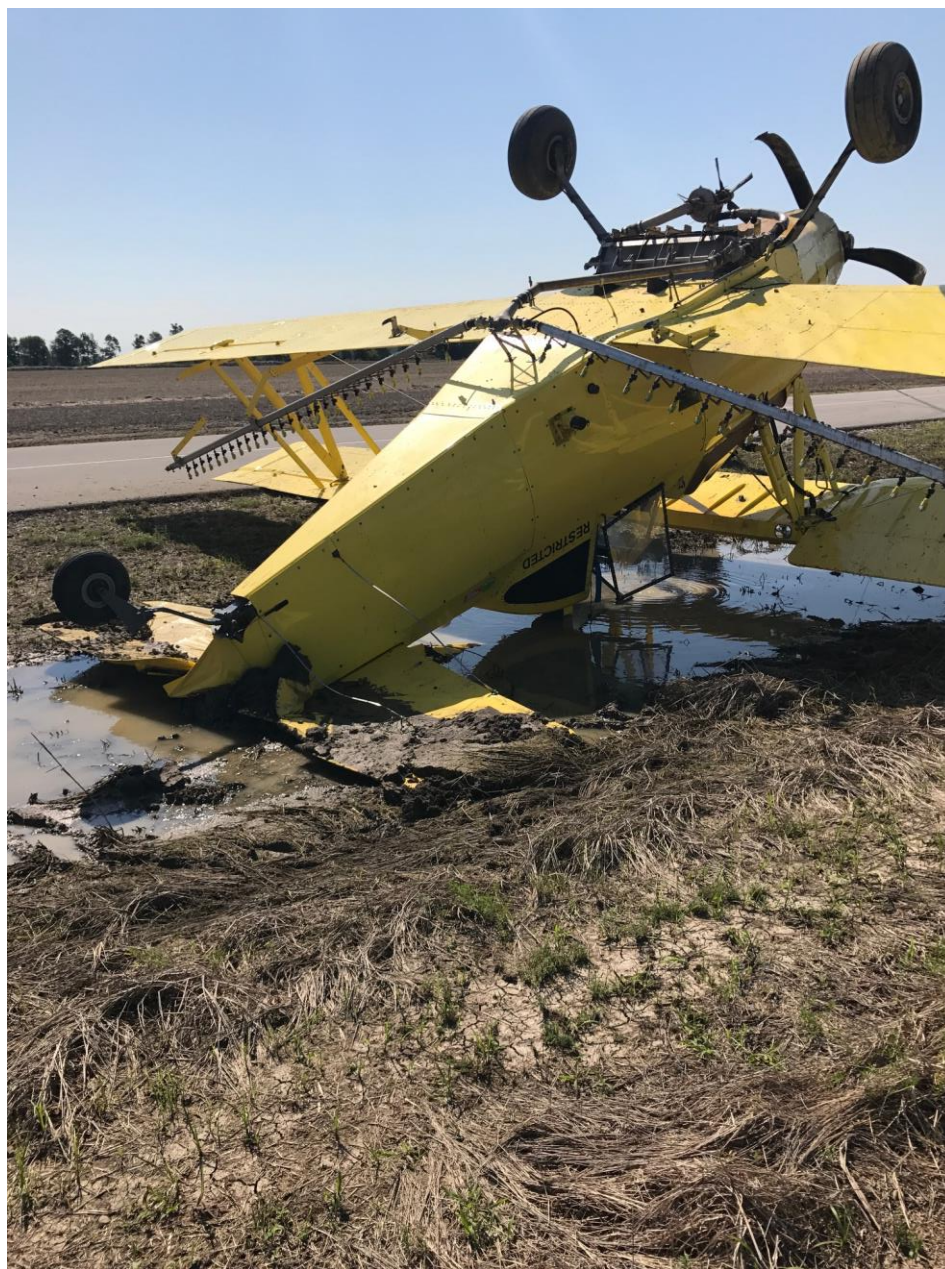
**Photo 1 – View of substantial damaged empennage (photo courtesy of the FAA)**
