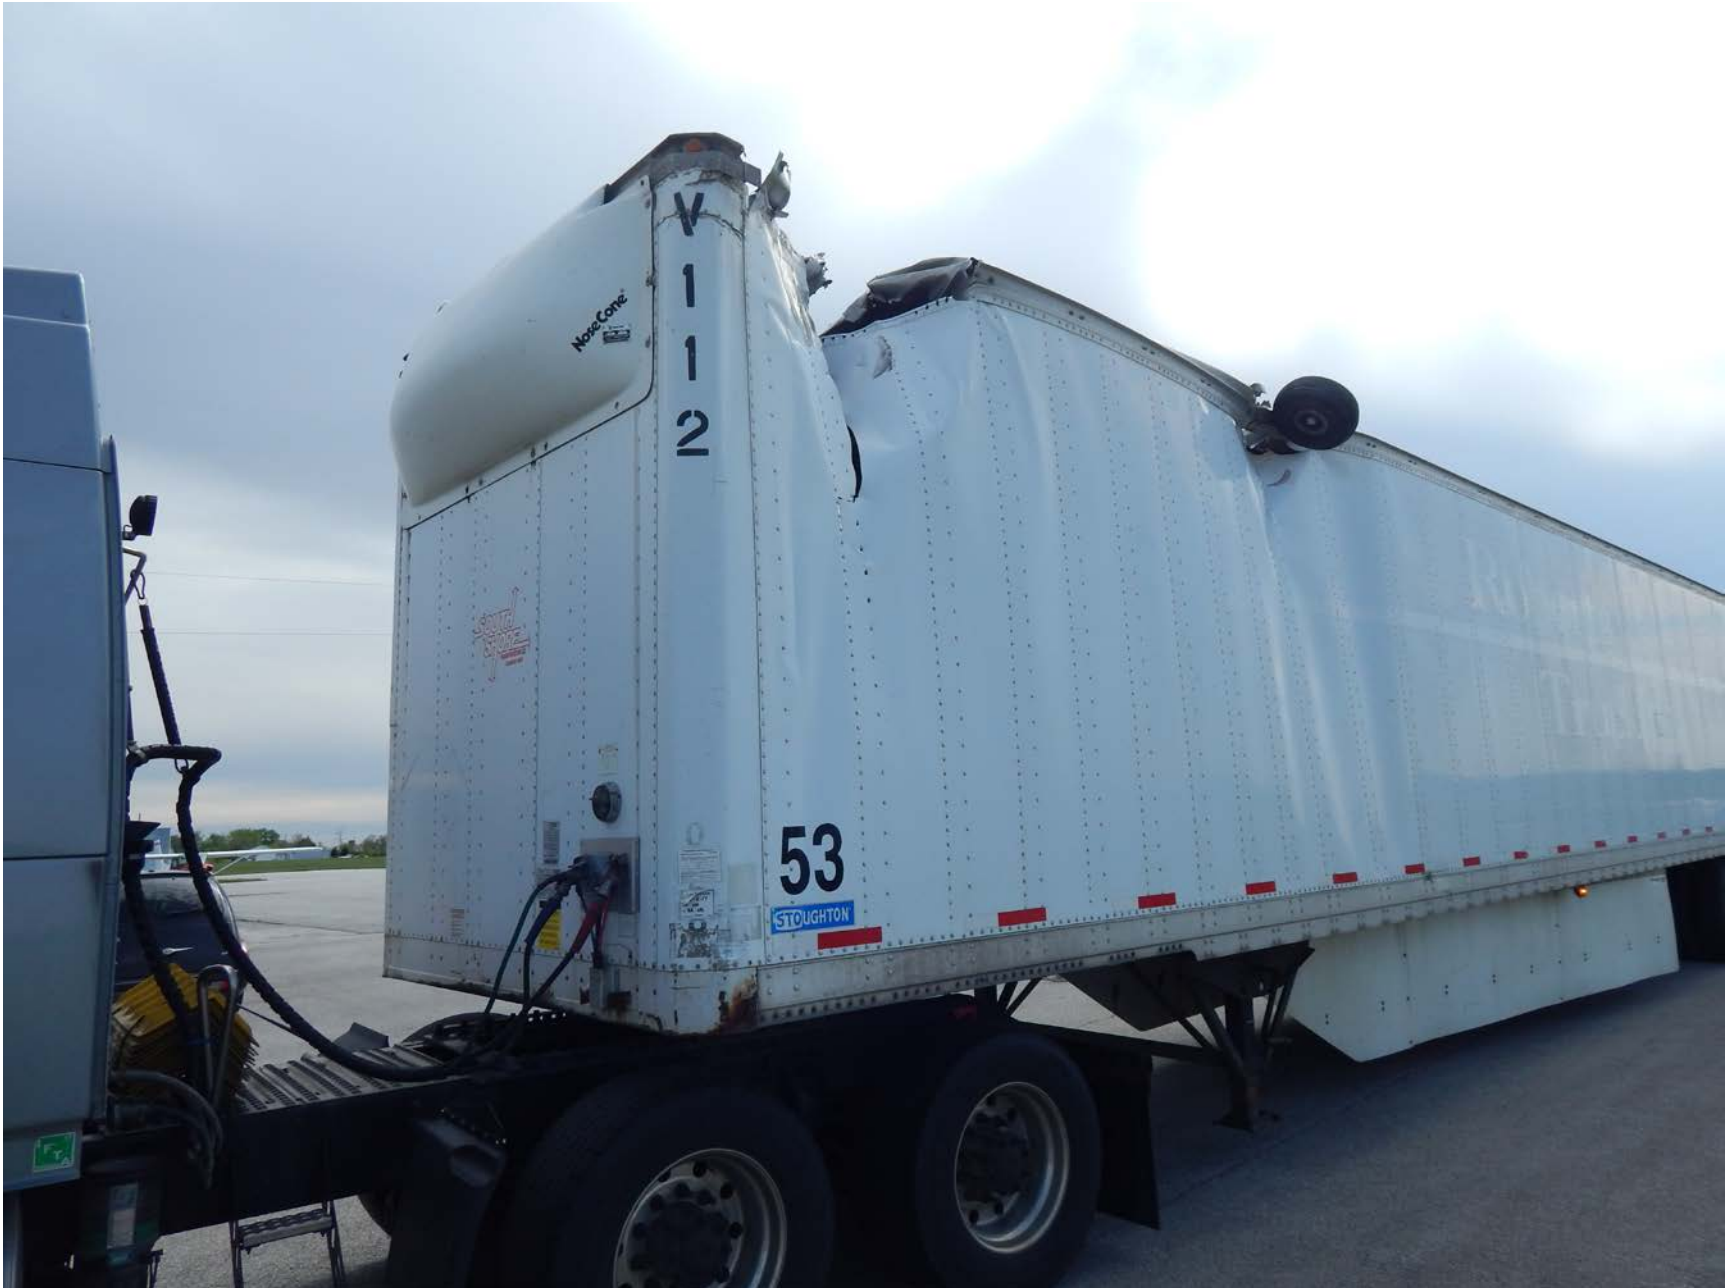
**Photo 1 – View of landing gear embedded in semi-truck (photo courtesy of FAA)**

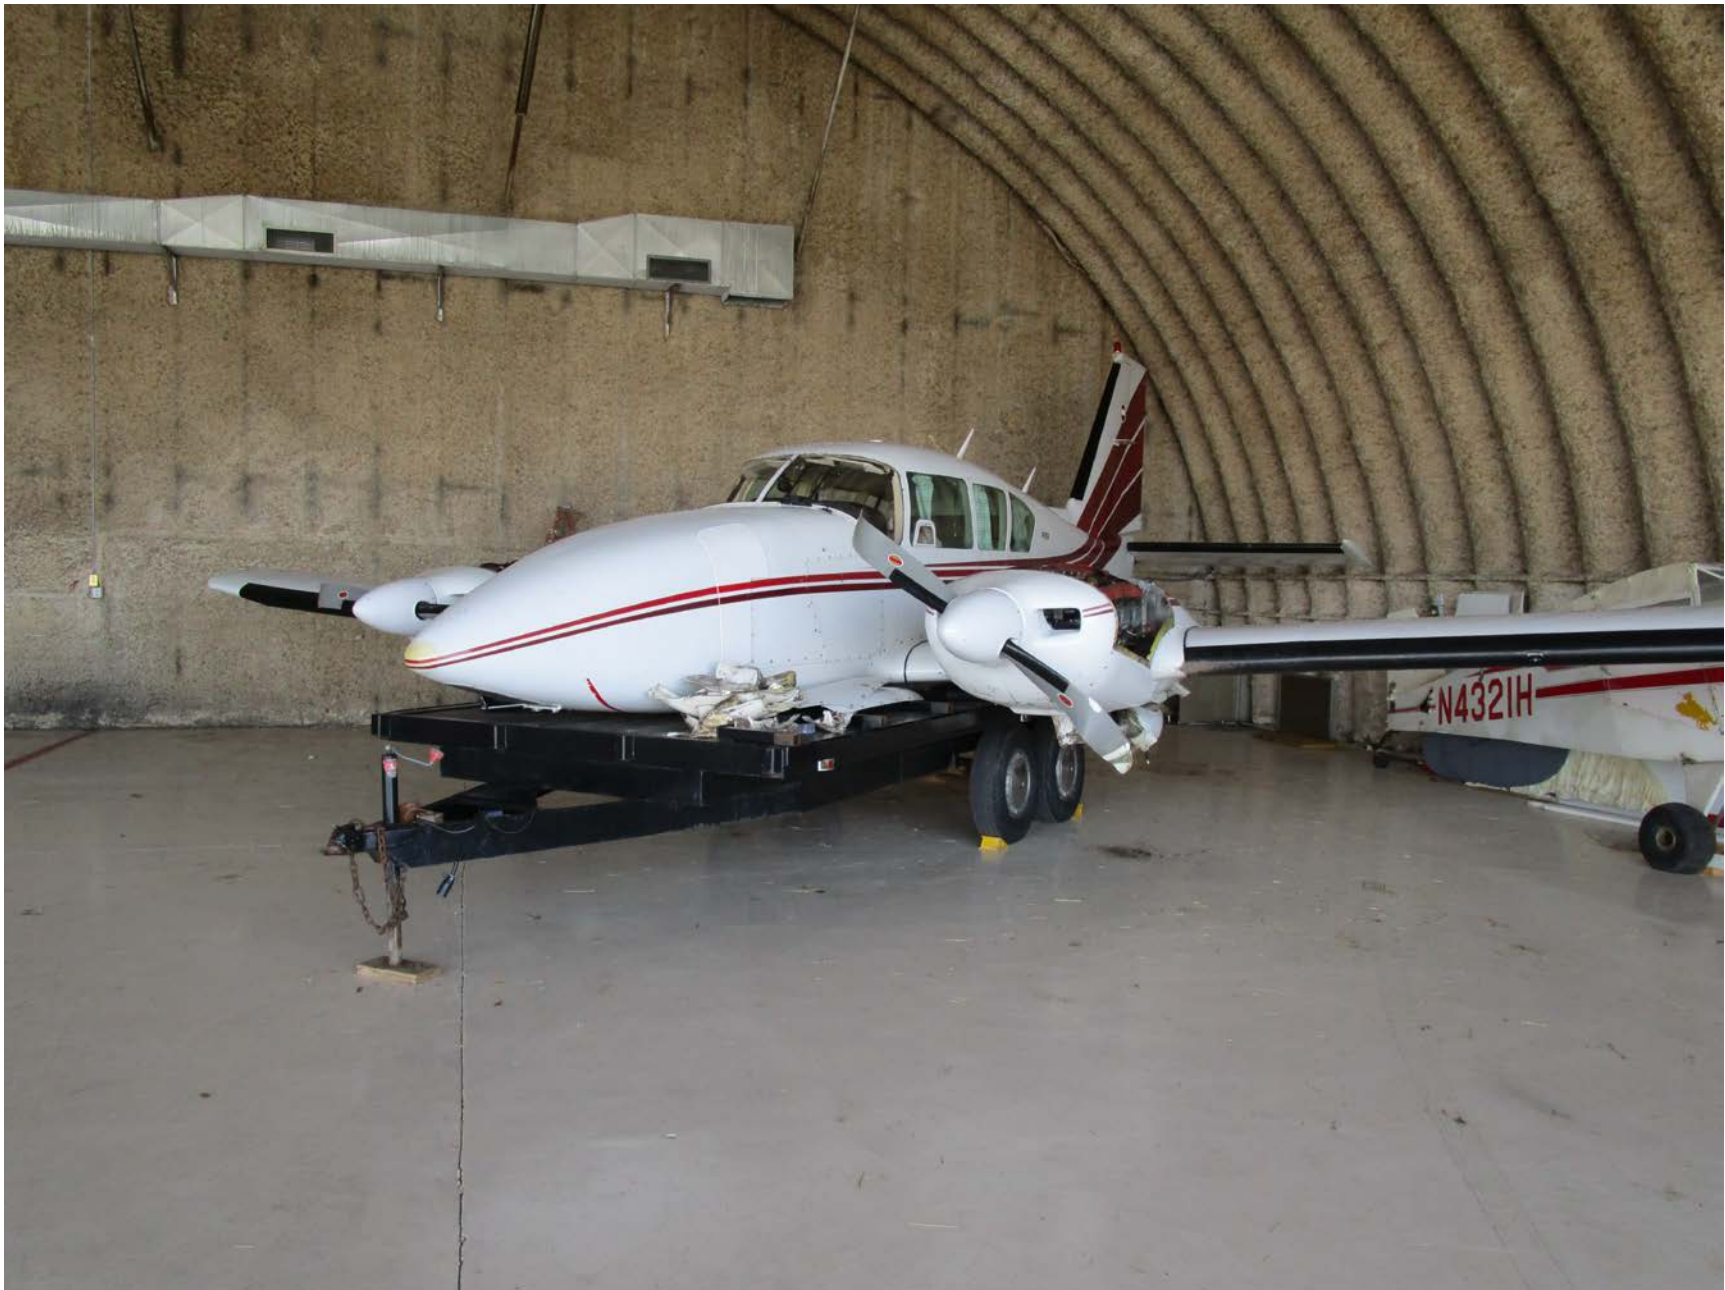
**Photo 2 – View of damaged airplane from front (photo courtesy of the FAA)**
