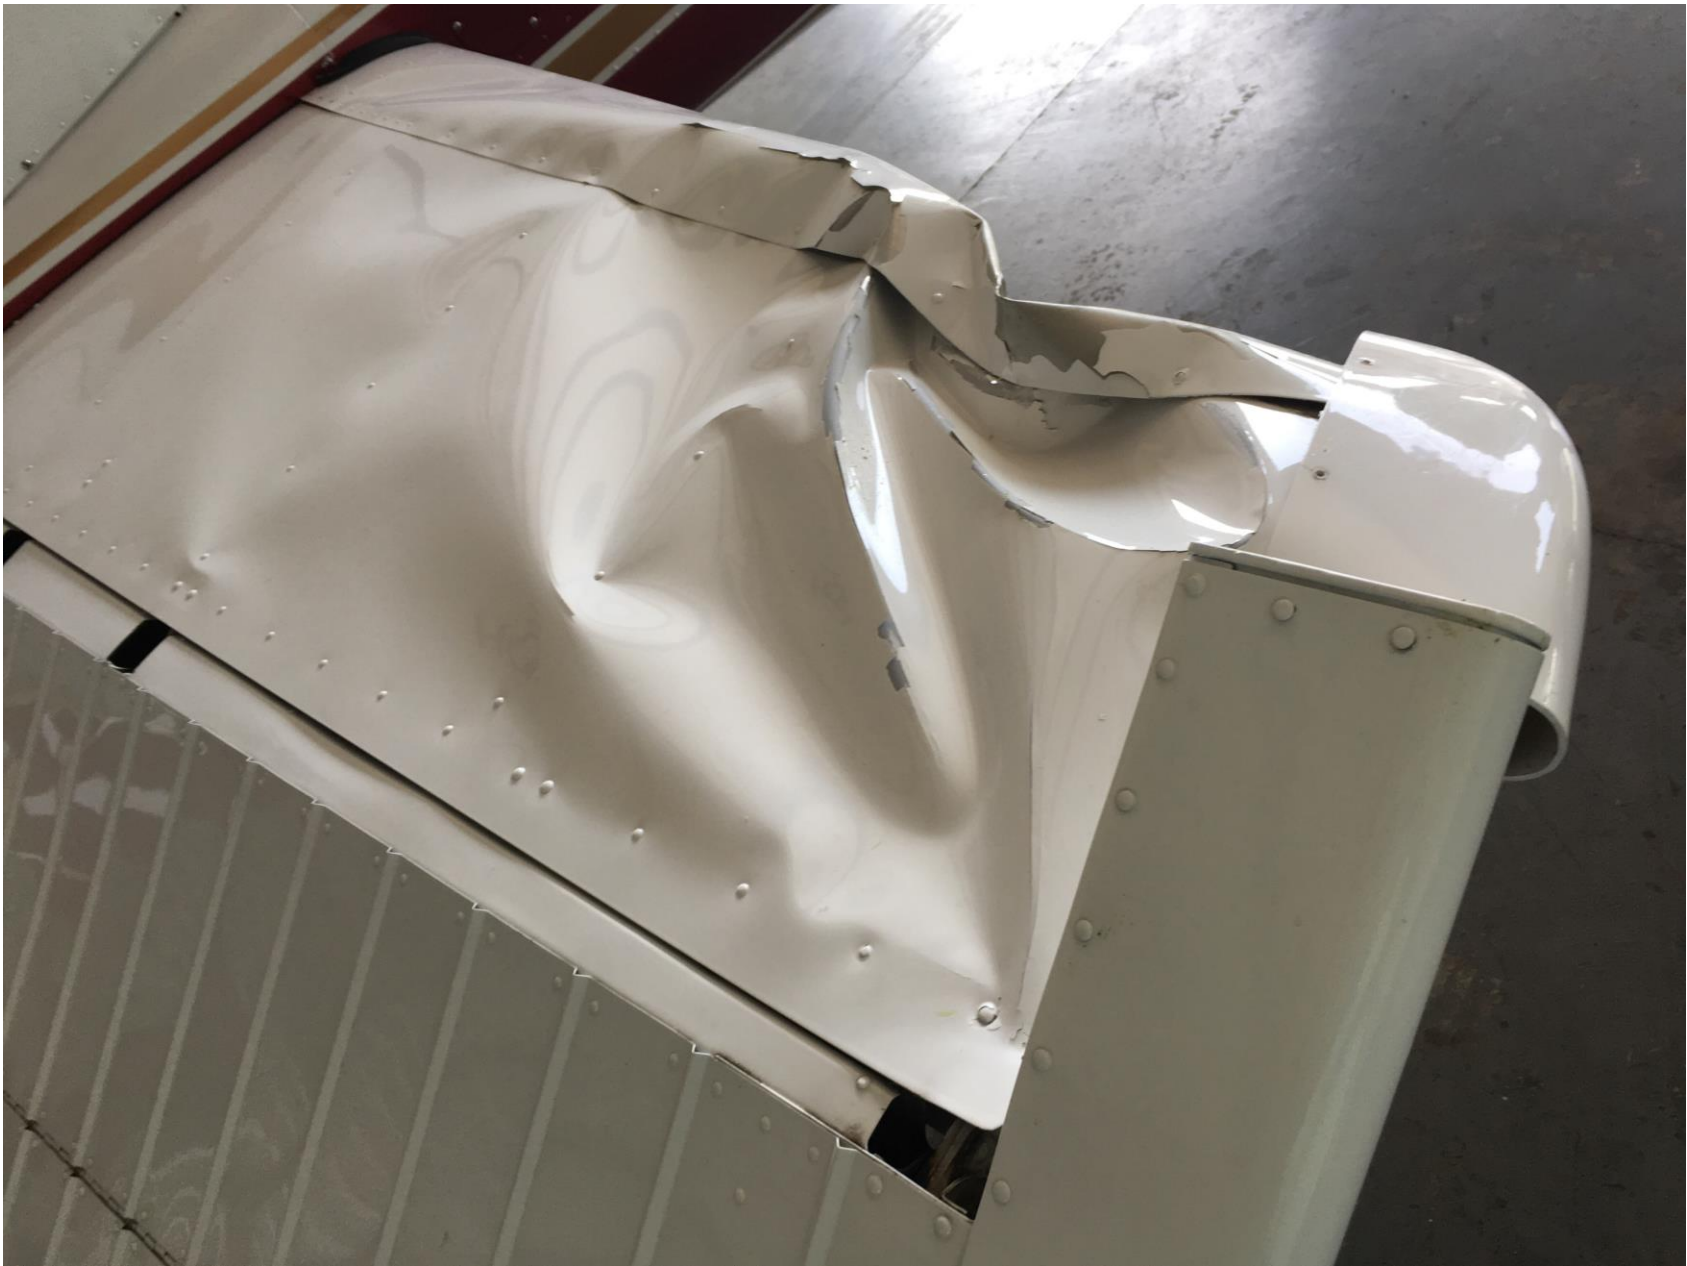
**Photo 1 – View of empennage damage. (photo courtesy of the FAA)**
