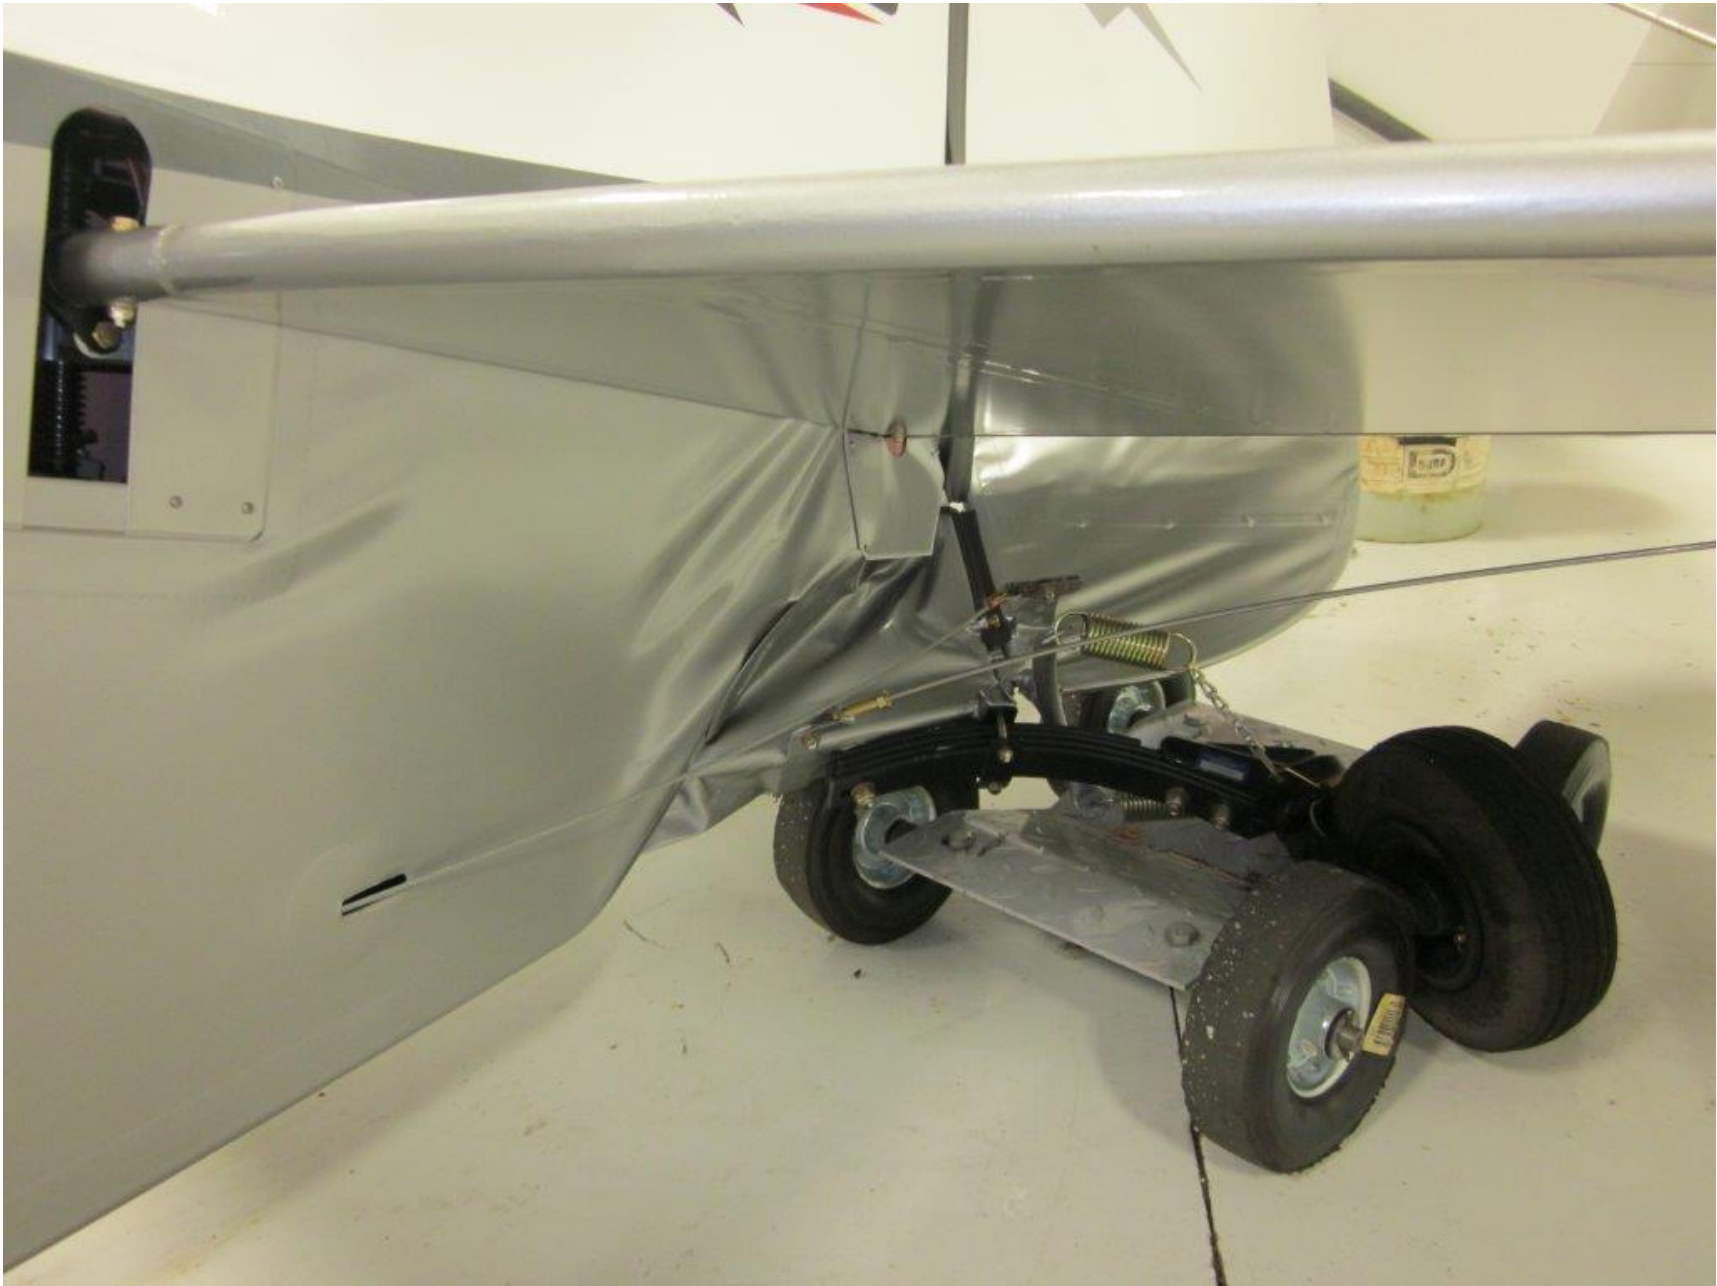
**Photo 1 – View of the damaged empennage (photo courtesy of the FAA)**
