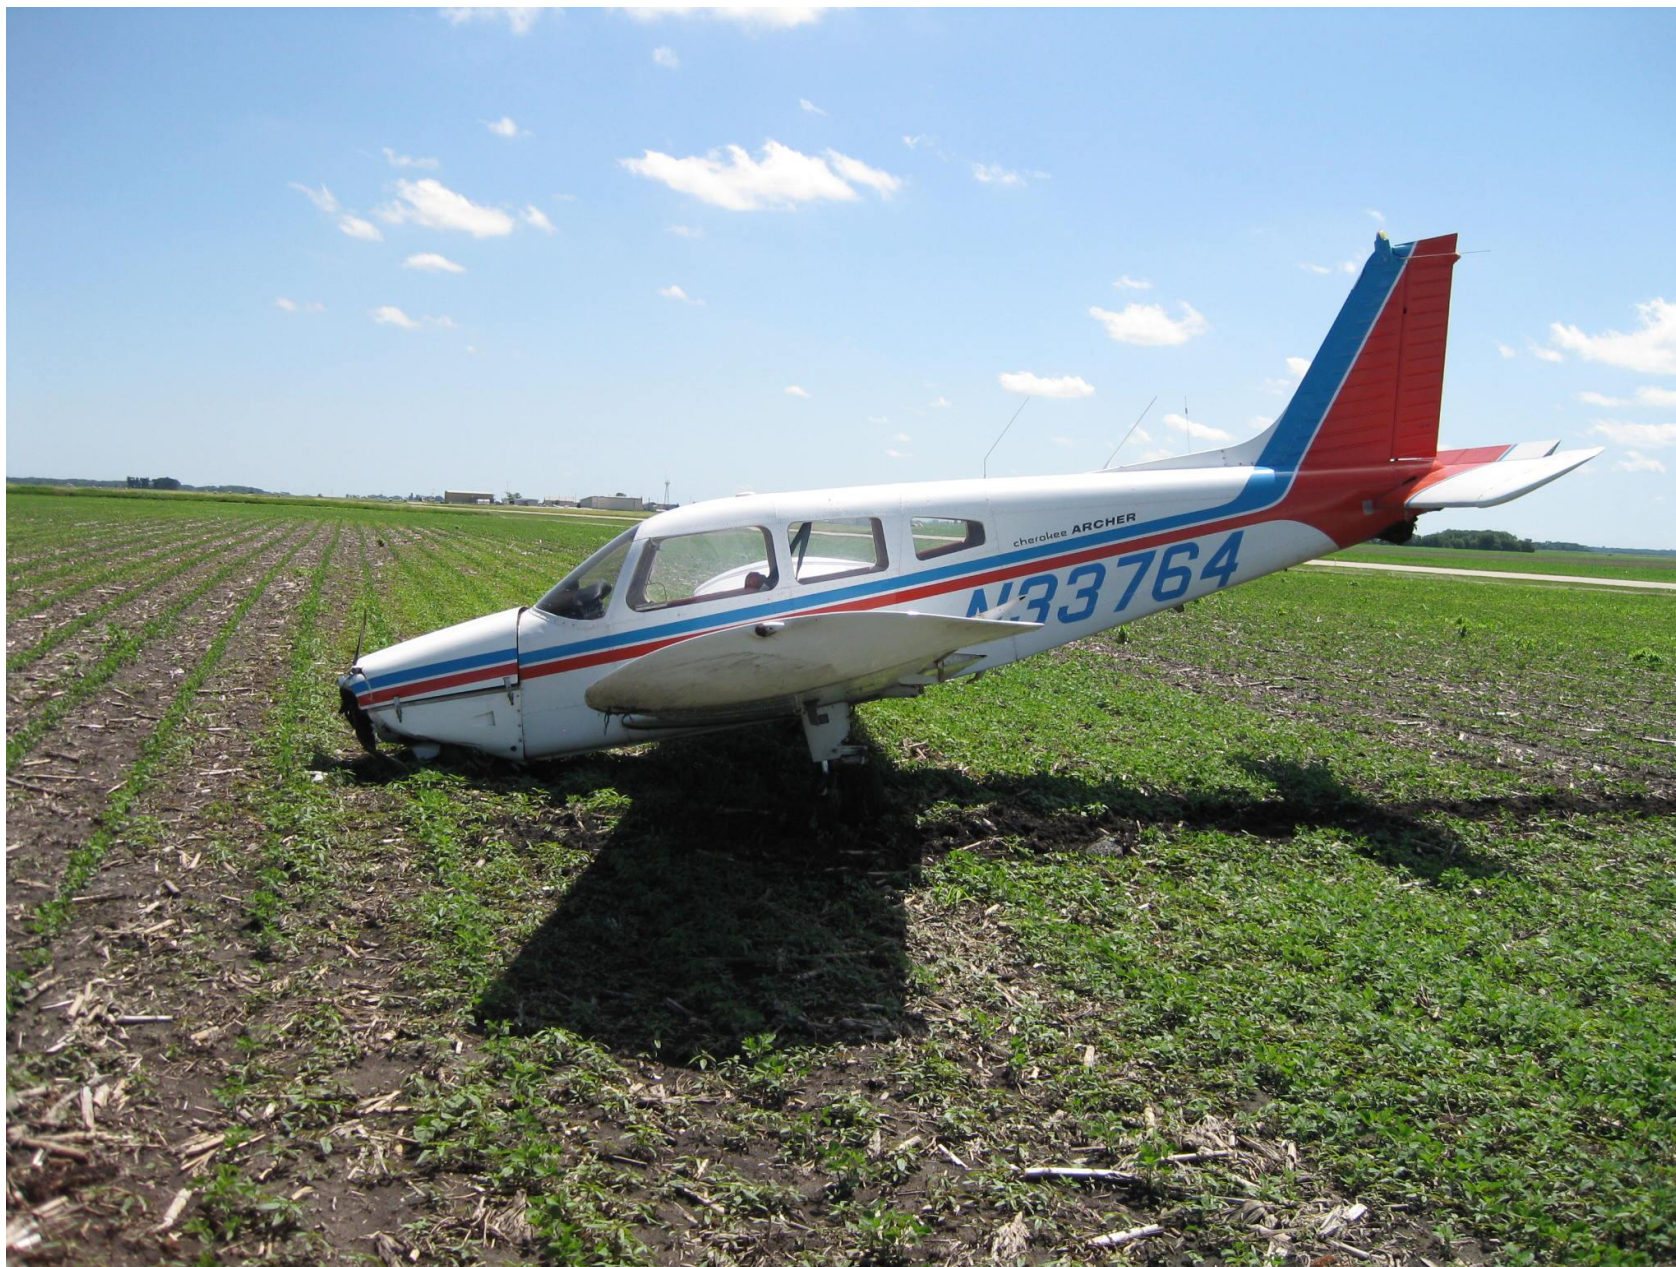
**Photo 1 – View of damage from the side (photo courtesy of the FAA).**

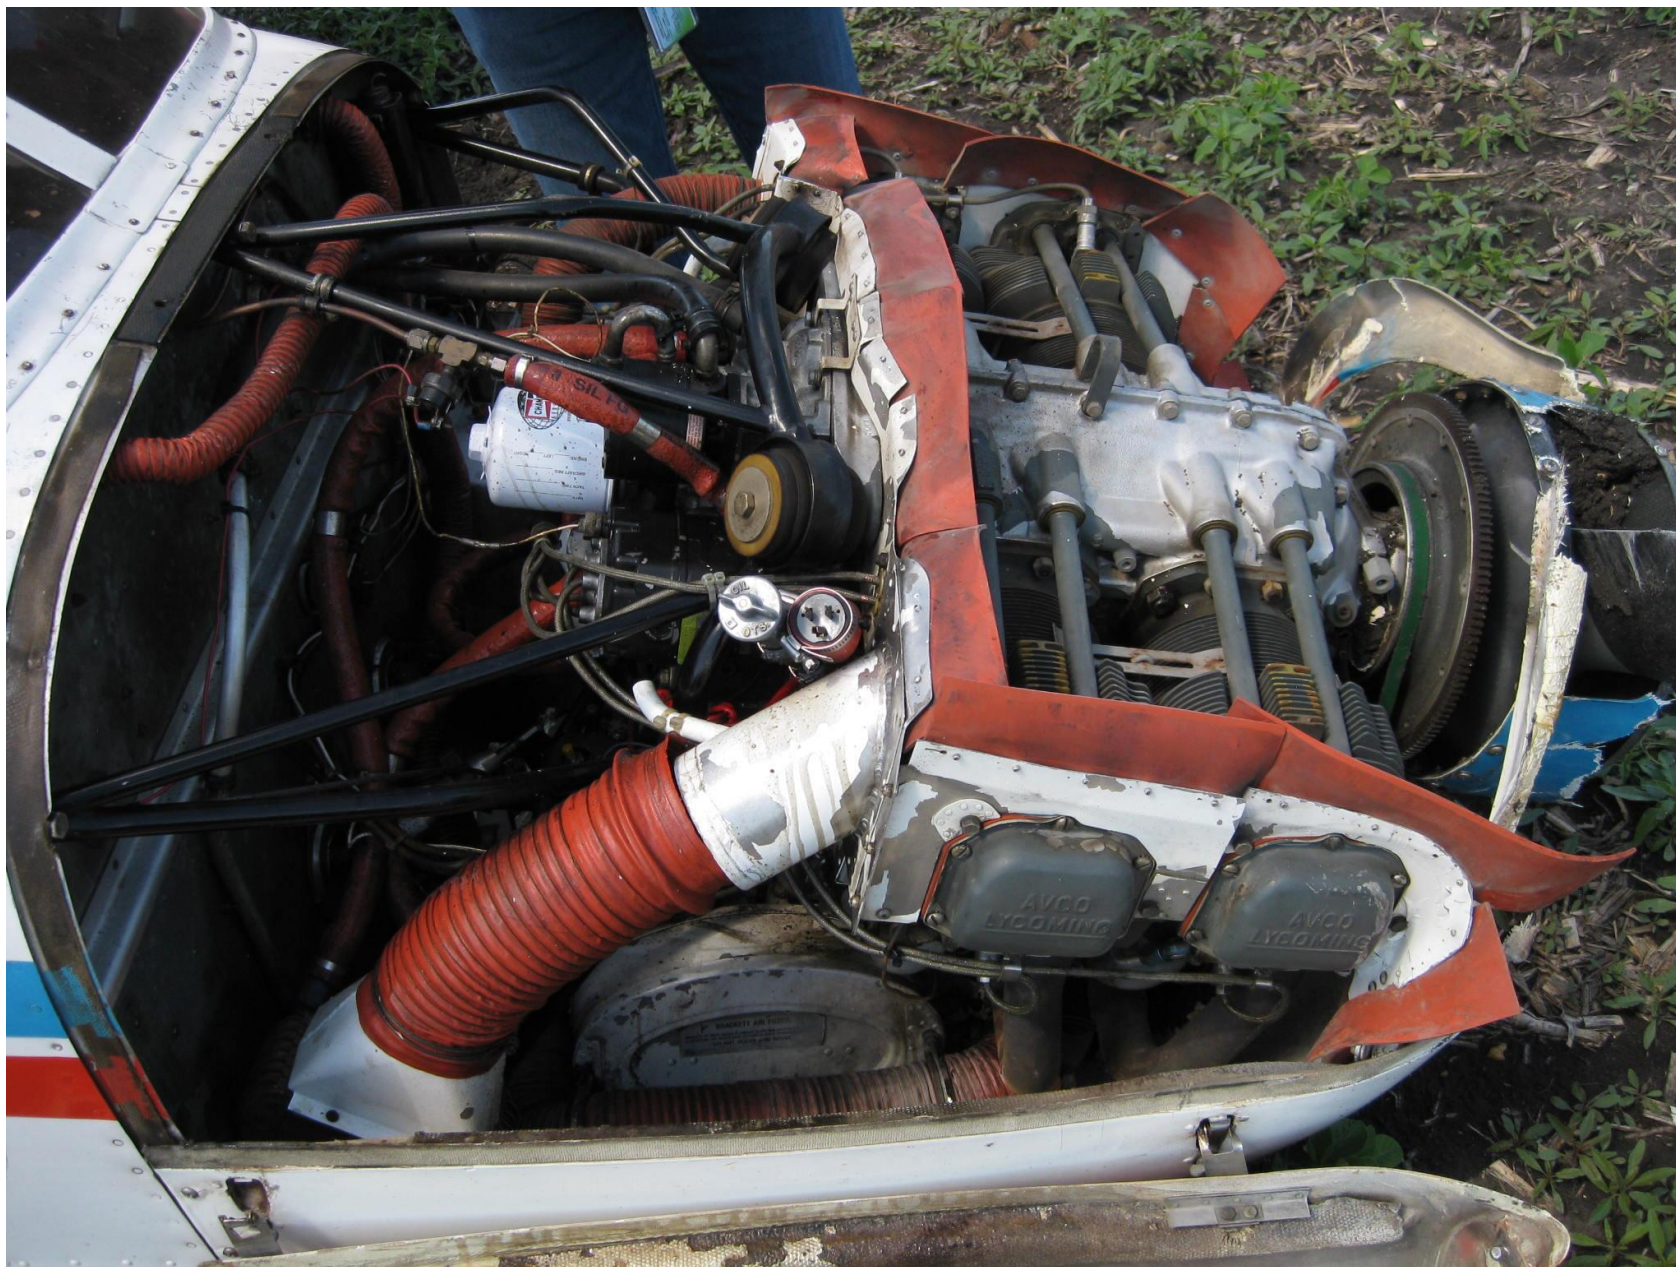
**Photo 2 - View of broken engine mount (photo courtesy of the FAA)**
