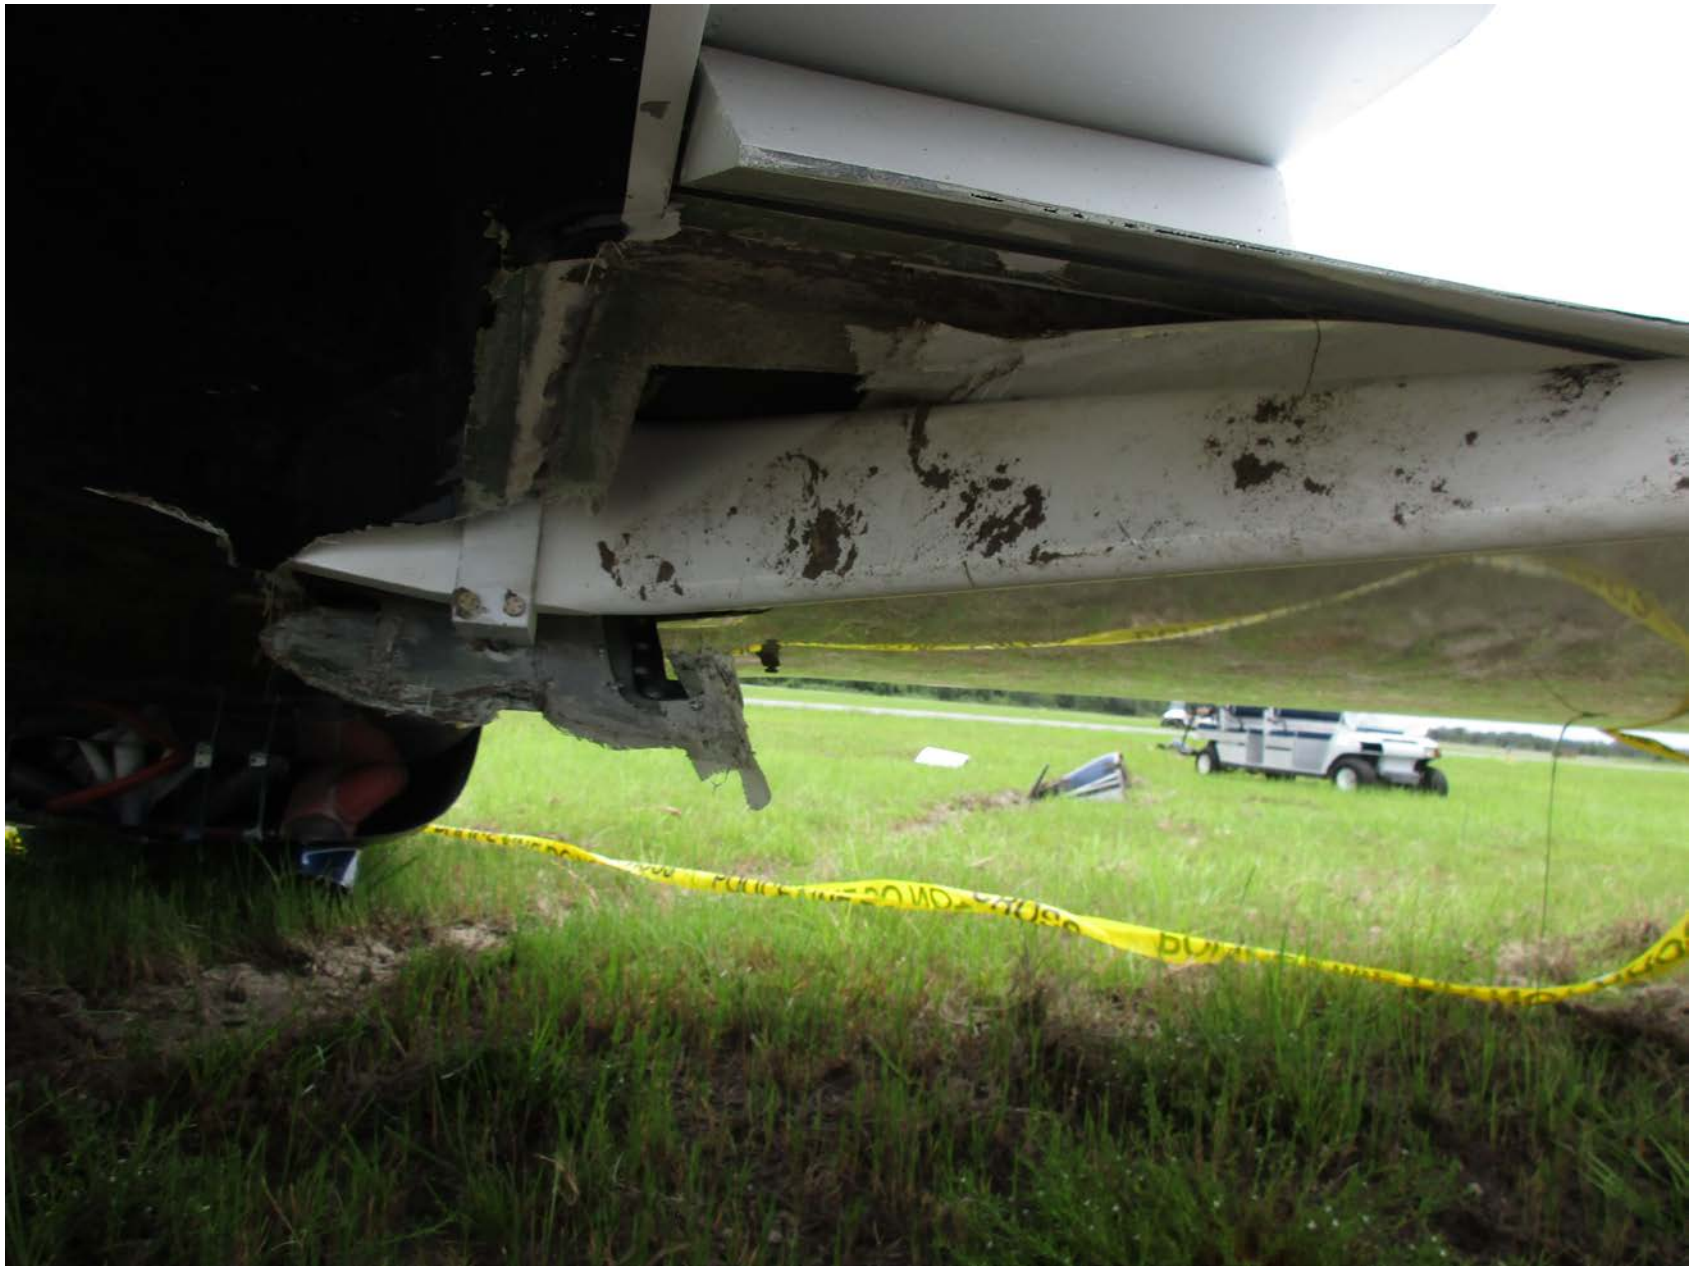
**Photo 1 – View of the damage to the composite lower fuselage (Courtesy of FAA)**
