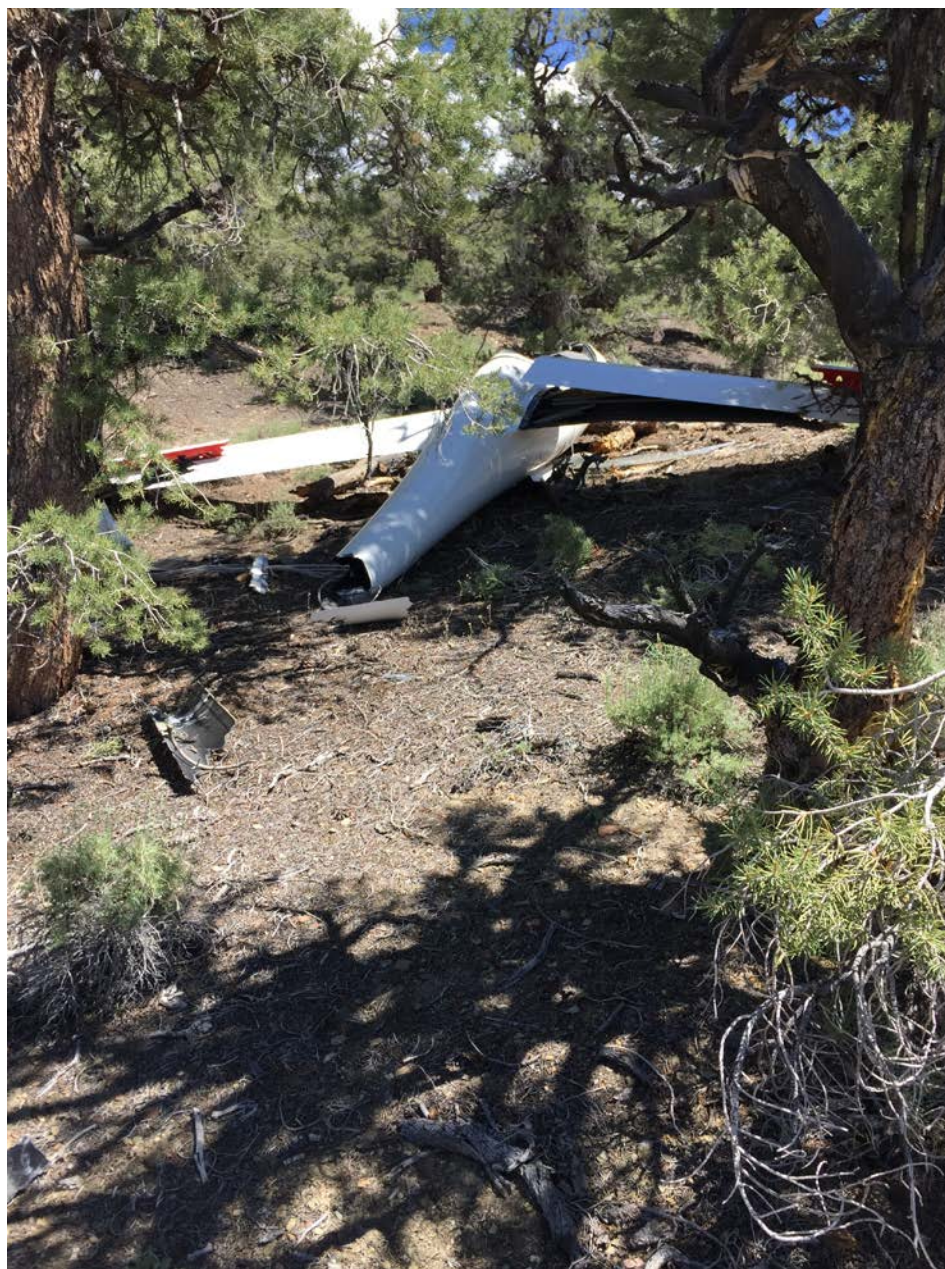
**Photo 1 – Substantially Damaged Fuselage and Wings (Photo Courtesy of Operator)**
