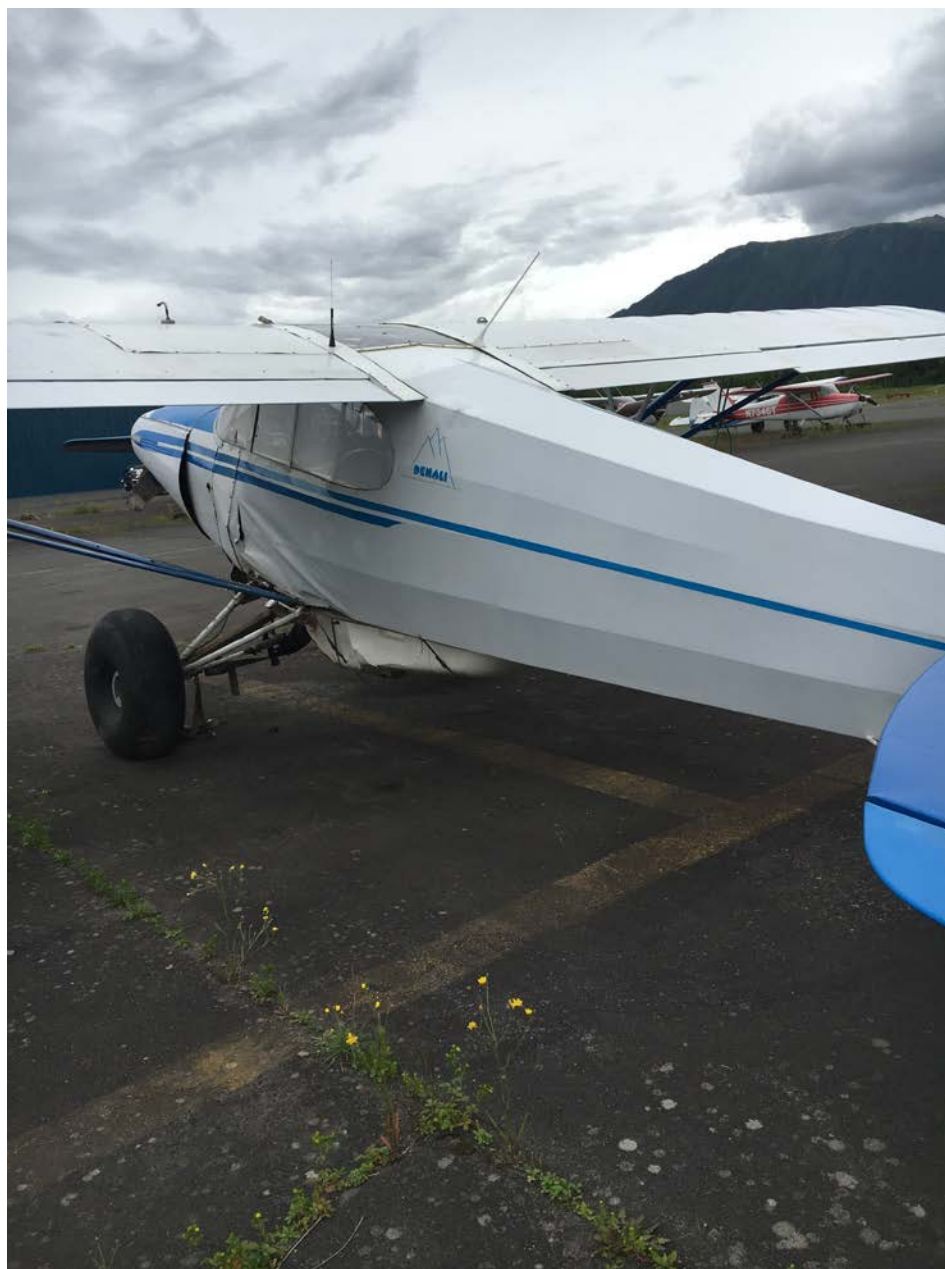
**Photo 1 – View of damage to the fuselage longerons (Courtesy of Operator)**
