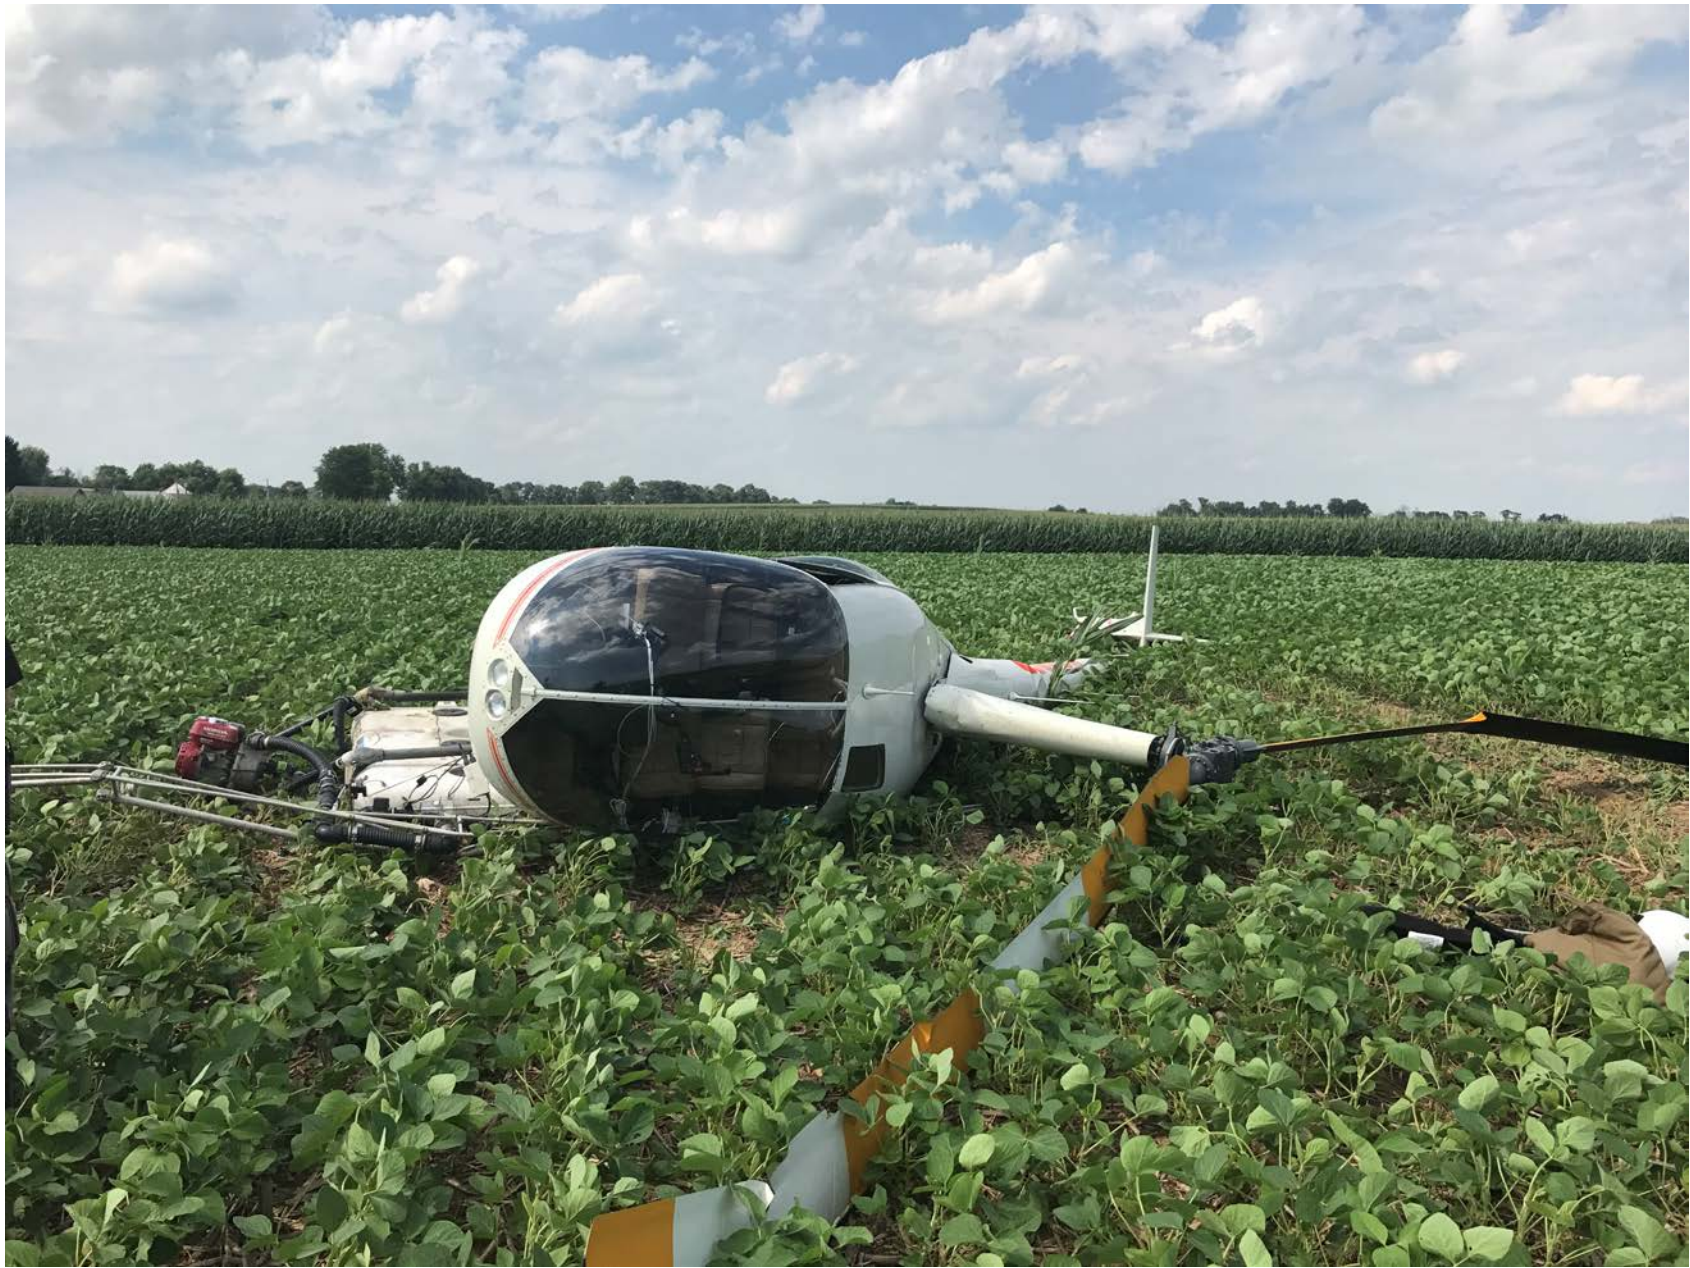
**Photo 1 – View of damage to the main rotor system and the tailboom (Courtesy of Operator)**
