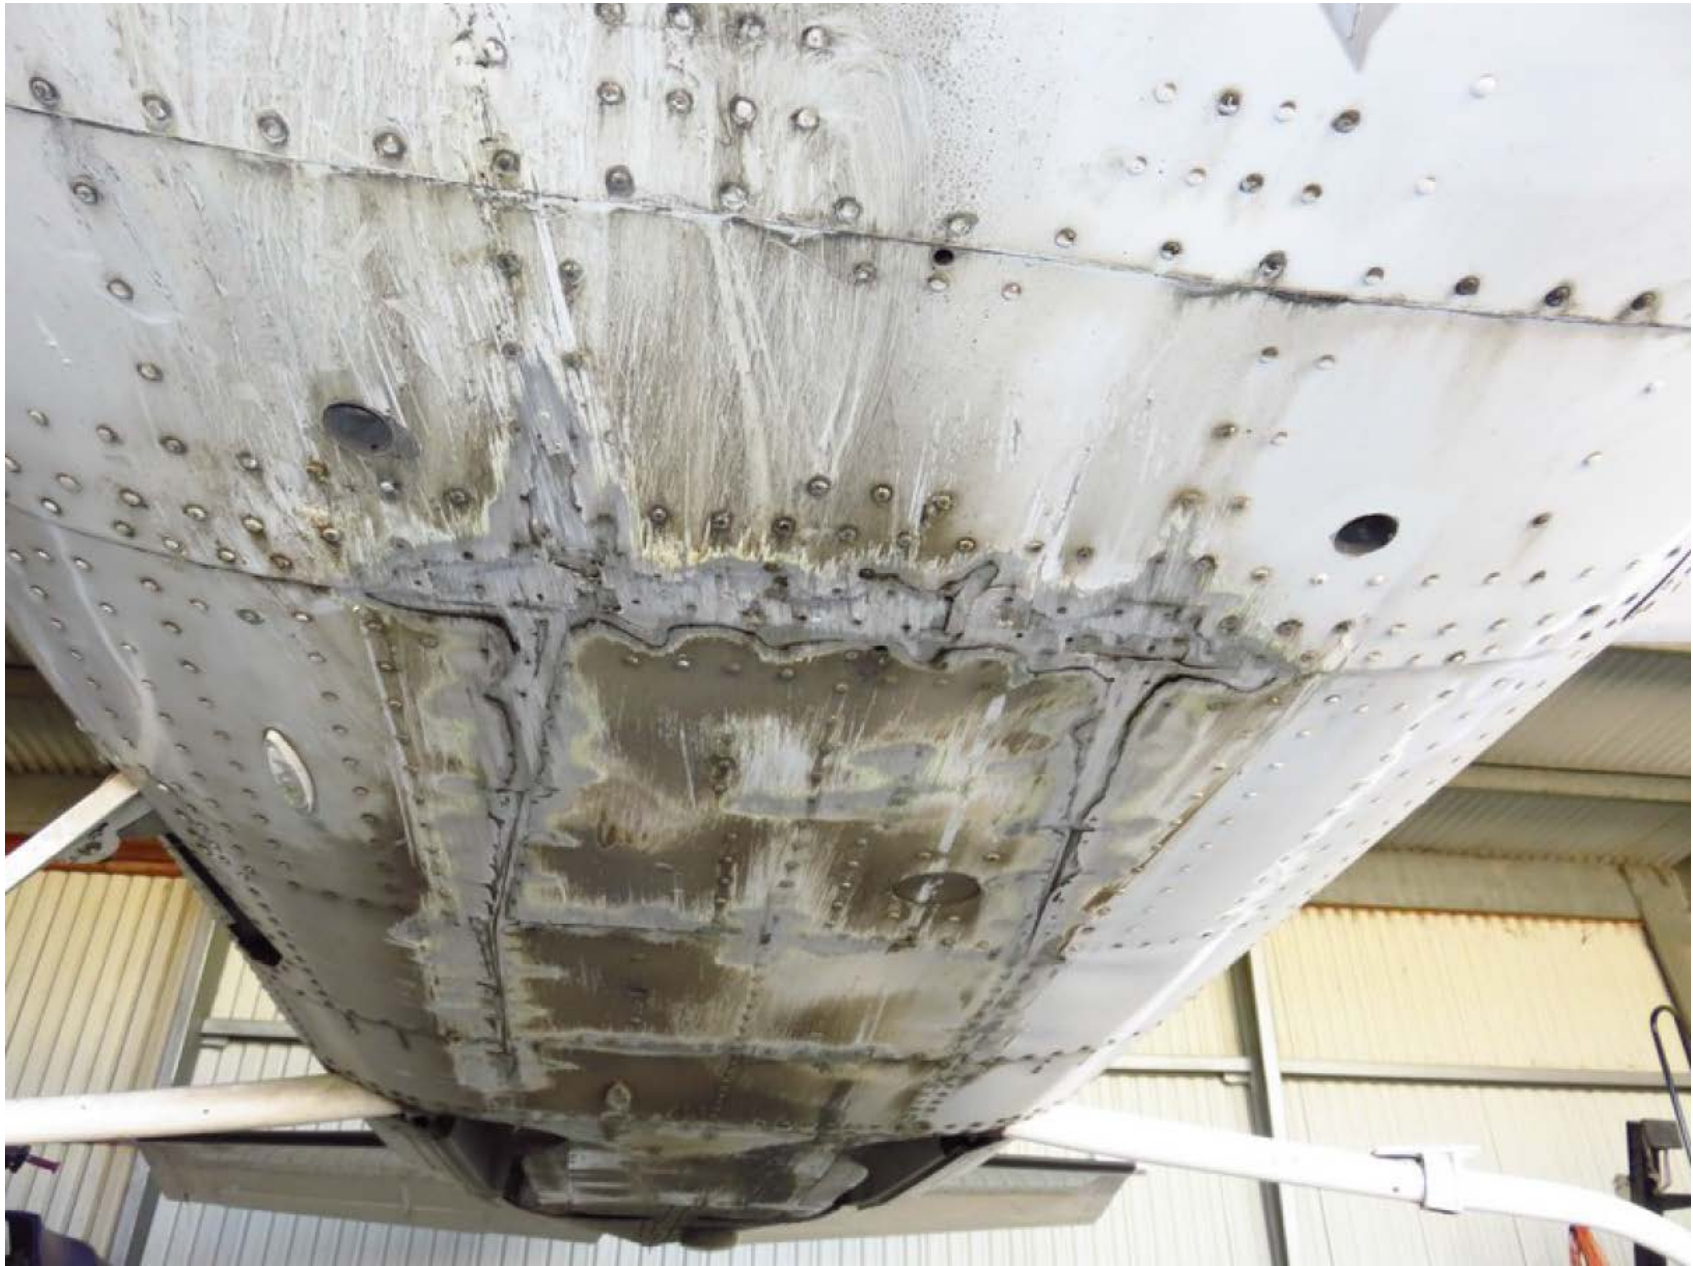
**Photo 1 – View of damage to longerons and formers (Courtesy of FAA)**
