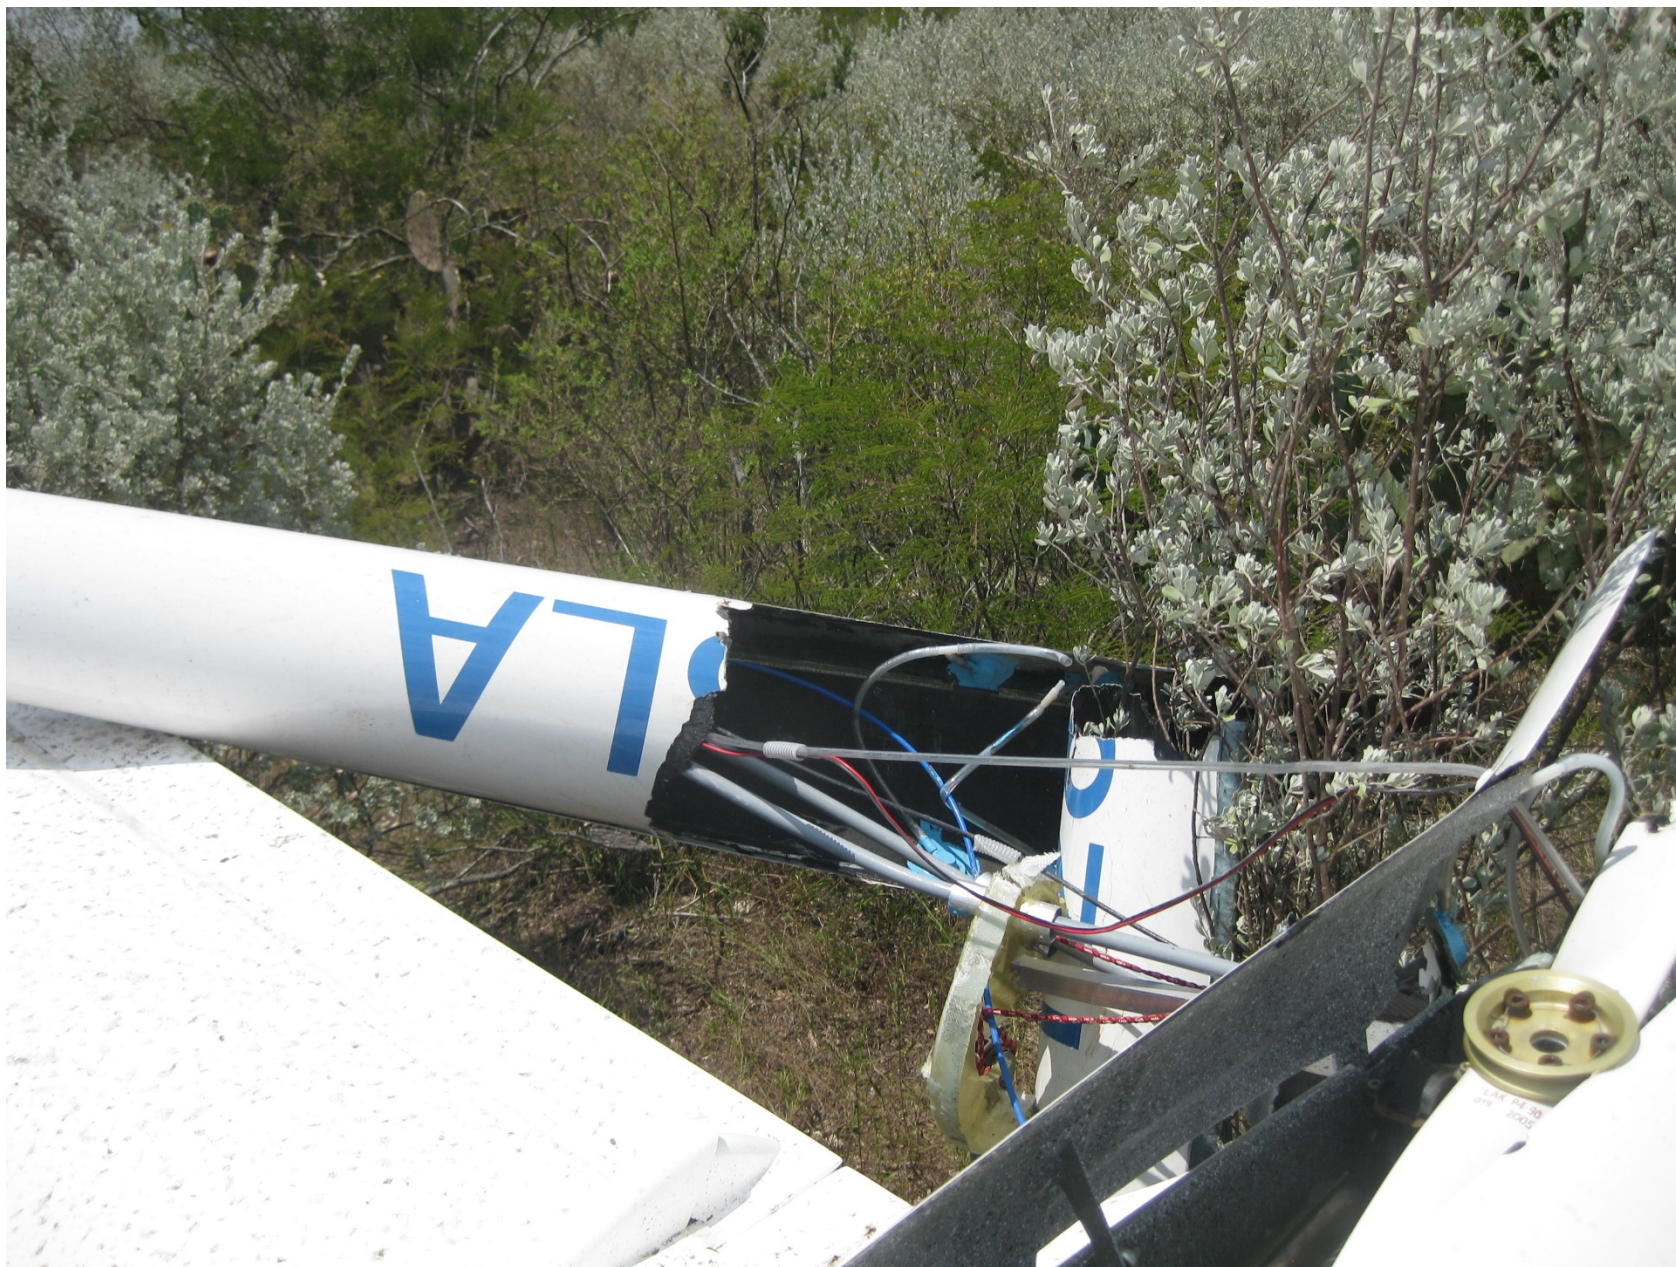
**Photo 1 – Substantially Damaged Fuselage (Photo Courtesy of FAA)**

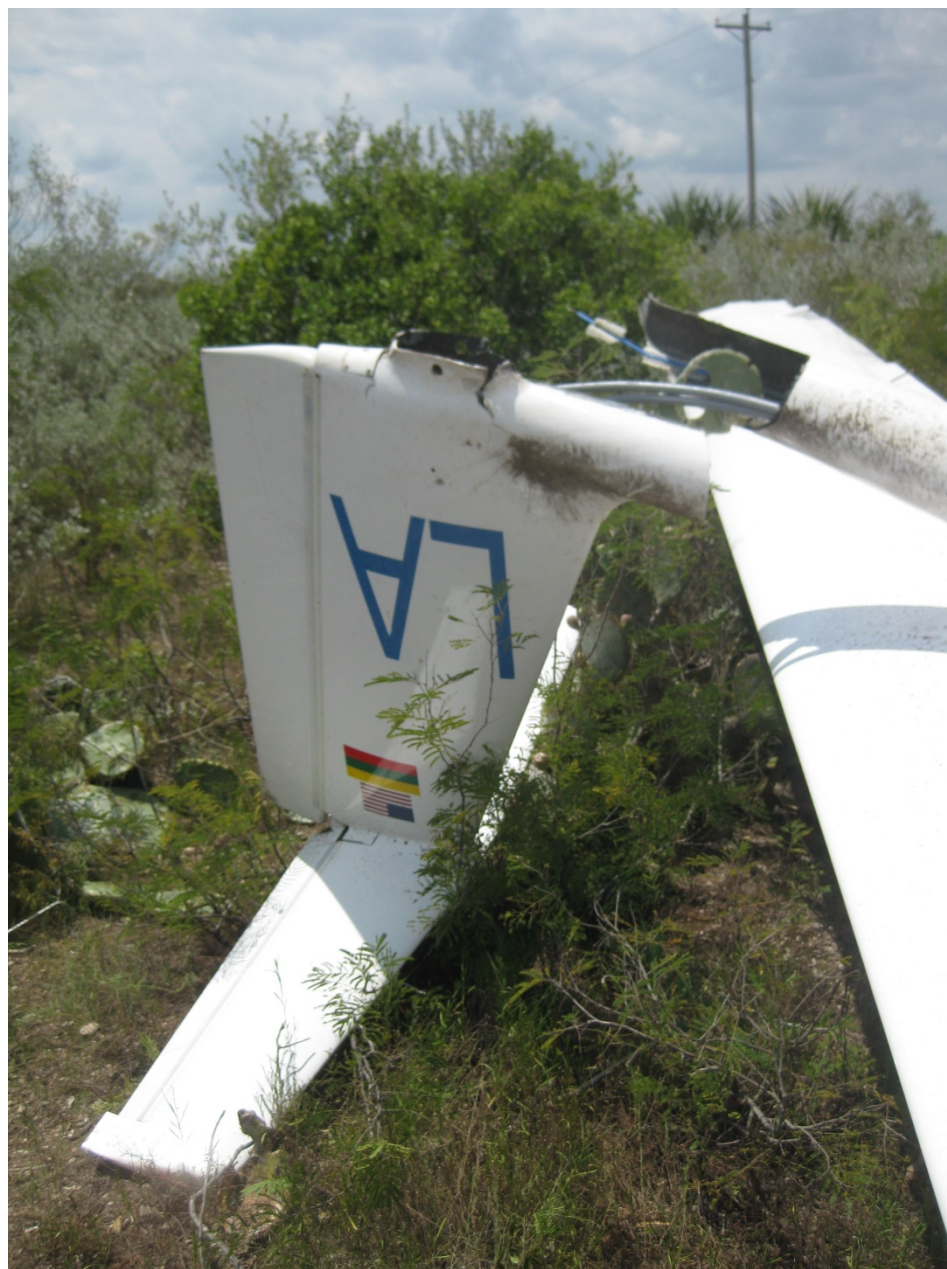
**Photo 2 - Substantially Damaged Empennage (Photo Courtesy of FAA)**

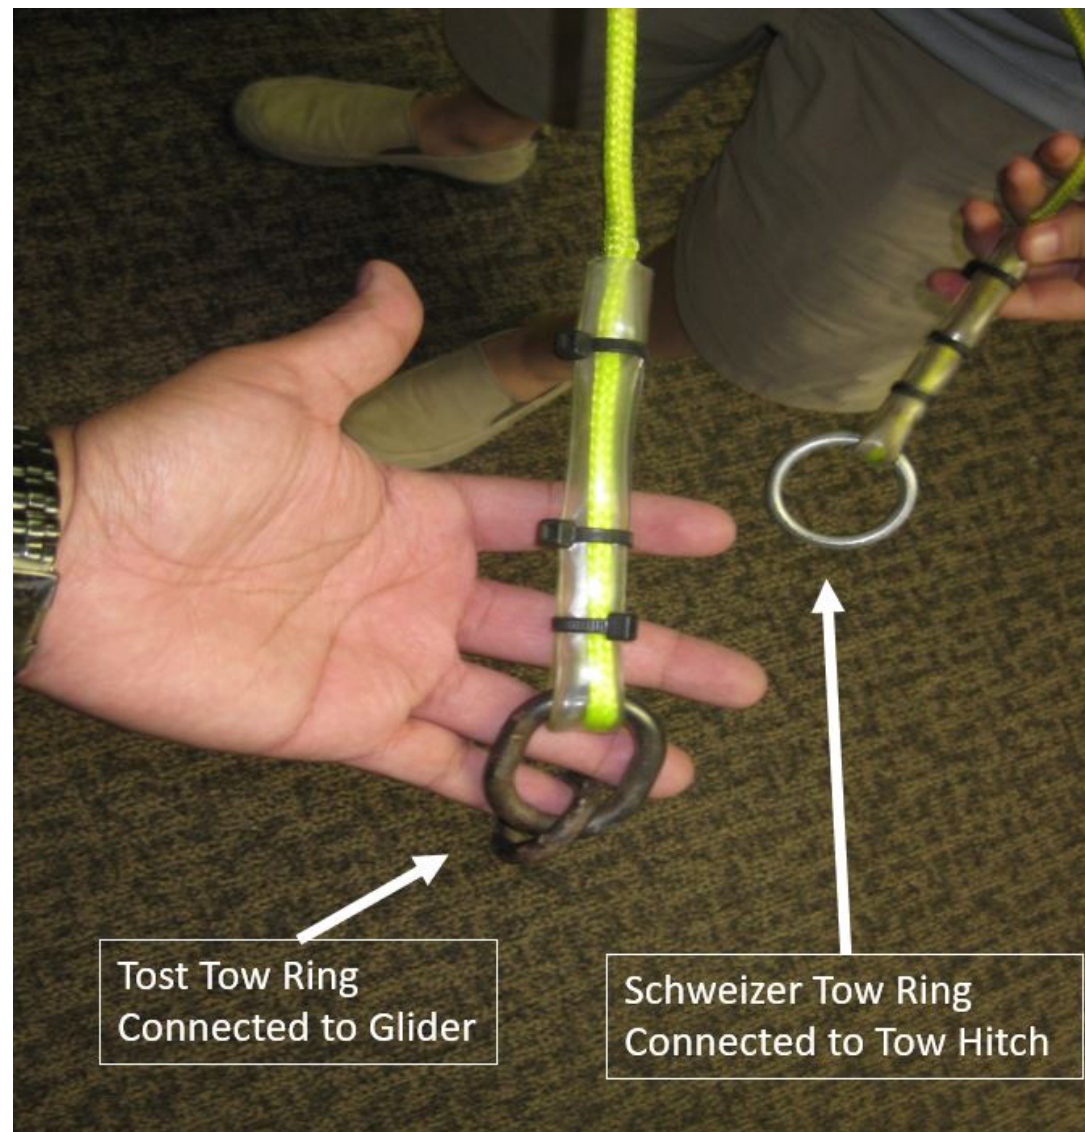
**Photo 3 – Tost and Schweizer Tow Rings from Accident (Photo Courtesy of FAA)**
