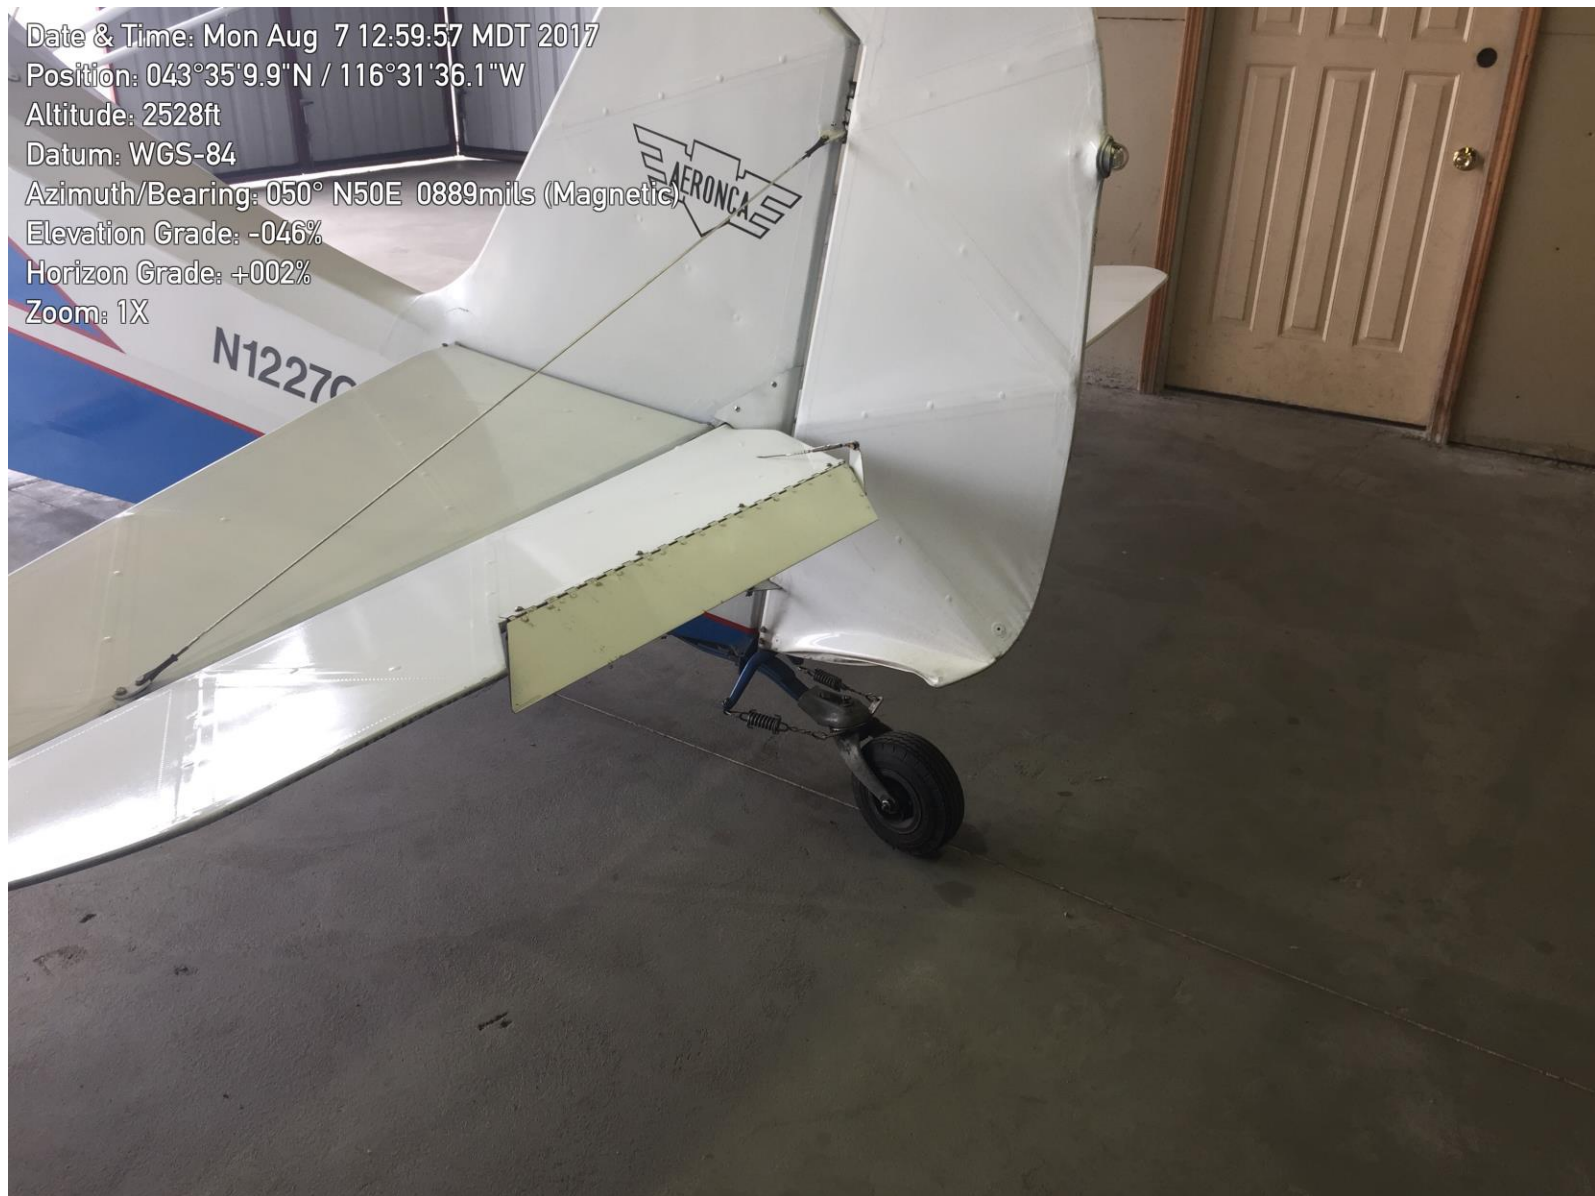
**Photo 1 – View of rudder damage (photo courtesy of the FAA).**
