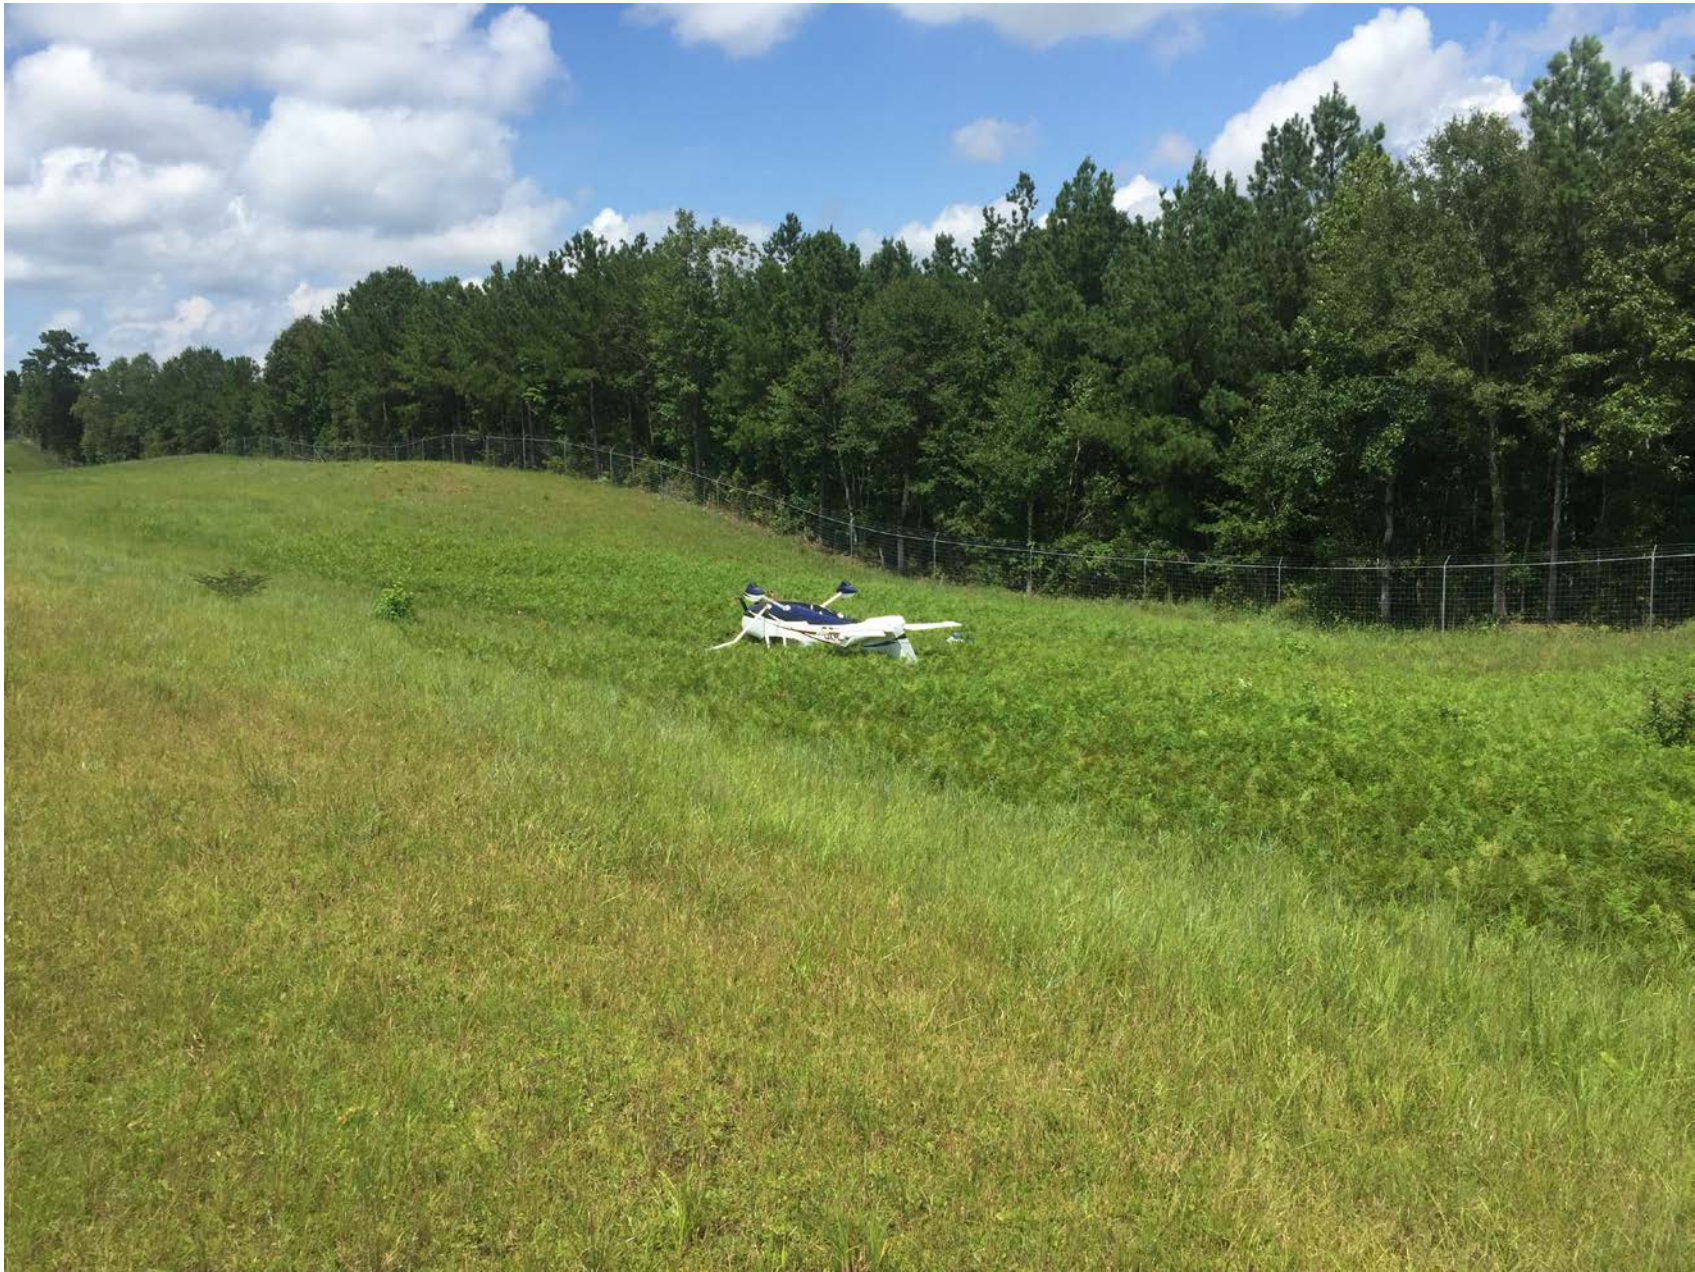
**Photo 1 – View of airplane inverted (photo courtesy of the FAA)**

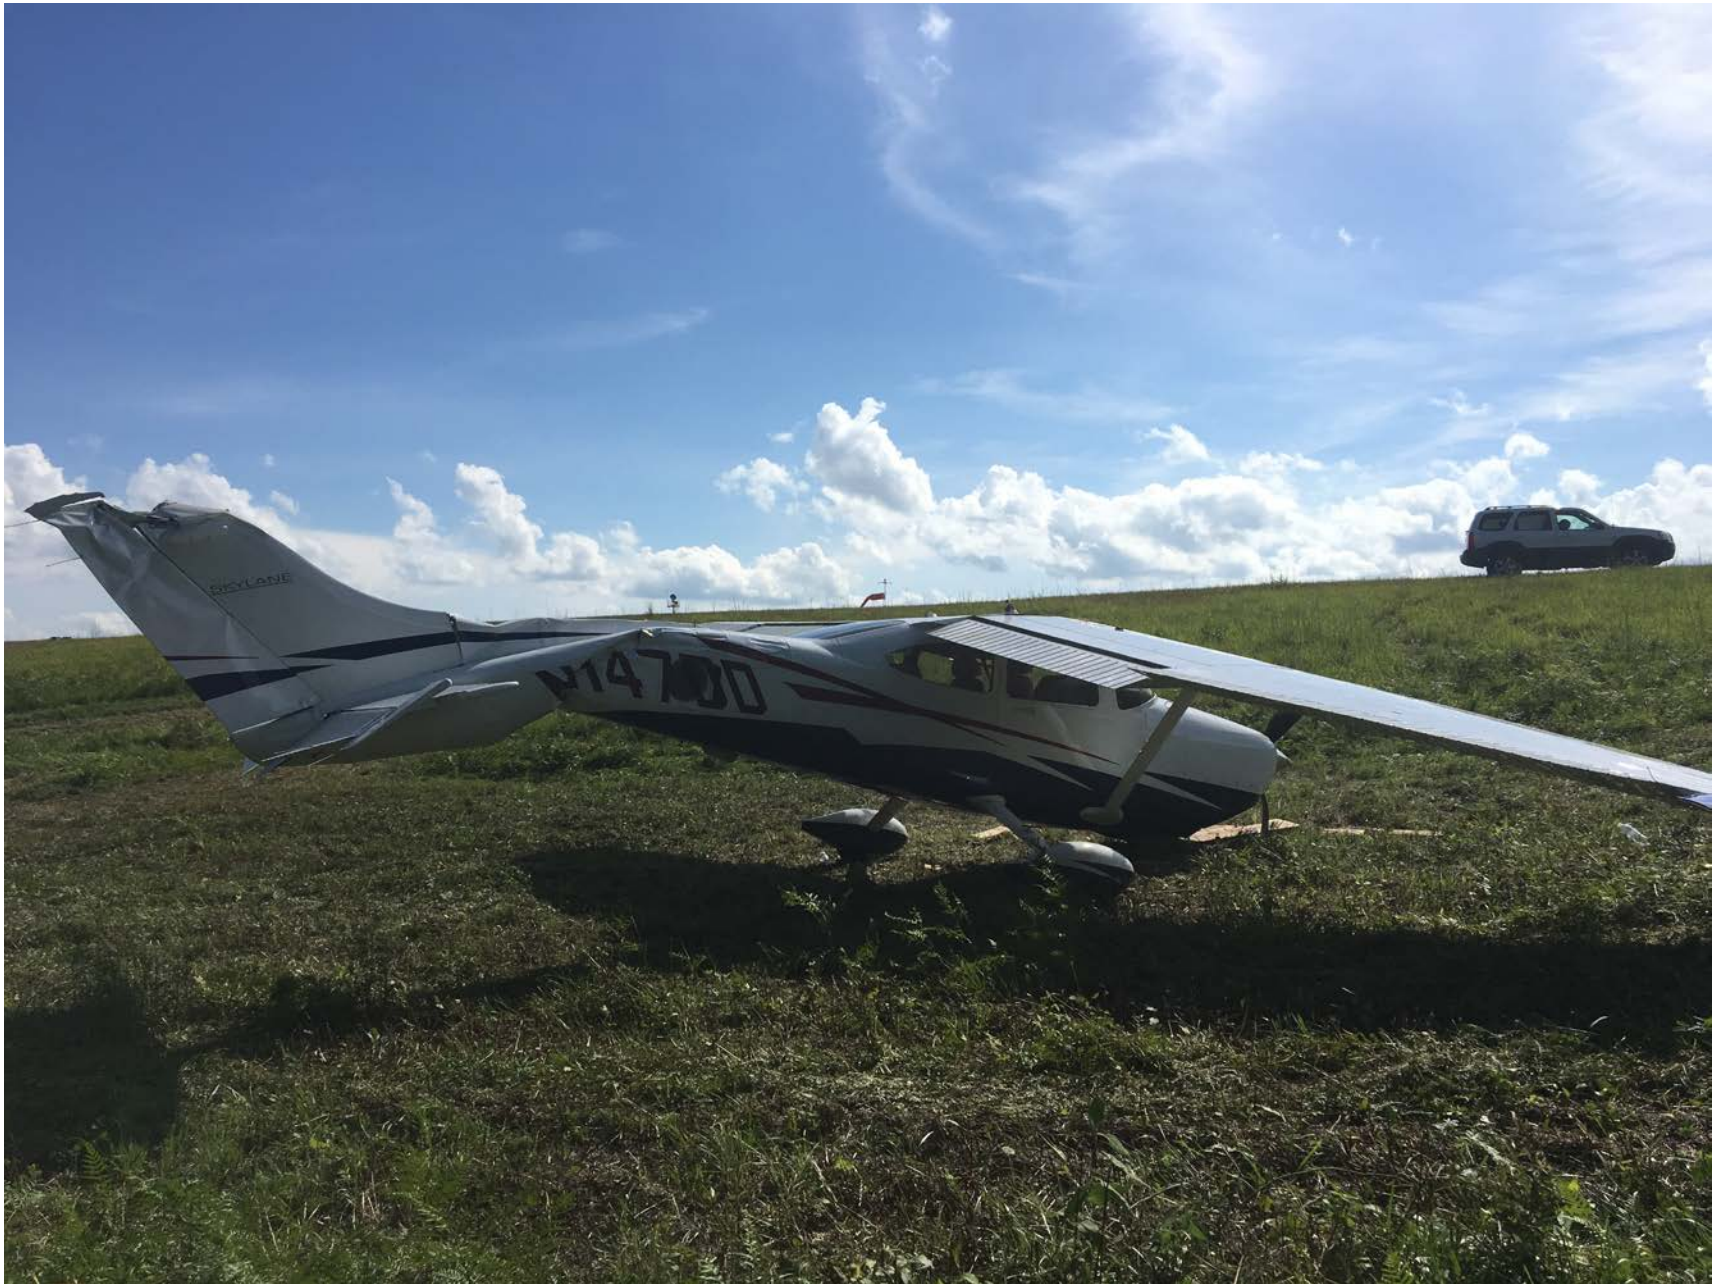
**Photo 2 – View of damaged empennage and wings (photo courtesy of the FAA)**
