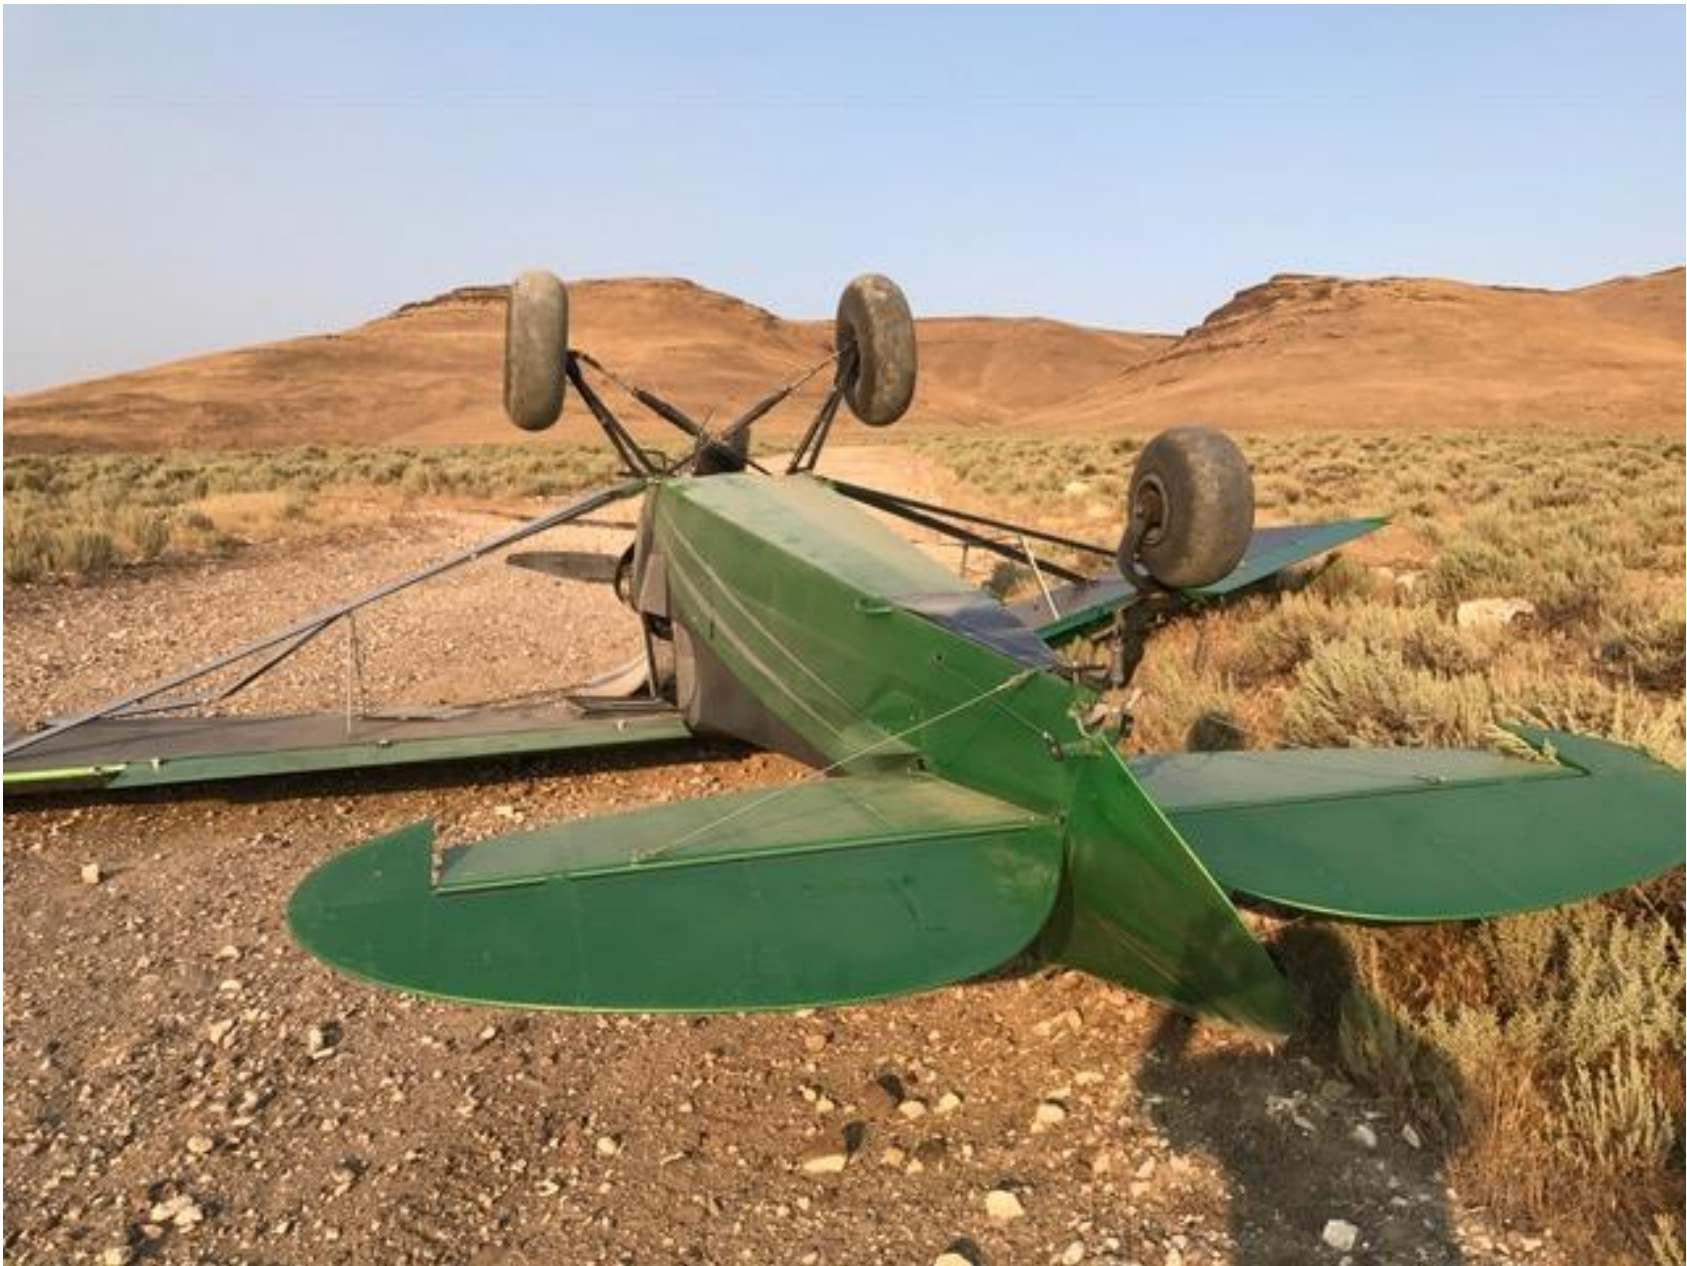
**Photo 1 – View of empennage damage (photo courtesy of the FAA)**

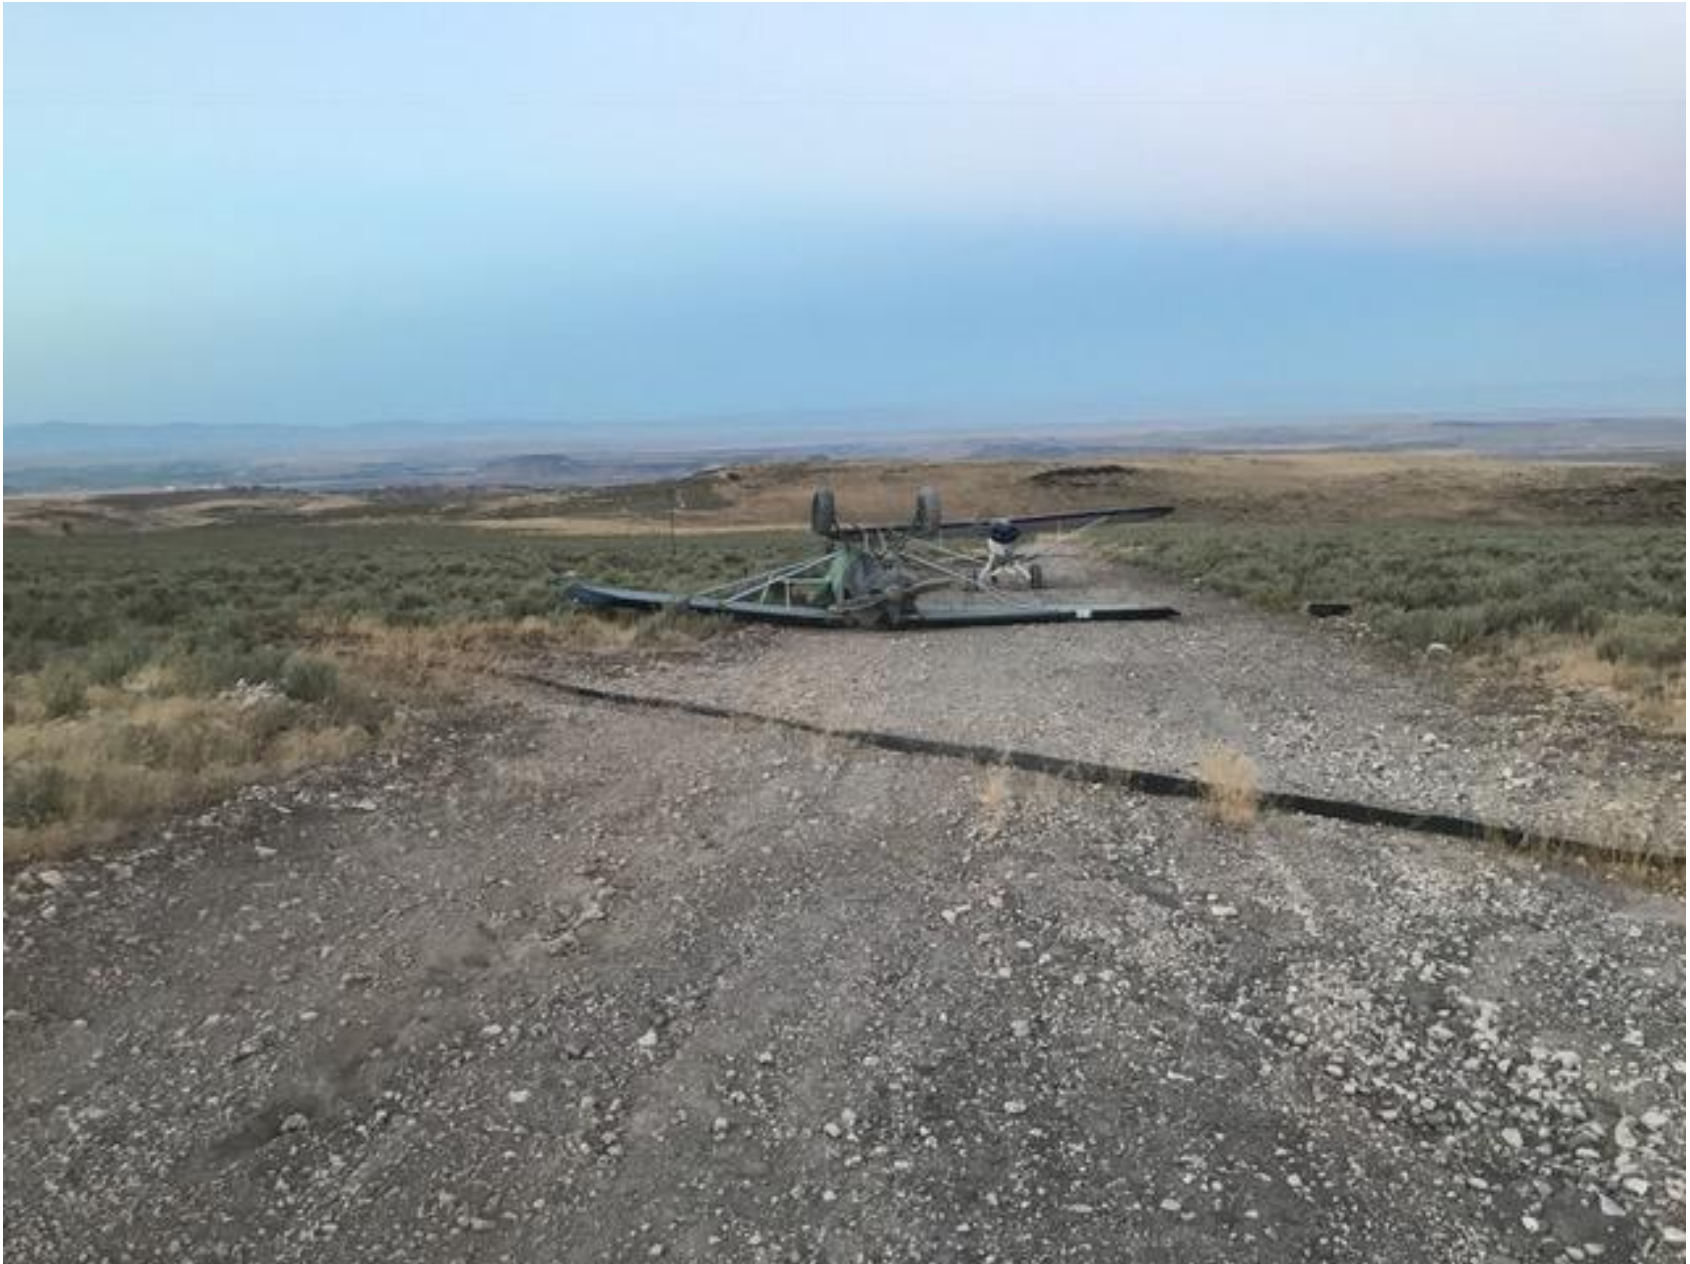
**Photo 2 - View of sand bar (photo courtesy of the FAA).**
