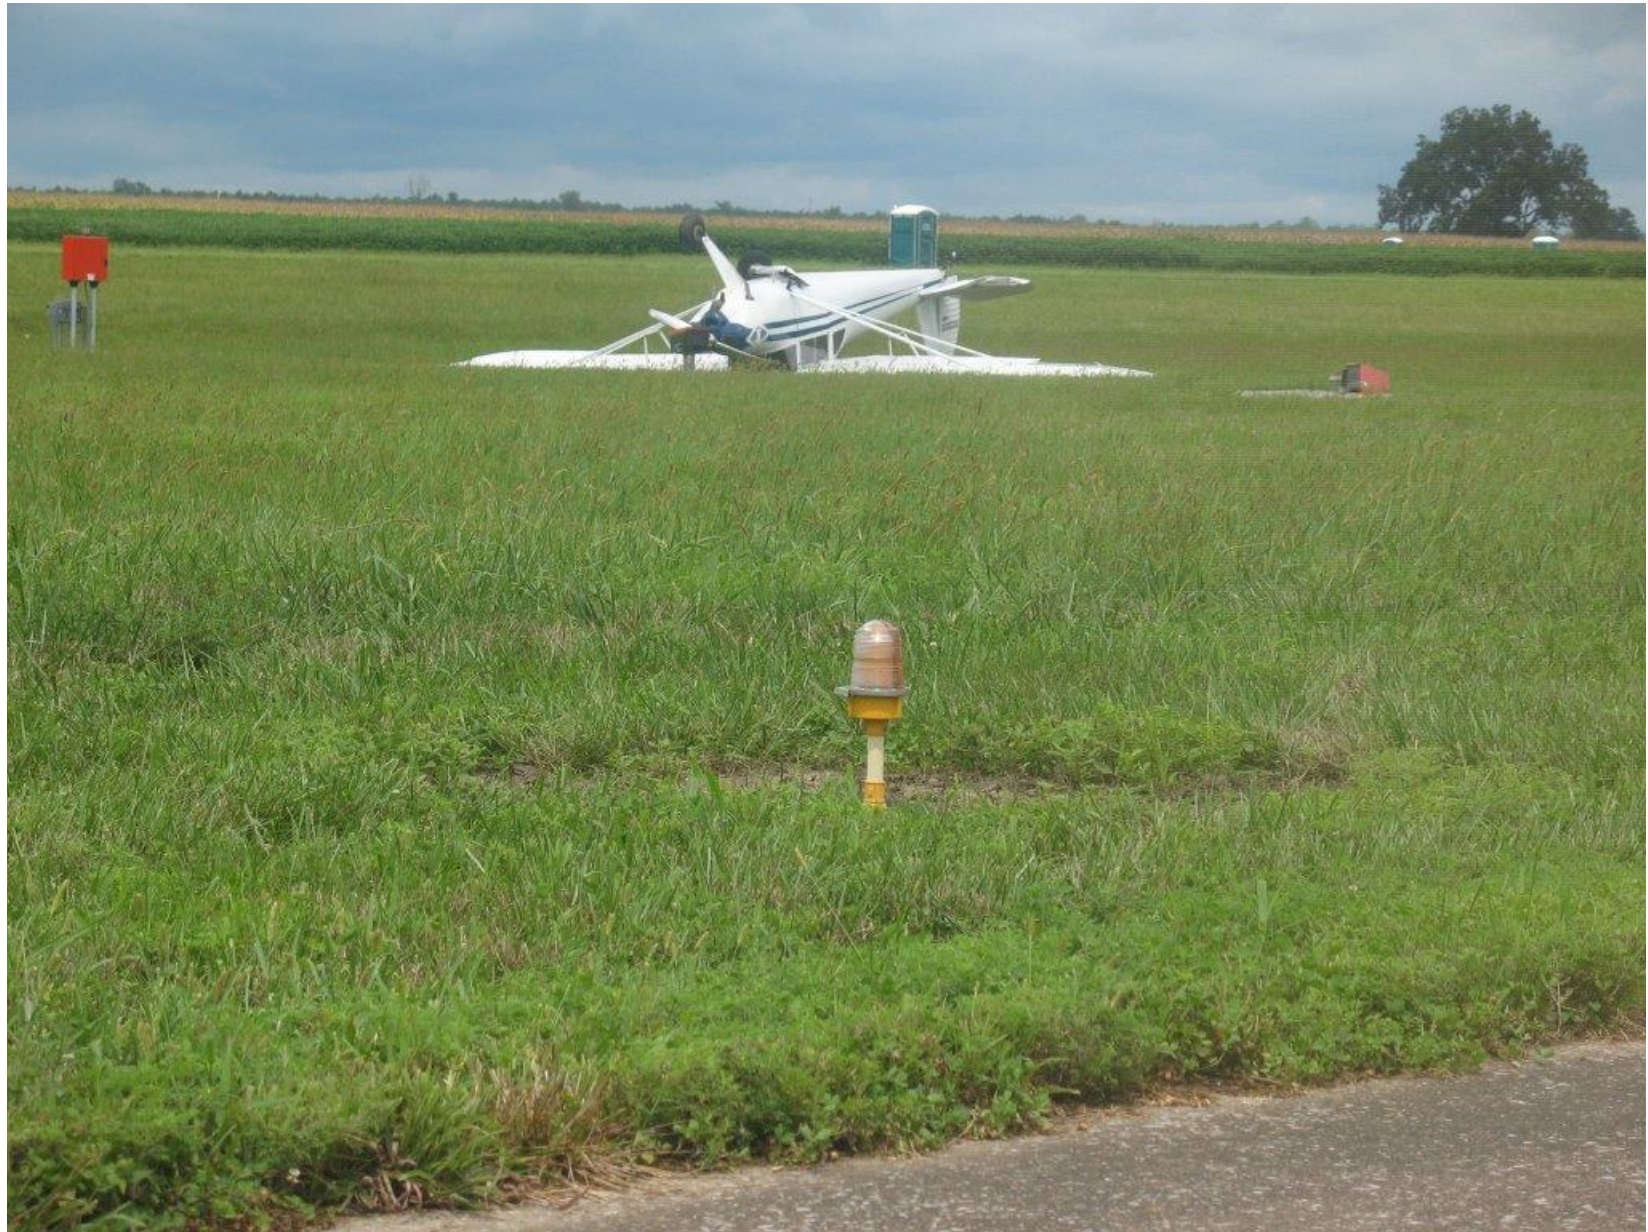
**Photo 1 – View of airplane inverted (photo courtesy of the FAA)**

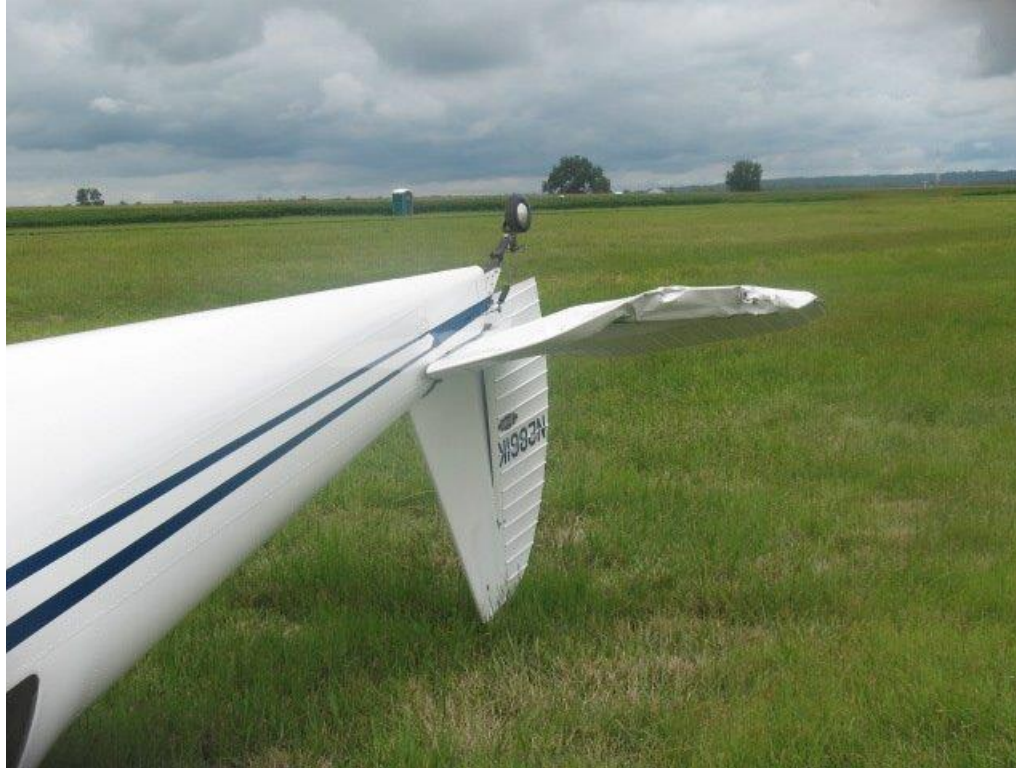
**Photo 2 – View of damaged empennage (photo courtesy of the FAA)**
