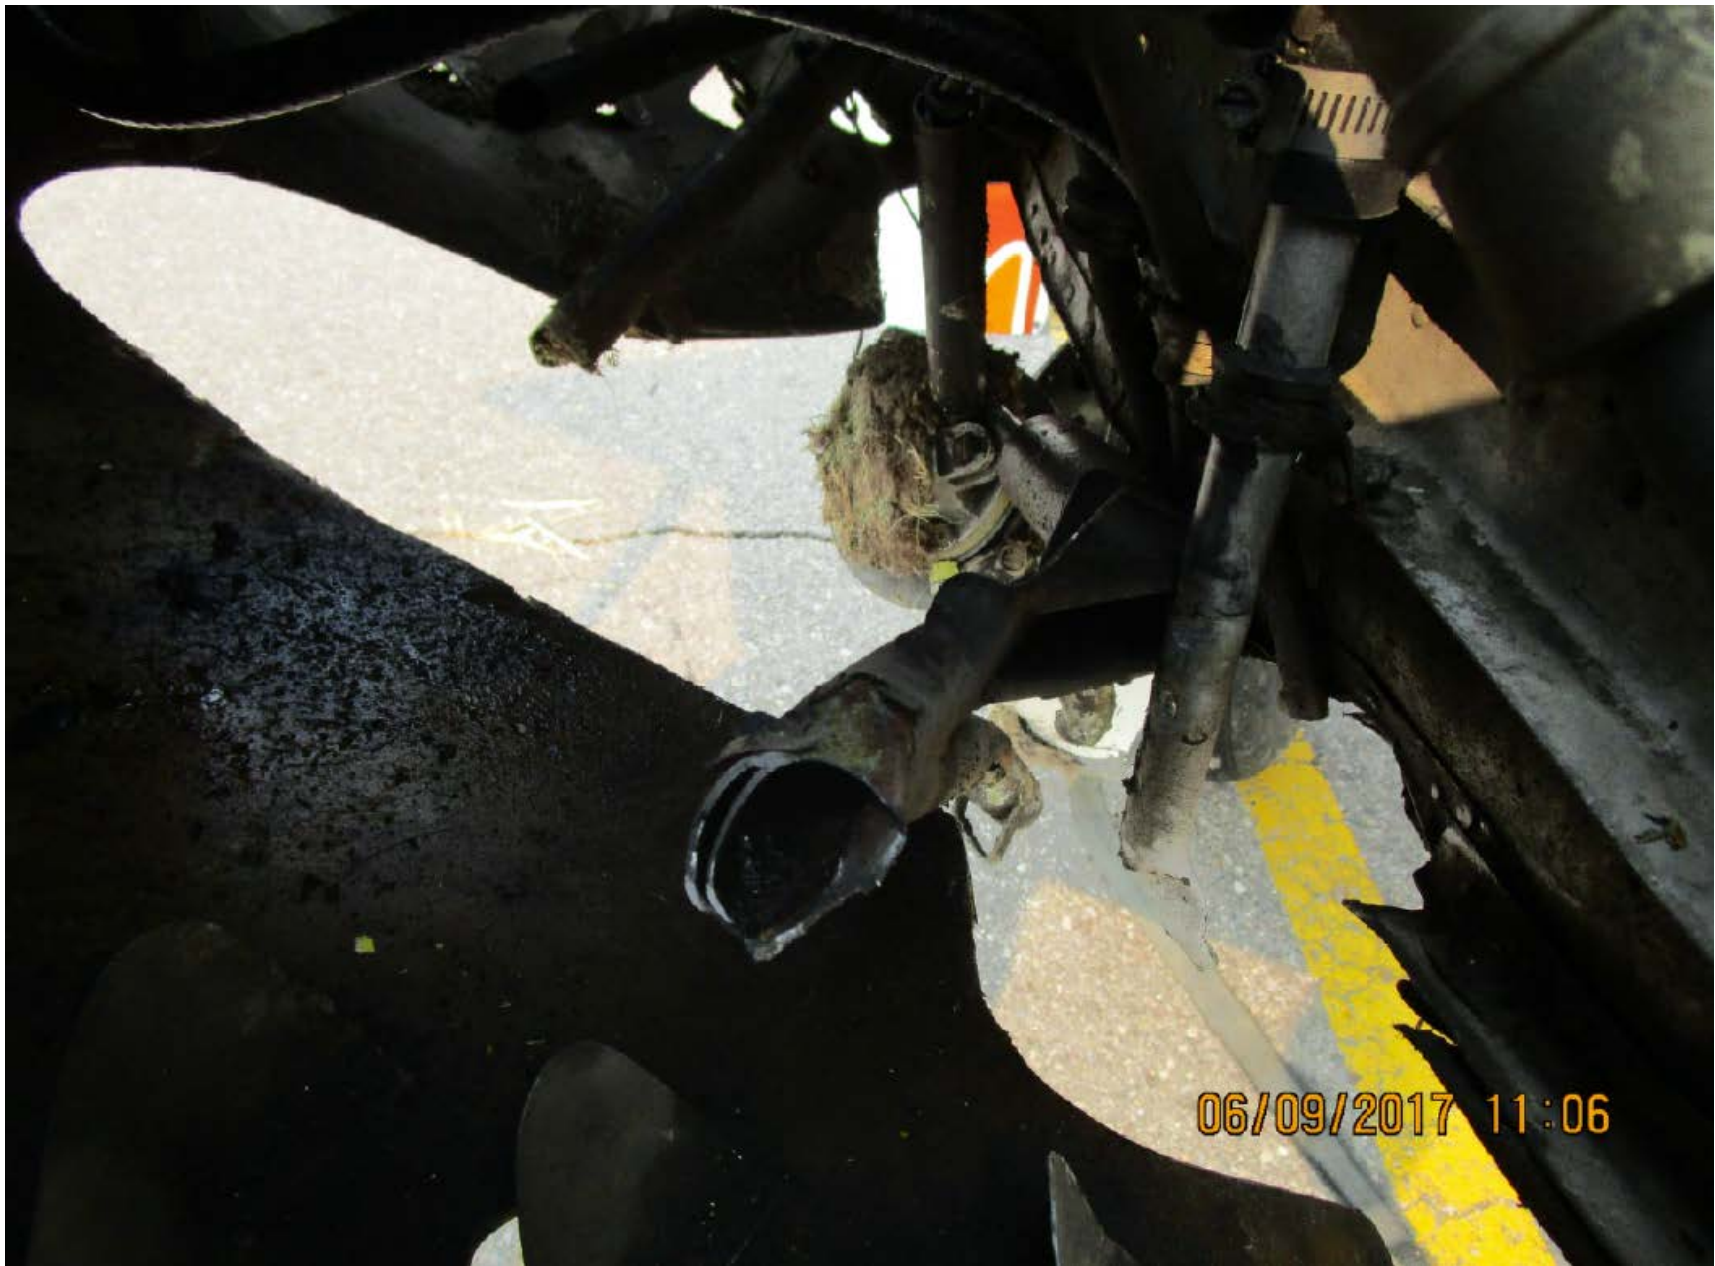
**Photo 1 – View of damage to engine mounts (Courtesy of FAA)**
